## VEHICLE INSPECTION REPORT

**BN64CWZ**

### Nissan Juke 1.2 DiG-T Acenta Premium 5dr

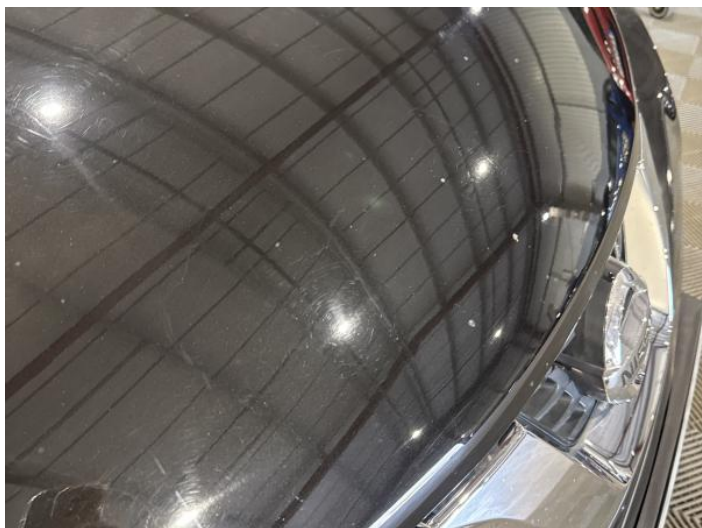
1: Bonnet  
Chipped  
1 To 5

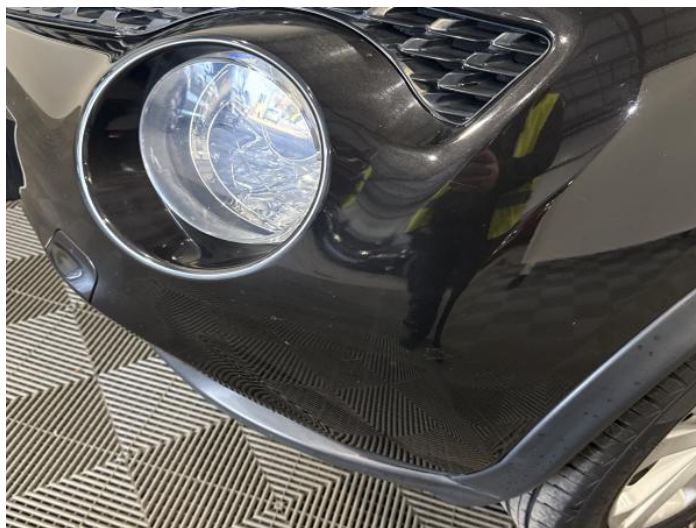
2: Bumper Front  
Scratched  
25 to 100mm Thru Paint

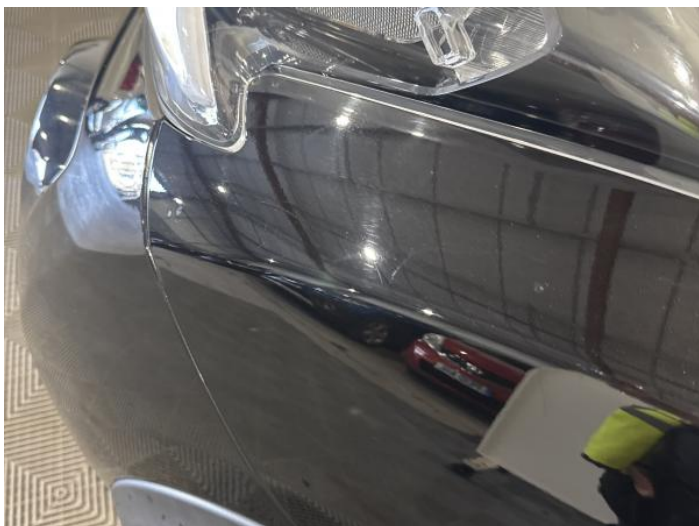
3: Wing nsf  
Scratched  
UpTo 25mm Thru Paint

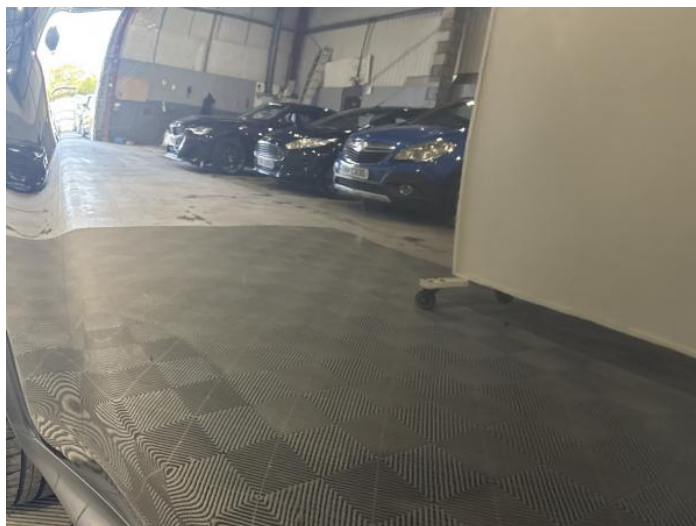
4: Door nsf  
Scratched  
UpTo 25mm Thru Paint

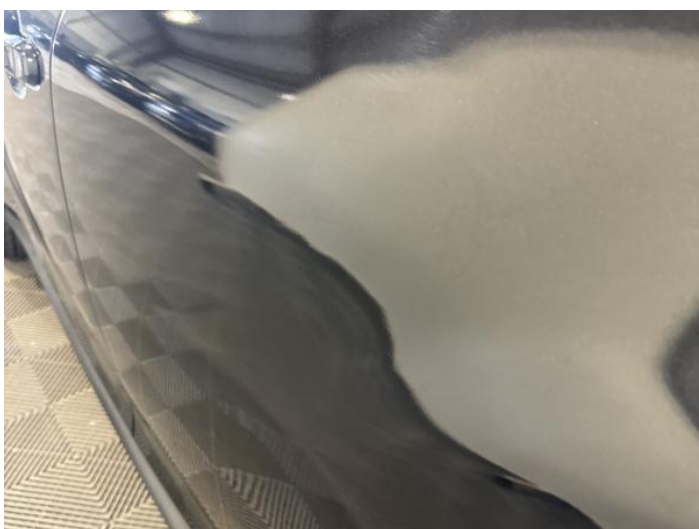
5: Door nsr  
Poor Previous Repair  
Poor Paint

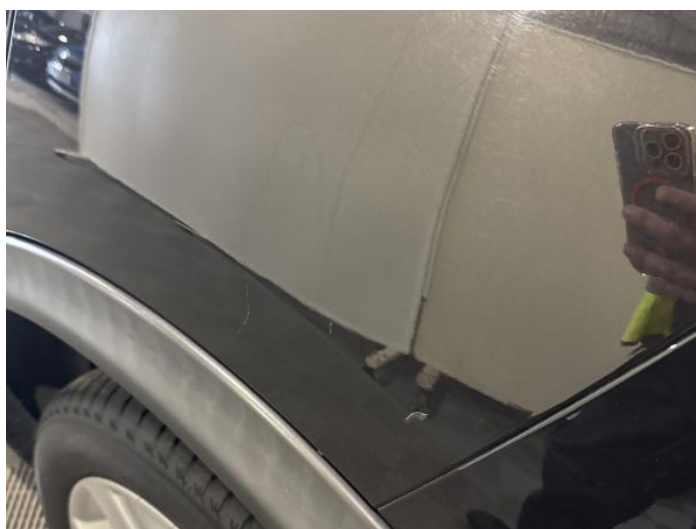
6: Qtr Panel nsr  
Scratched  
Over 25mm Thru Paint

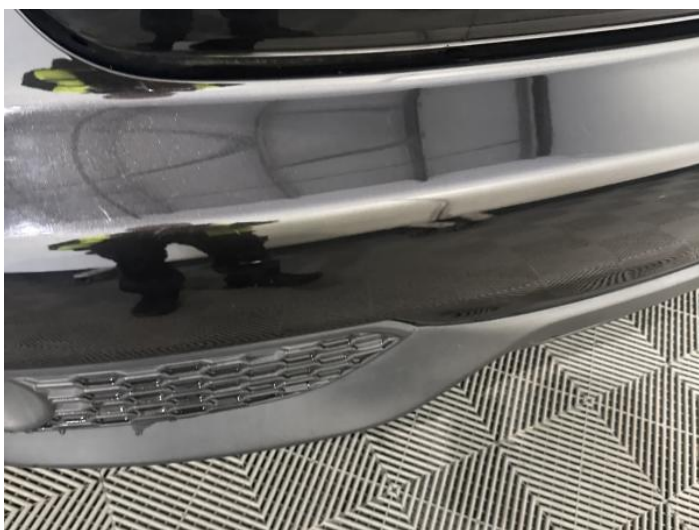
7: Bumper Rear  
Scratched  
25 to 100mm Thru Paint

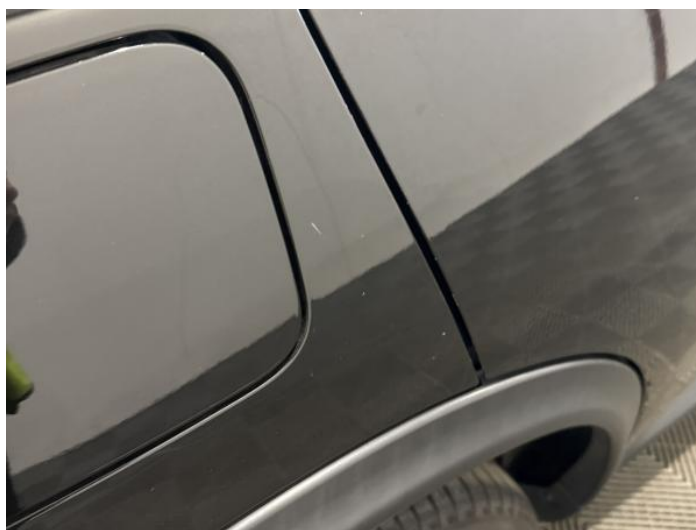
8: Qtr Panel osr  
Scratched  
UpTo 25mm Thru Paint

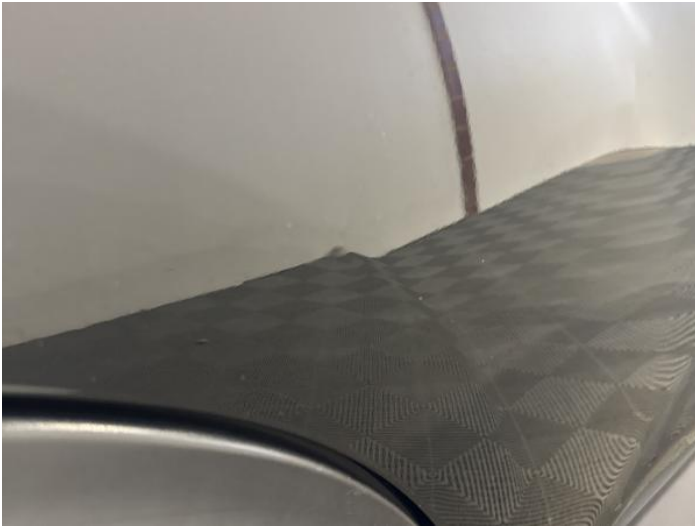
9: Door osr  
Dented  
2 Or Less UpTo 10mm

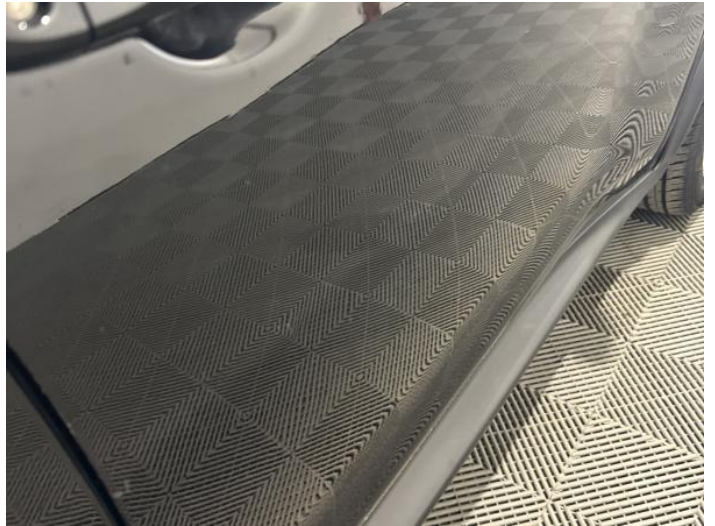
10: Door osf  
Scratched  
Over 25mm Thru Paint

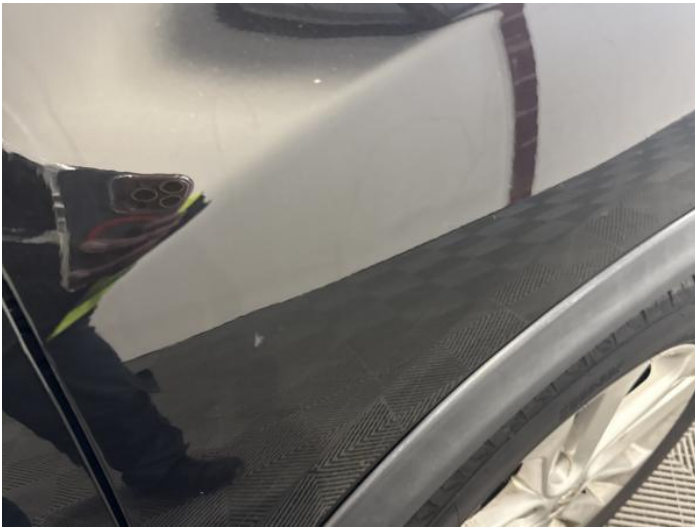
11: Wing osf  
Scratched  
UpTo 25mm Thru Paint

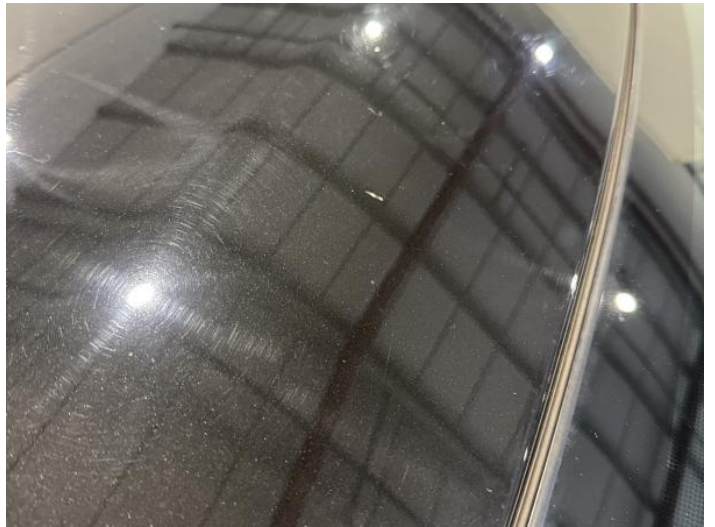
12: Roof  
Chipped  
1 To 5

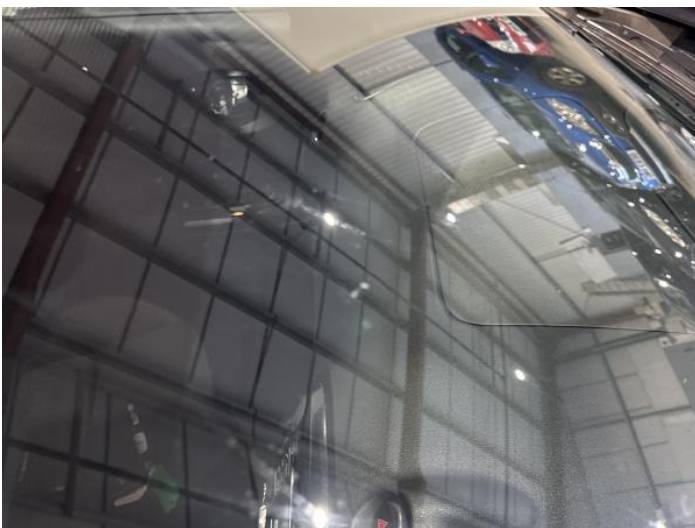
13: Screen Front  
Chipped  
UpTo 10mm
