VEHICLE INSPECTION REPORT

GY17UGP

Honda HR-V 1.5 i-VTEC EX CVT 5dr

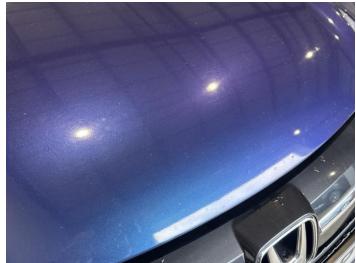
1: Bonnet Chipped Multiple Chips

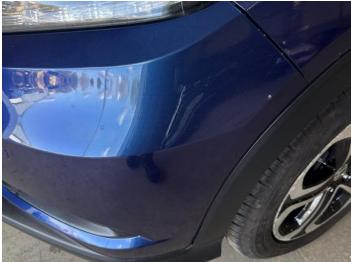
2: Bumper Front Scratched 25 to 100mm Thru Paint

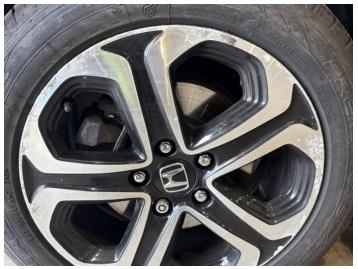
3: Wheel nsf Scratched Over 50mm

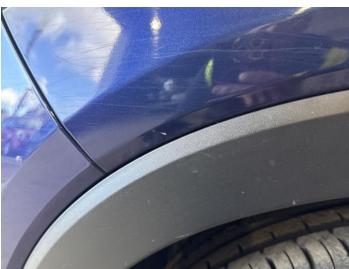
4: Wing nsf Scratched UpTo 25mm Thru Paint

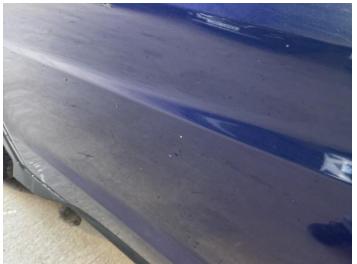
5: Door nsf Chipped Multiple Chips

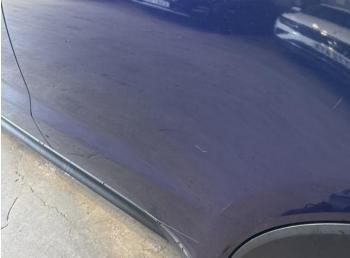
6: Door nsr Scratched Over 25mm Thru Paint

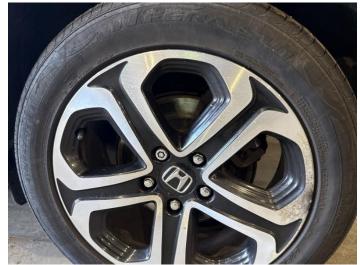
7: Wheel nsr Corroded Light

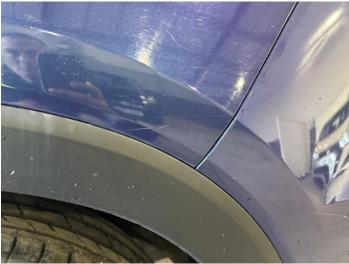
8: Qtr Panel nsr Scratched UpTo 25mm Thru Paint

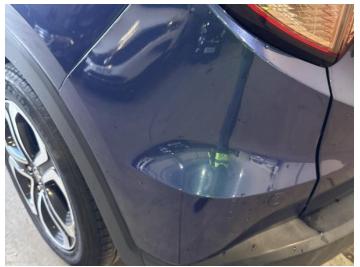
9: Bumper RearScratched25 to 100mm Thru Paint

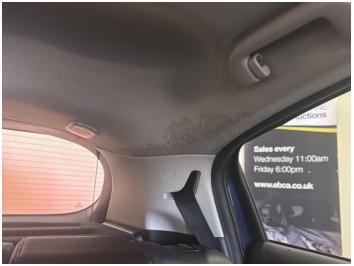
11: Roof Lining Soiled Light

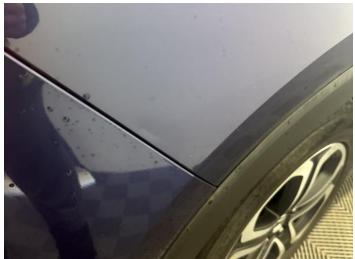
12: Qtr Panel osr Dented Between 10mm + 30mm

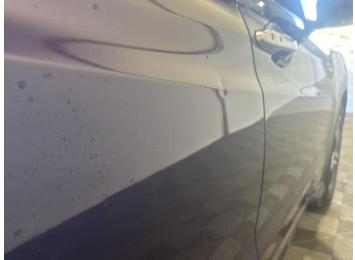
13: Door osr Dented Over 30mm

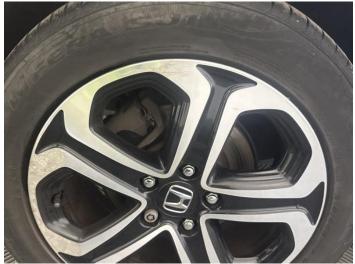
14: Wheel osr Corroded Light

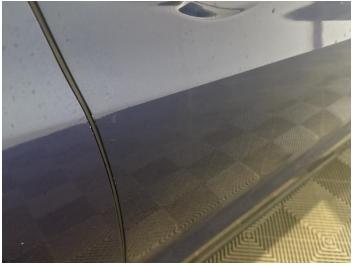
15: Door osf Chipped Edge Chip

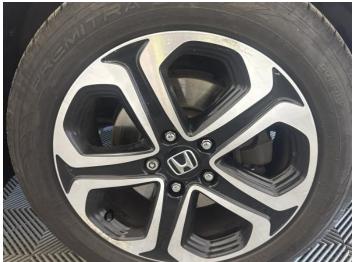
16: Wheel osf Scratched Over 50mm

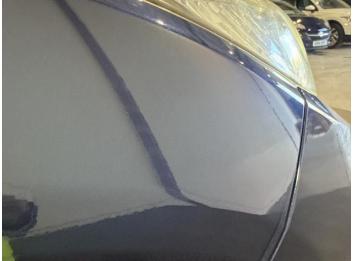
17: Wing osf Poor Previous Repair Poor Paint
