## VEHICLE INSPECTION REPORT

**GU64CRJ**

### Volkswagen Tiguan 2.0 TDi BlueMotion Tech R-Line 177 5dr DSG

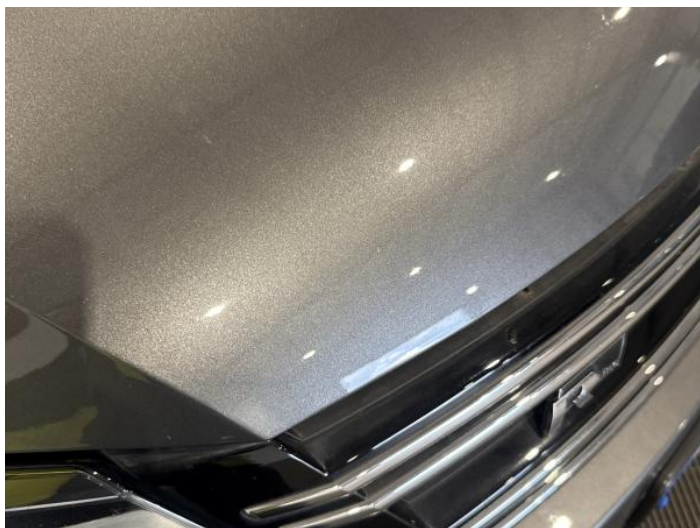
1: Bonnet  
Chipped  
1 To 5

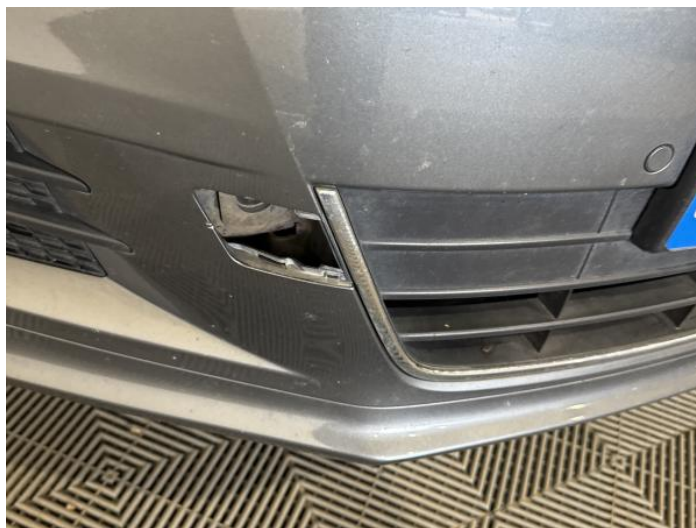
2: Front TowEye Cvr  
Missing  
Replace

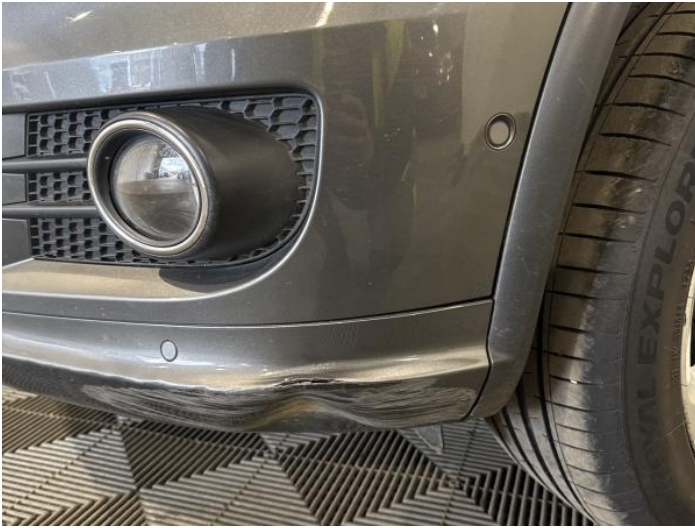
3: Bumper Front  
Cracked  
Over 25mm

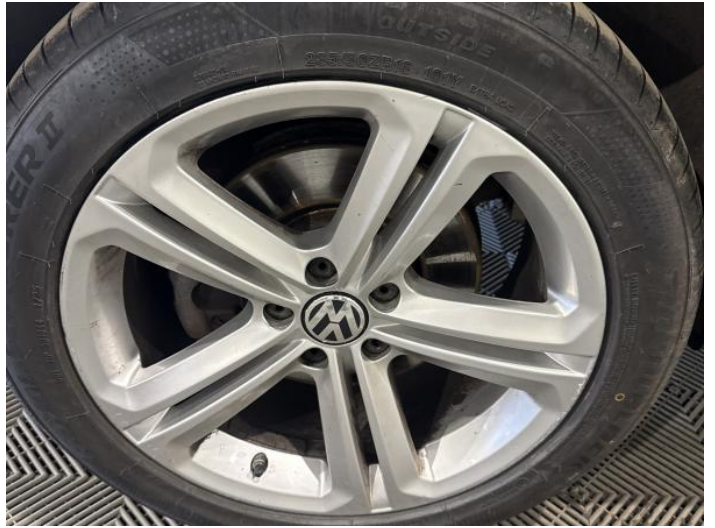
4: Wheel nsf  
Scratched  
Over 50mm

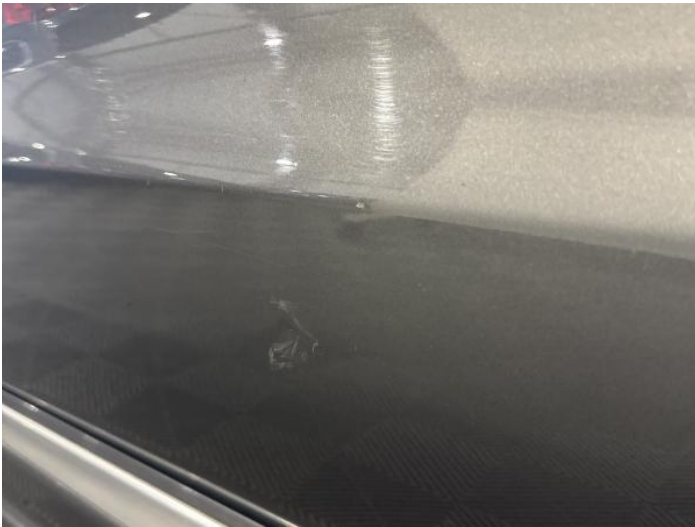
5: Door osf  
Dented  
With Paint Damage

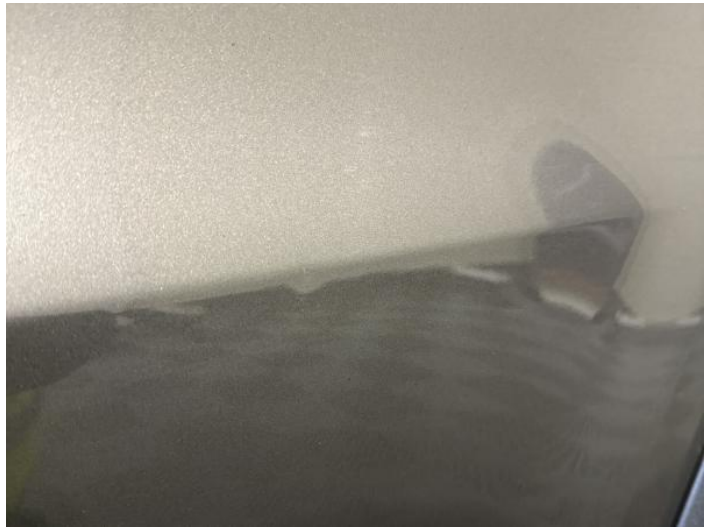
6: Door nsr  
Dented  
2 Or Less UpTo 10mm

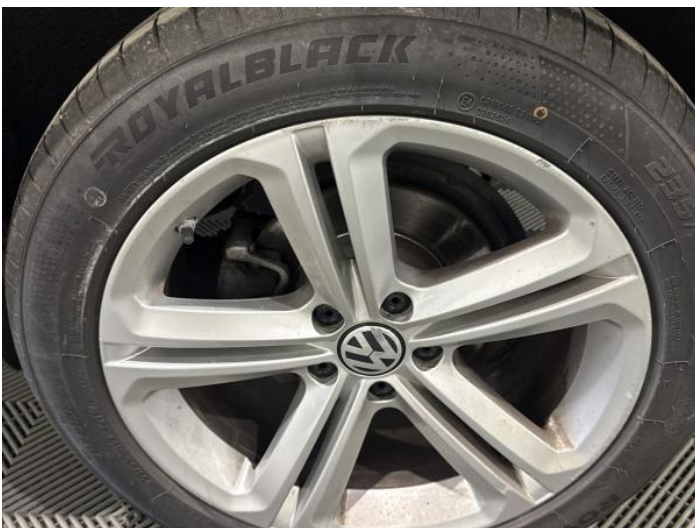
7: Wheel nsr  
Scratched  
Over 50mm

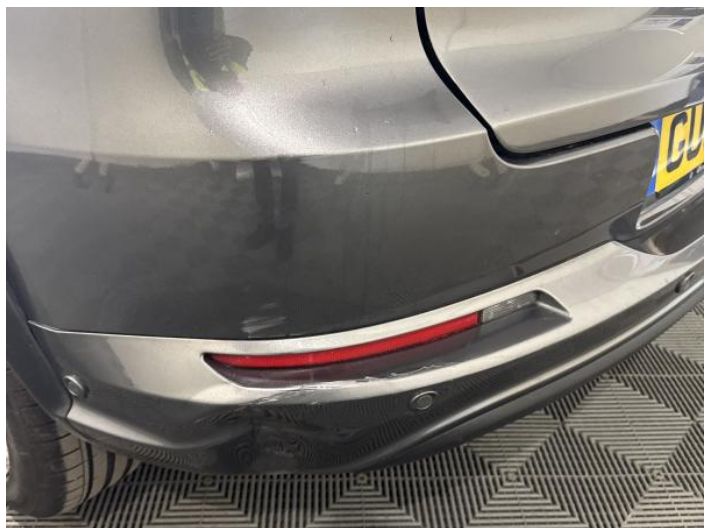
8: Bumper Rear  
Dented  
With Paint Damage

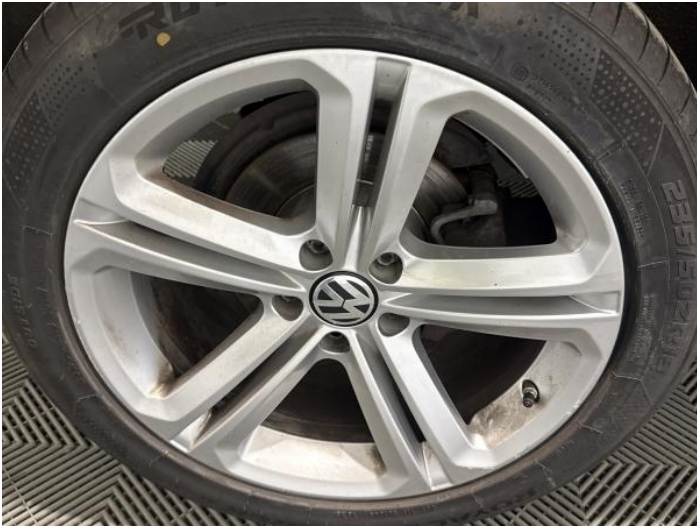
9: Wheel osr  
Scratched  
Over 50mm

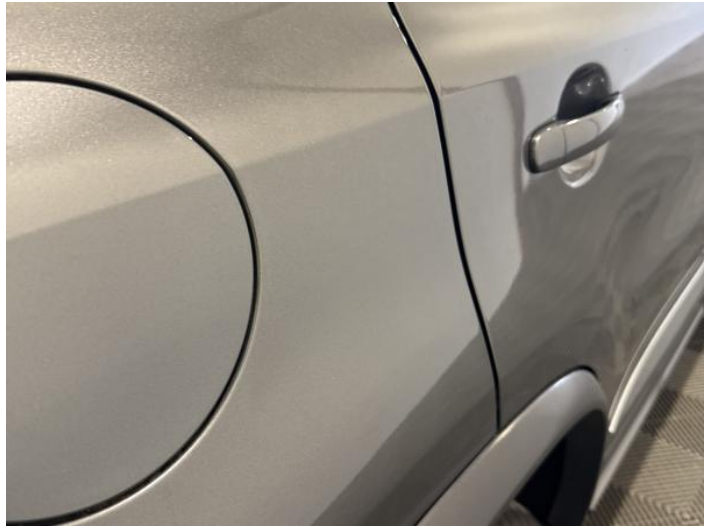
10: Qtr Panel osr  
Dented  
2 Or Less UpTo 10mm

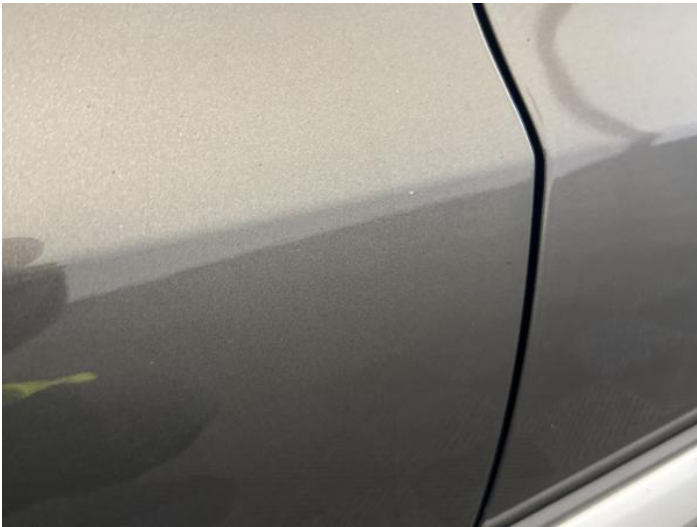
11: Door osr  
Chipped  
1 To 5

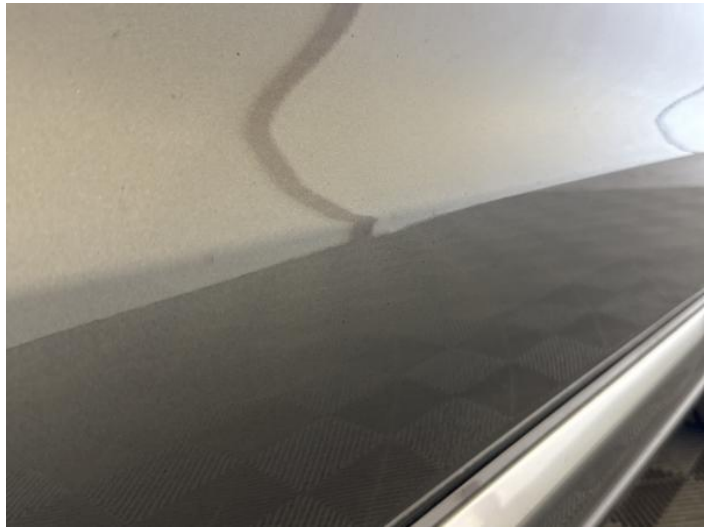
12: Door osf  
Dented  
Over 2 UpTo 10mm

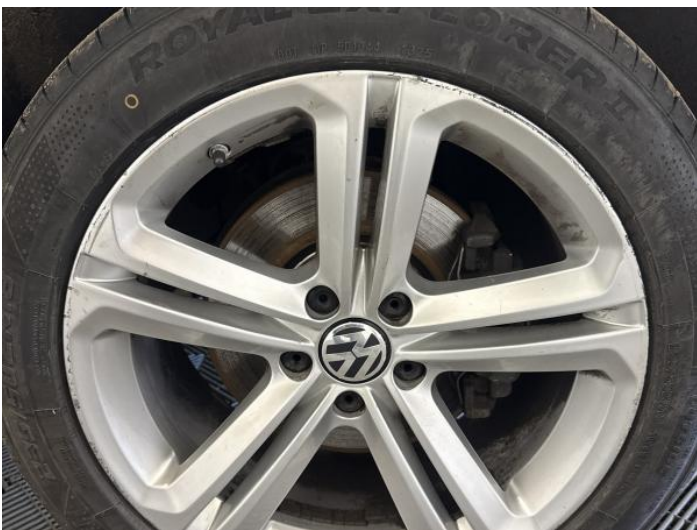
13: Wheel osf  
Scratched  
Over 50mm
