VEHICLE INSPECTION REPORT

WO17OPX

Volkswagen Touran 2.0 TDI SE 5dr

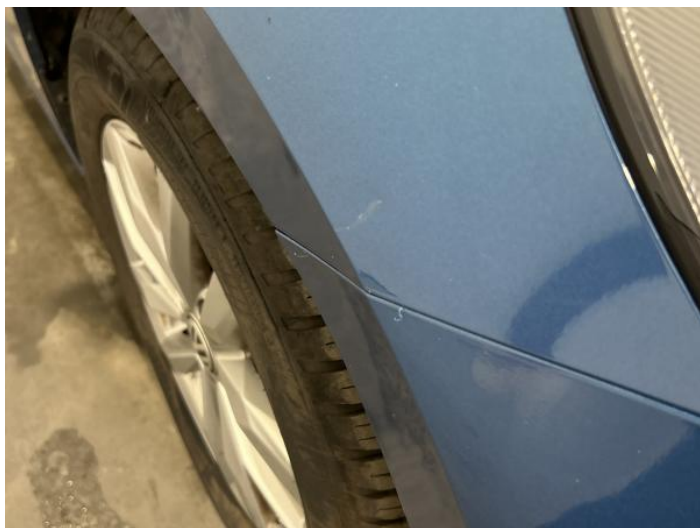
1: Wing osf
Dented
Between 10mm + 30mm

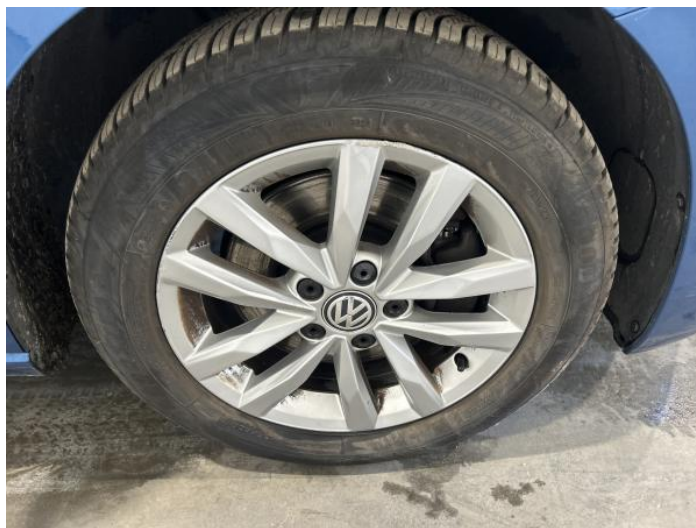
2: Wheel osf
Scratched
Over 50mm

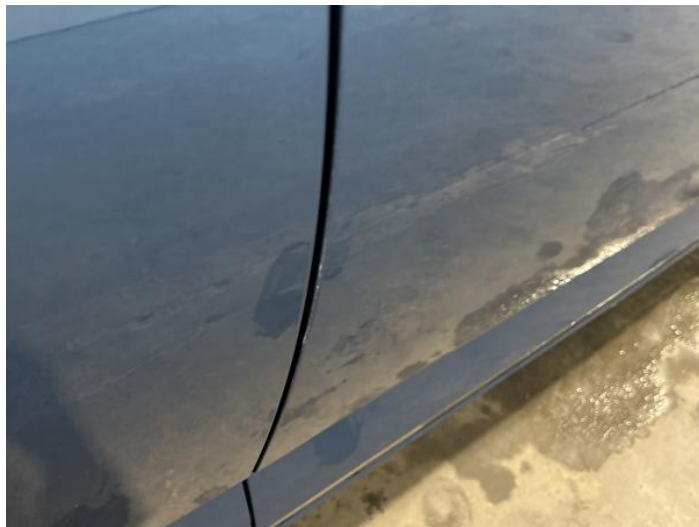
4: Door osf
Chipped
Edge Chip

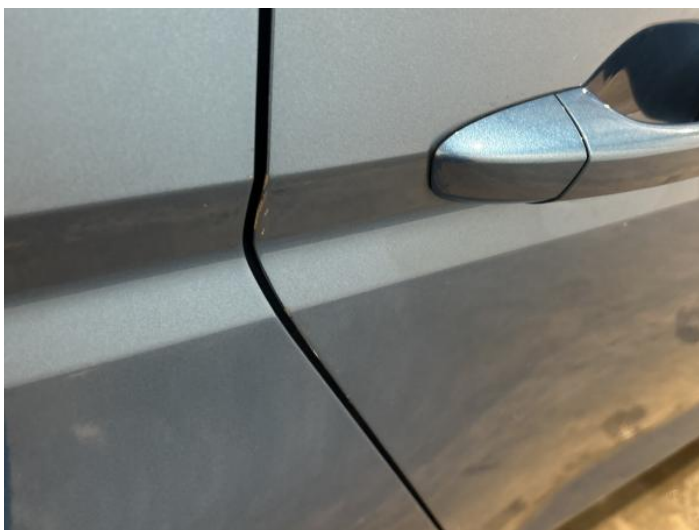
5: Door osr
Chipped
Edge Chip

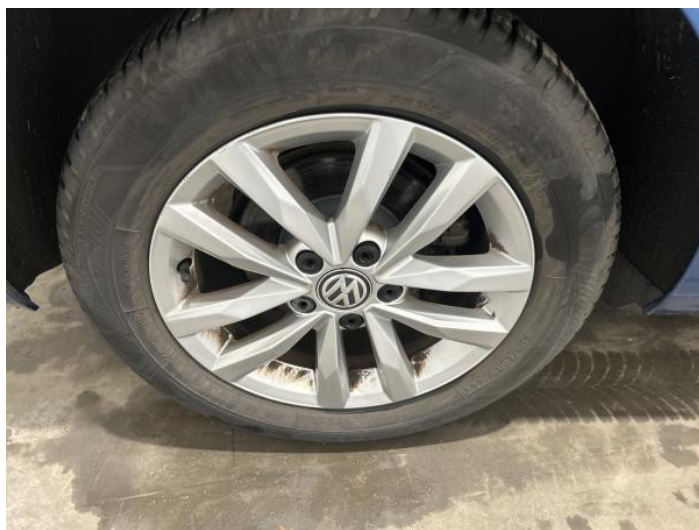
6: Wheel osr
Scratched
Up To 50mm

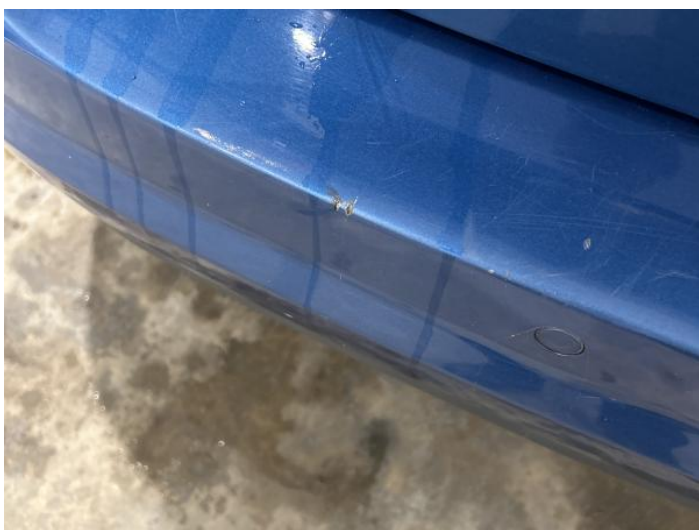
7: Bumper Rear
Chipped
Multiple Chips

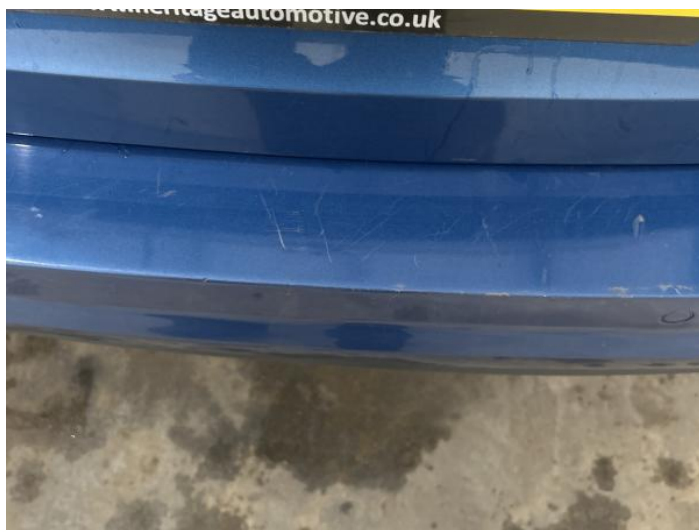
8: Bumper Rear
Scratched
Over 25mm Not Thru Paint

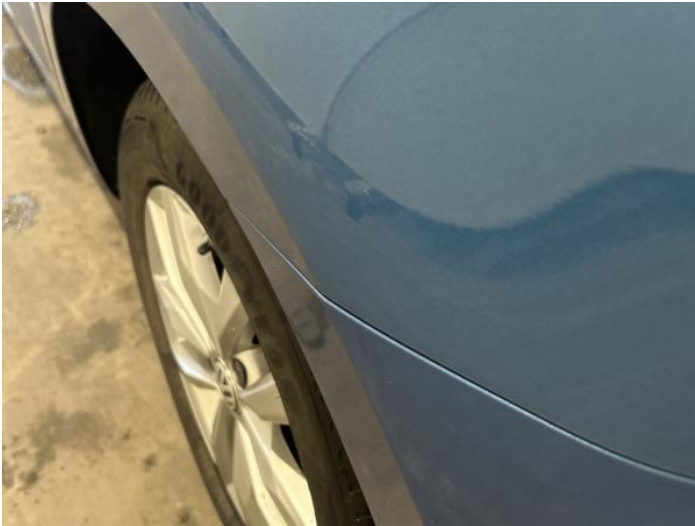
9: Qtr Panel nsr
Scratched
Over 25mm Not Thru Paint

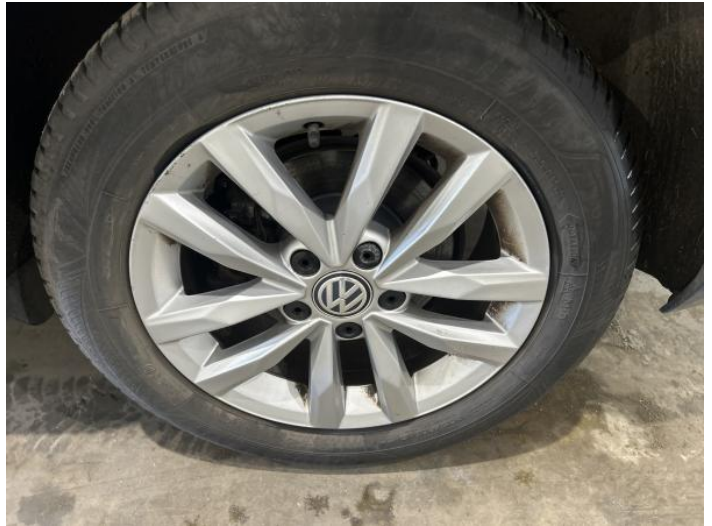
10: Wheel nsr
Scratched
Up To 50mm

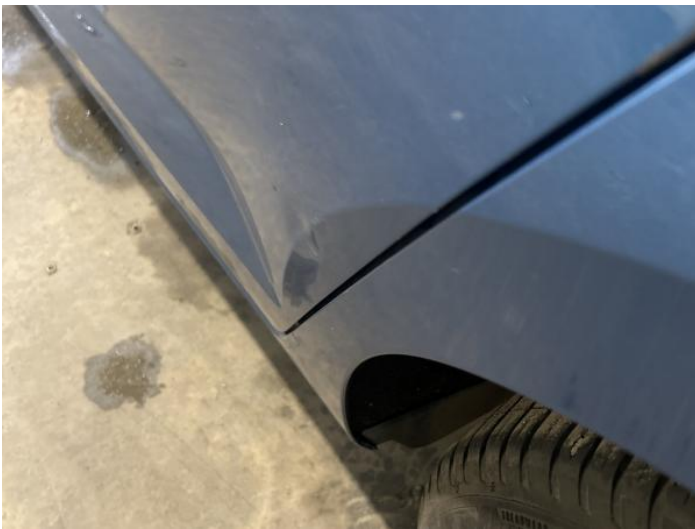
11: Door nsr
Dented
Over 30mm

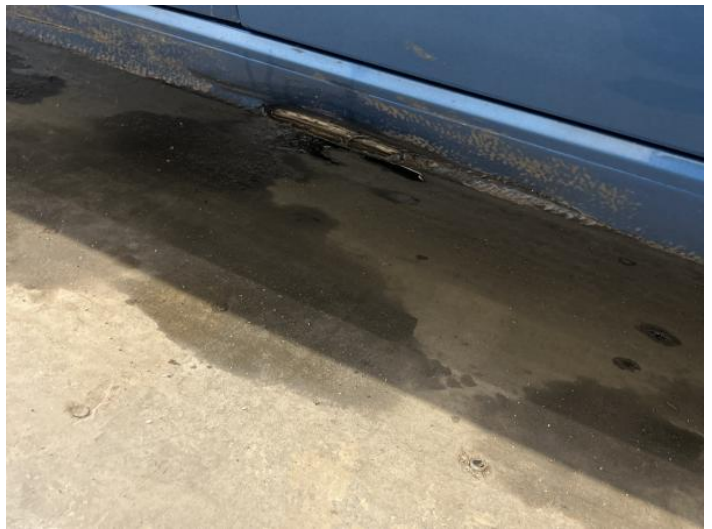
12: Sill ns
Hole
Over 10mm

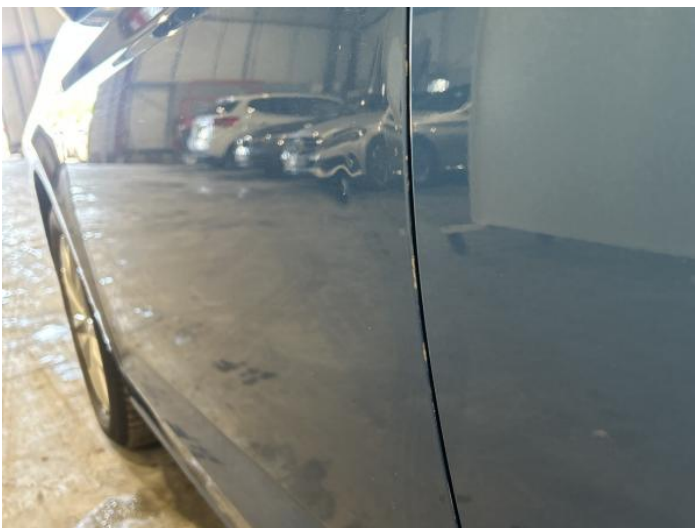
13: Door nsf
Chipped
Edge Chip

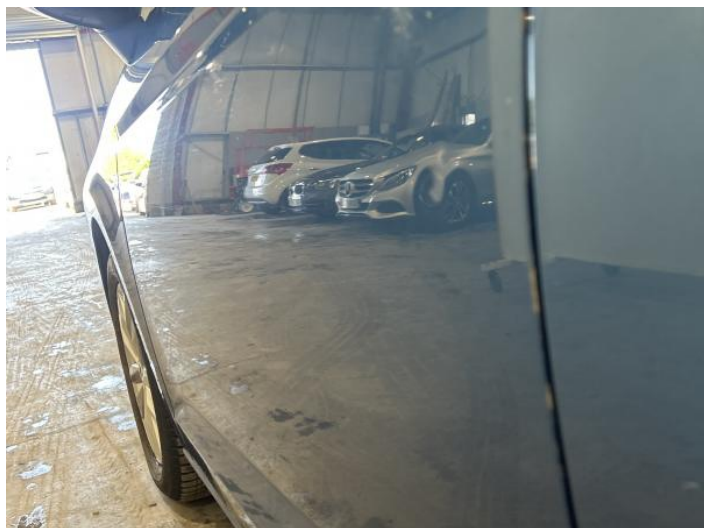
14: Door nsf
Dented
2 Or Less Up To 10mm

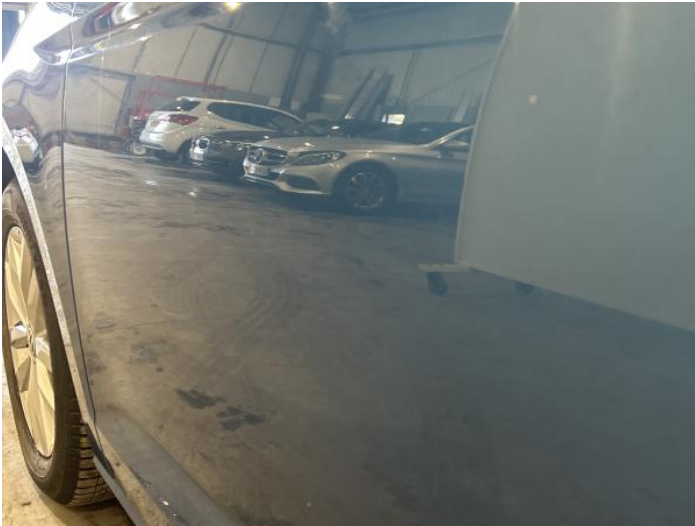
15: Door nsf
Scratched
Over 25mm Not Thru Paint

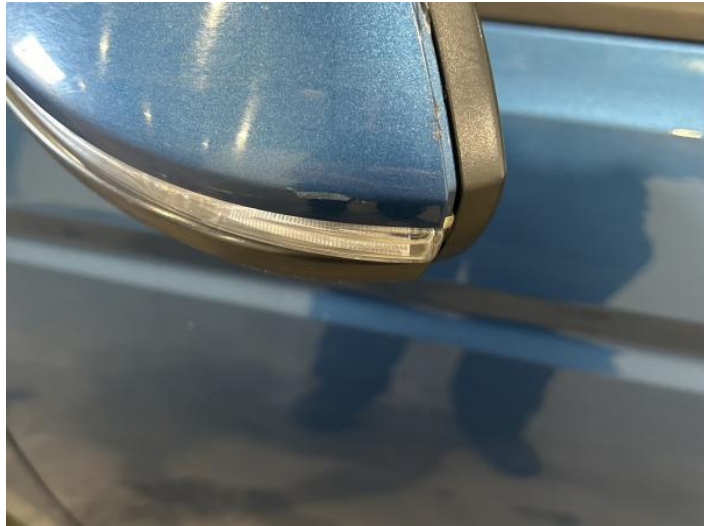
16: Door Mirror Assy nsf
Scratched (Painted)
UpTo 25mm Thru Paint

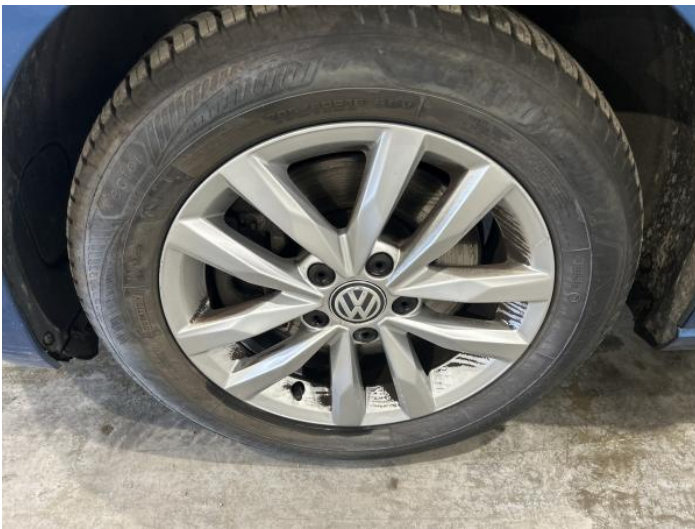
17: Wheel nsf
Scratched
Up To 50mm

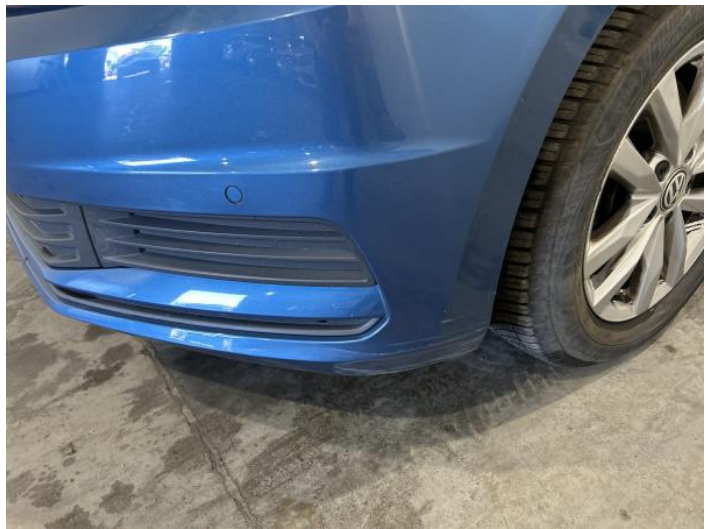
18: Bumper Front
Scratched
Over 100mm Thru Paint

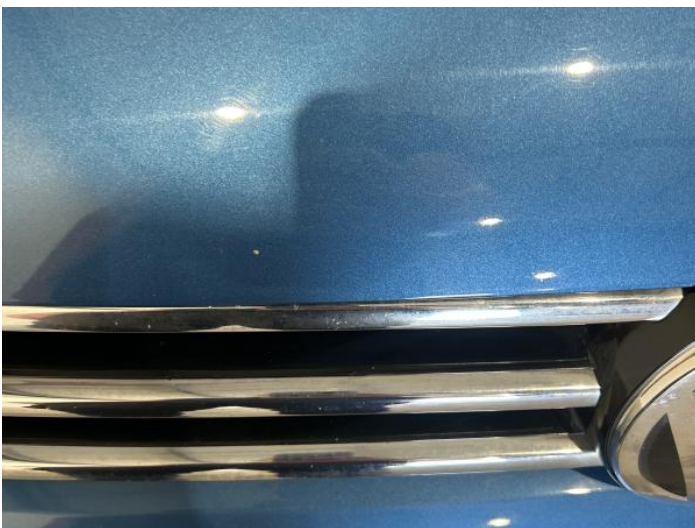
19: Bonnet
Chipped
1 To 5

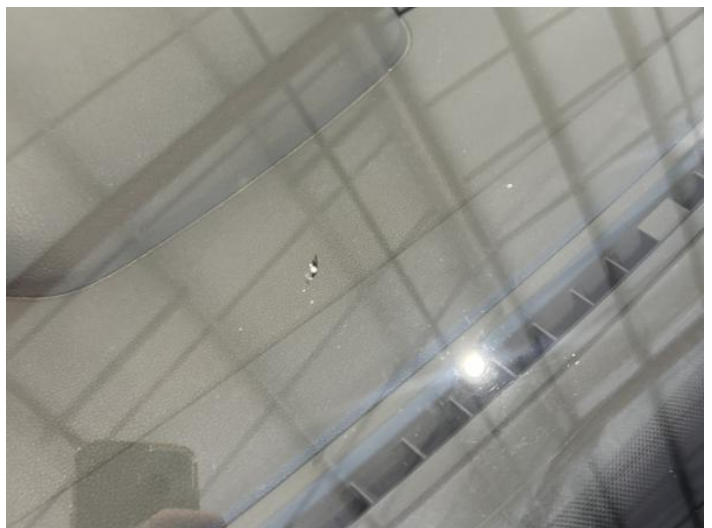
20: Screen Front
Chipped
UpTo 10mm
