# VEHICLE INSPECTION REPORT

**BG65VOT**

## Toyota Aygo 1.0 VVT-i X-Cite 2 5dr

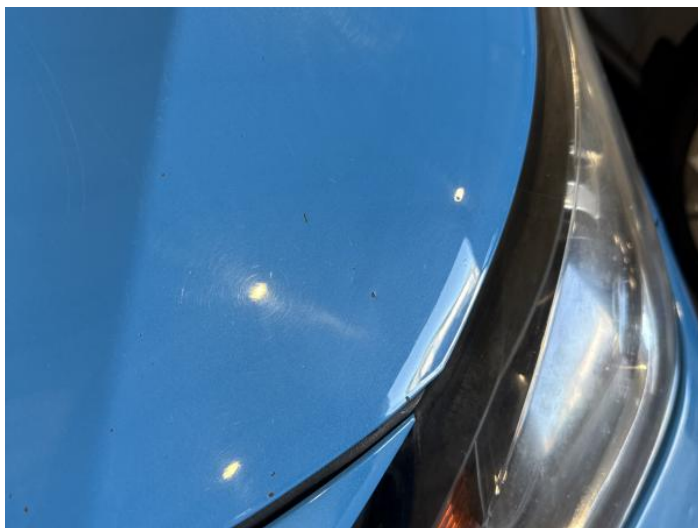
1: Bonnet  
Dented  
2 Or Less UpTo 10mm

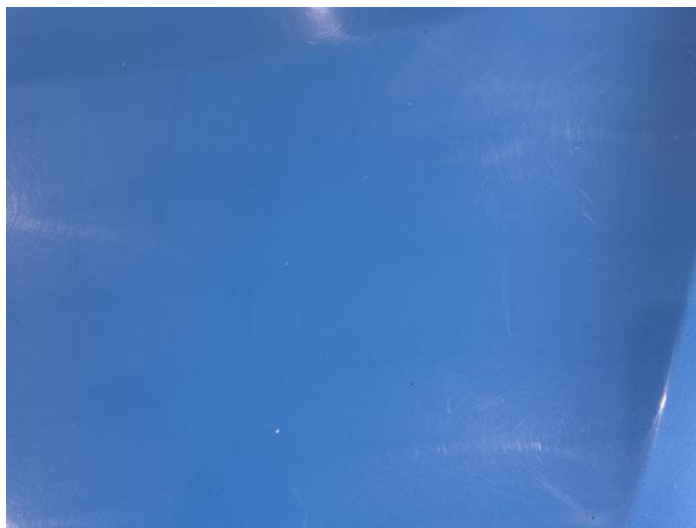
2: Bonnet  
Chipped  
1 To 5

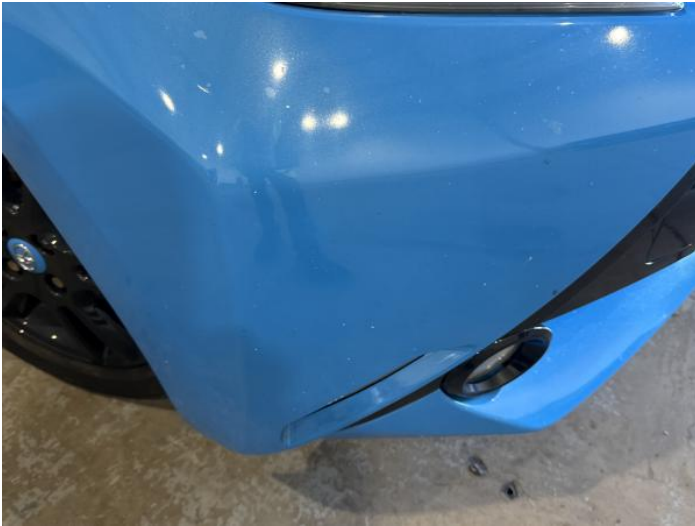
3: Bumper Front  
Poor Previous Repair  
Poor Paint

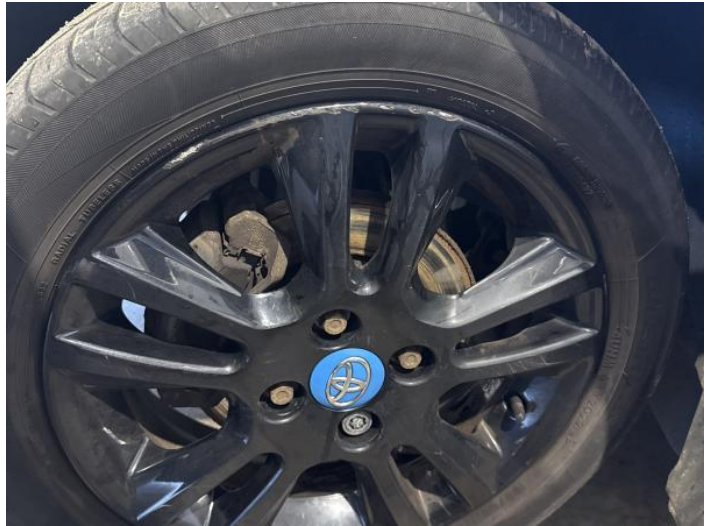
4: Wheel nsf  
Scratched  
Over 50mm

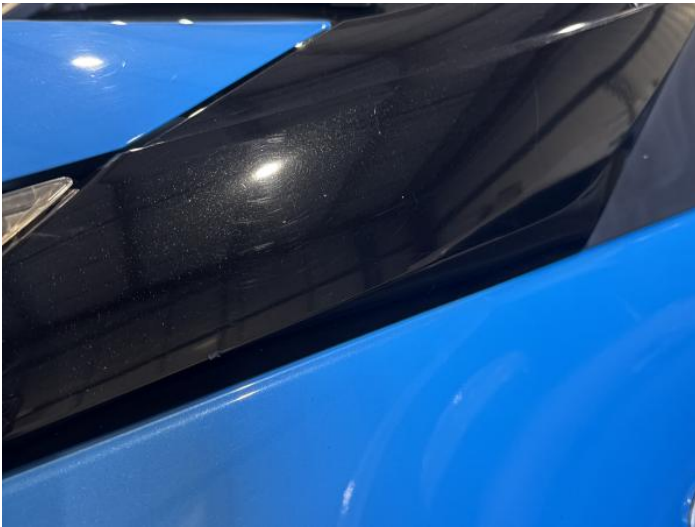
5: Wing nsf  
Scratched  
Over 25mm Thru Paint

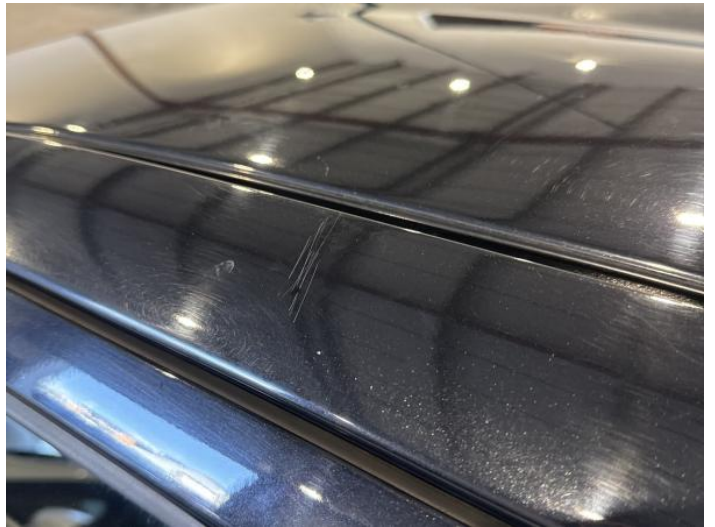
6: A Post ns  
Scratched  
Over 25mm Thru Paint

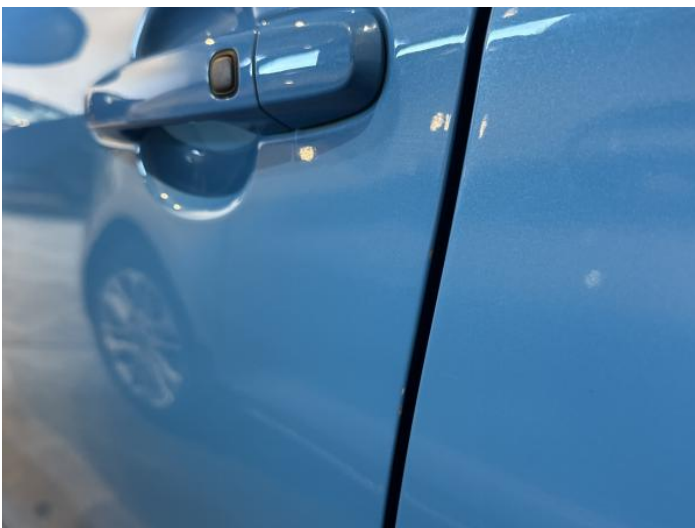
7: Door nsf  
Chipped  
Edge Chip

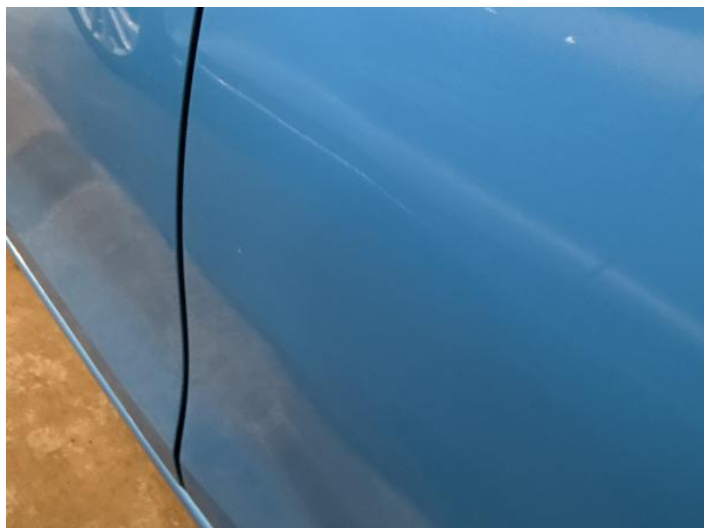
8: Door nsr  
Dented  
Over 30mm

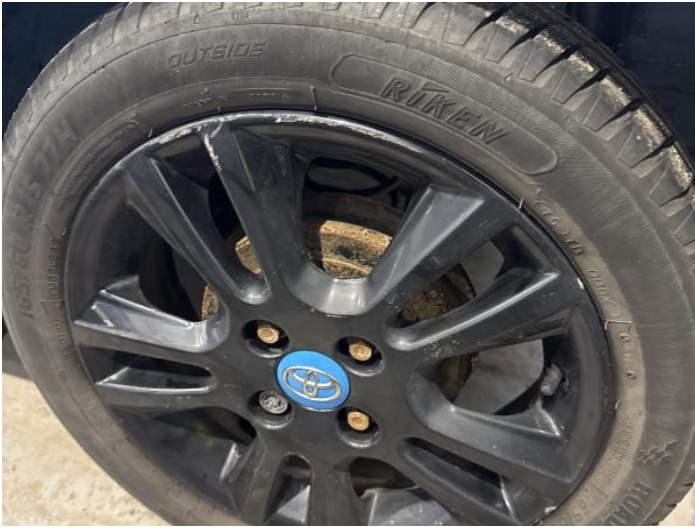
9: Wheel nsr  
Scratched  
Over 50mm

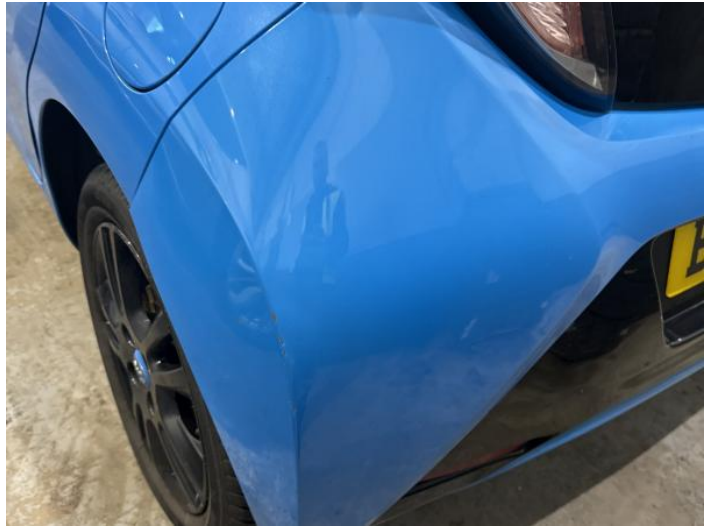
10: Bumper Rear  
Scratched  
25 to 100mm Thru Paint

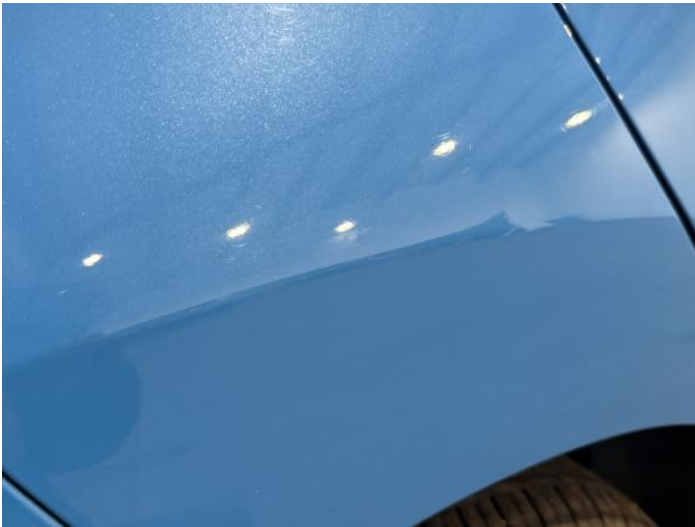
11: Qtr Panel osr  
Scratched  
UpTo 25mm Thru Paint

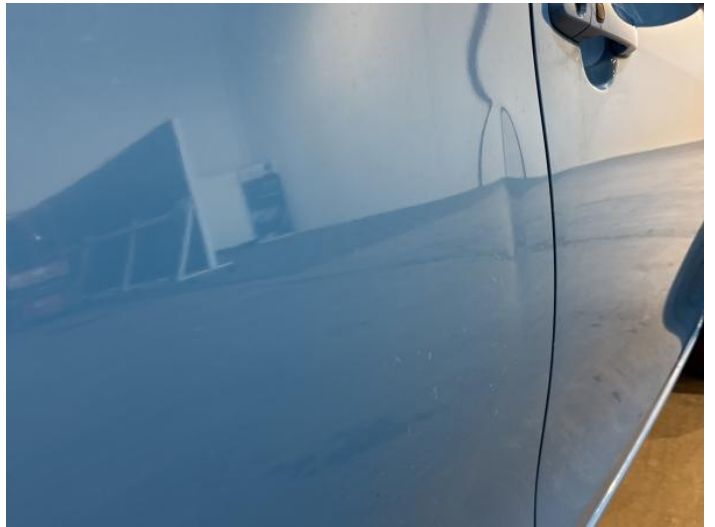
12: Door osr  
Dented  
Over 30mm

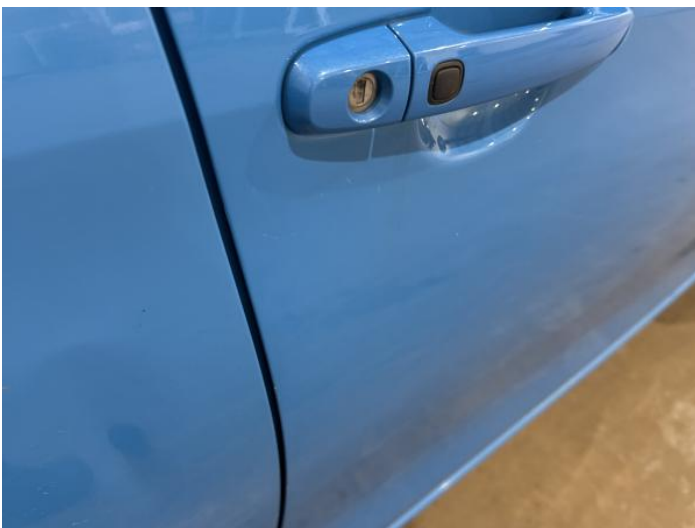
13: Door osf  
Chipped  
Edge Chip

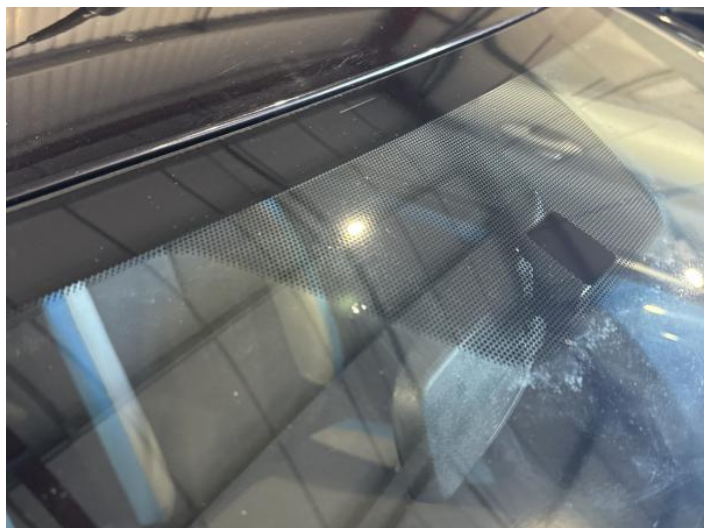
14: Screen Front  
Chipped  
UpTo 10mm

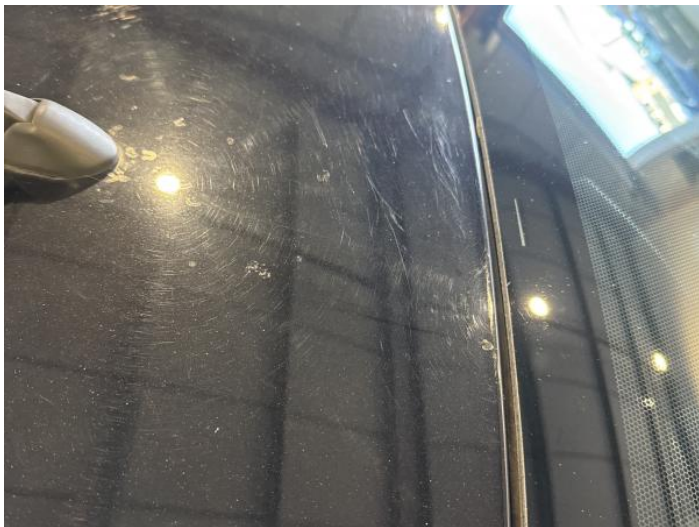
15: Roof  
Scratched  
Over 25mm Thru Paint

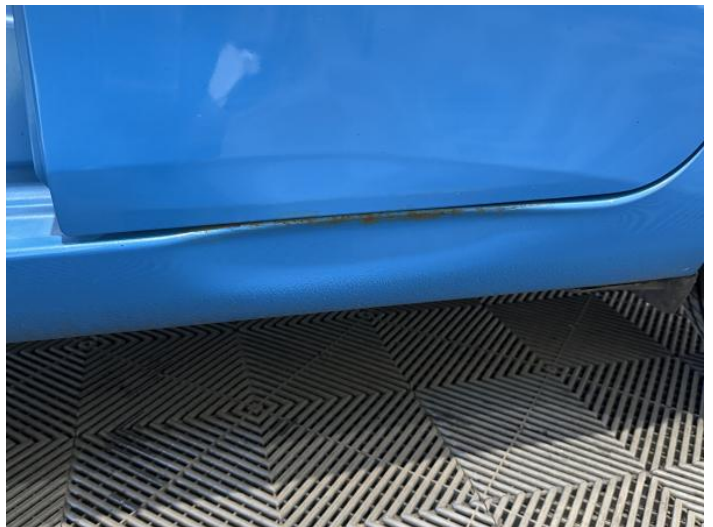
16: Sill ns  
Dented  
With Paint Damage
