## VEHICLE INSPECTION REPORT

**PO14RNU**

### Nissan Qashqai 1.2 DiG-T Acenta Premium 5dr

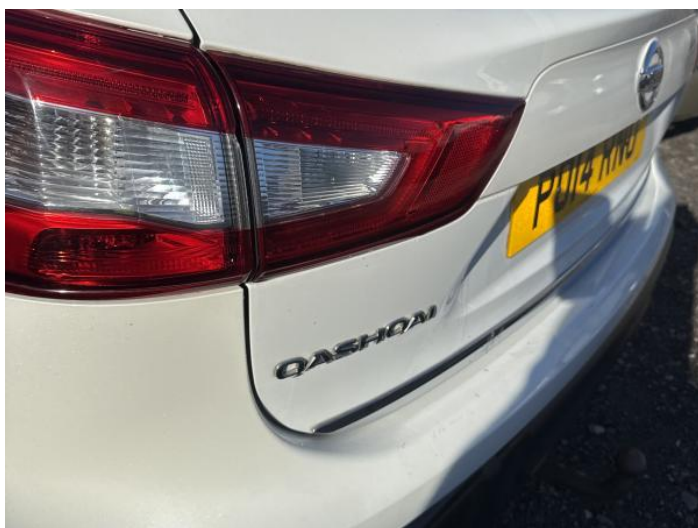
1: Bumper Rear  
Scratched  
25 to 100mm Thru Paint

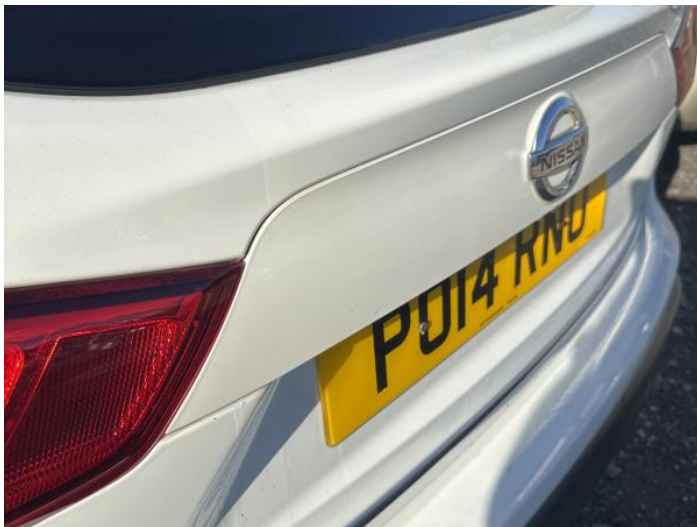
3: Boot Lid  
Chipped  
1 To 5

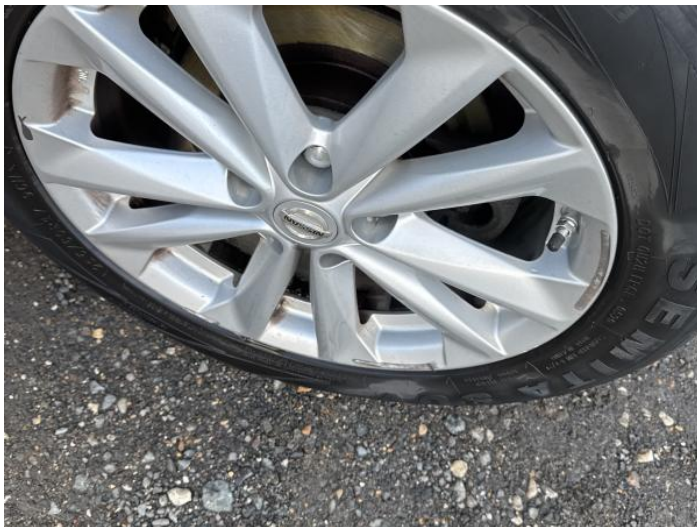
5: Wheel nsr  
Scratched  
Over 50mm

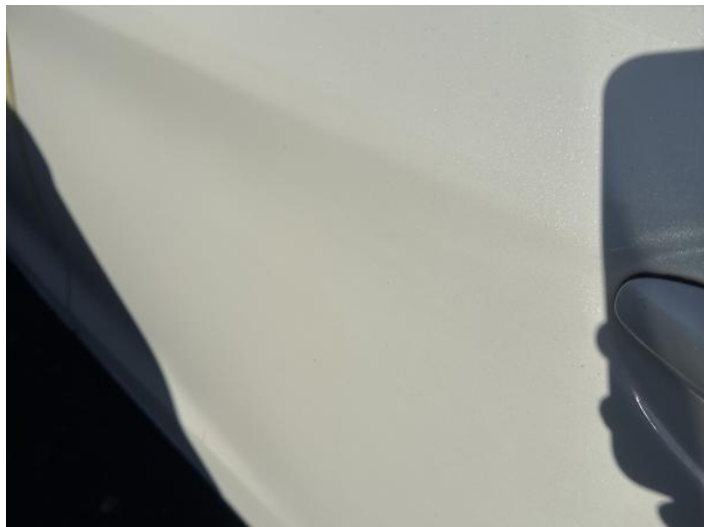
6: Door nsr  
Scratched  
UpTo 25mm Thru Paint

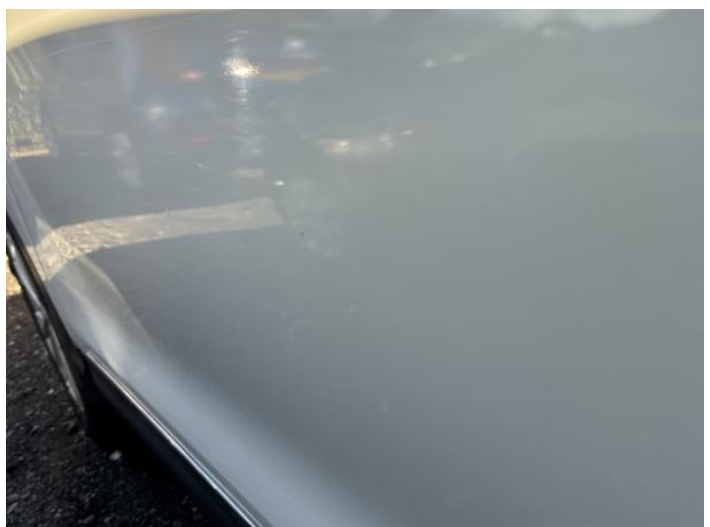
8: Door nsf  
Chipped  
Multiple Chips

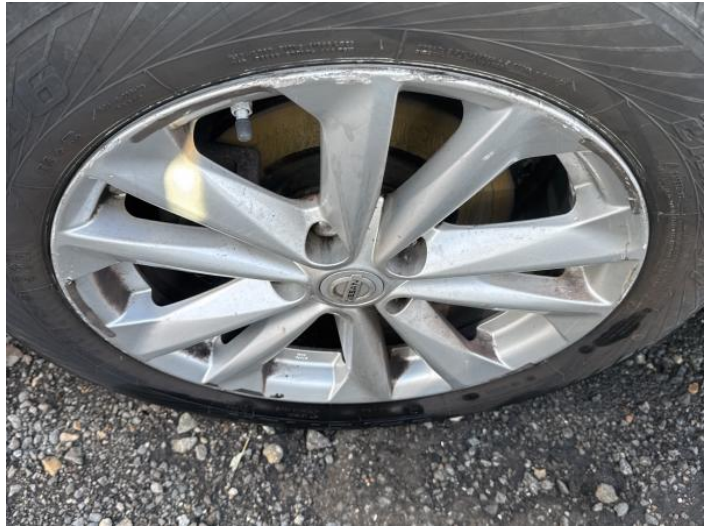
10: Wheel nsf  
Scratched  
Over 50mm

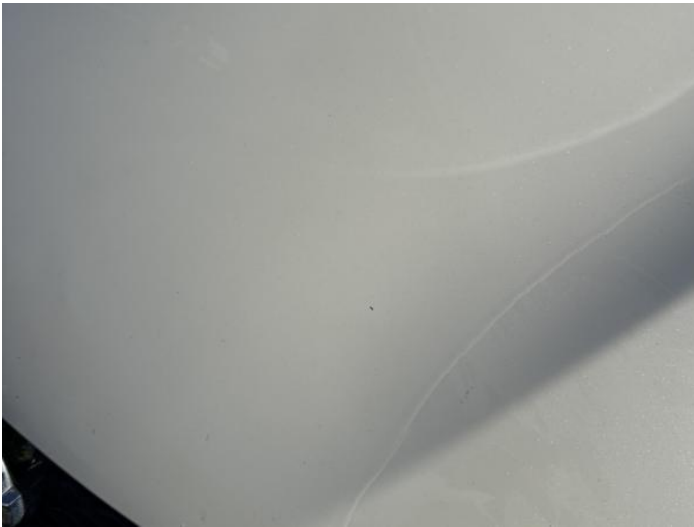
11: Bonnet  
Chipped  
Multiple Chips

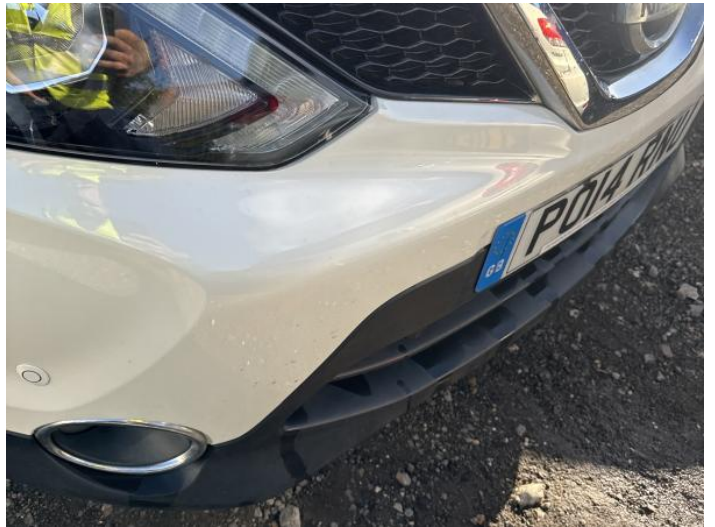
12: Bumper Front  
Chipped  
Multiple Chips

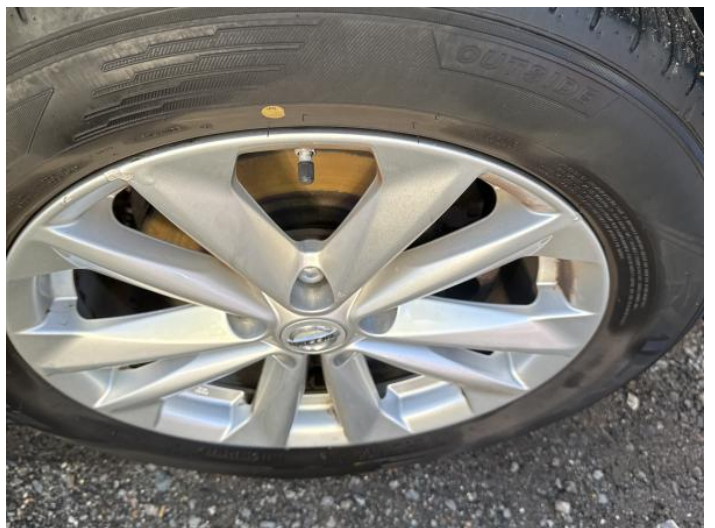
14: Wheel osf  
Scratched  
Over 50mm

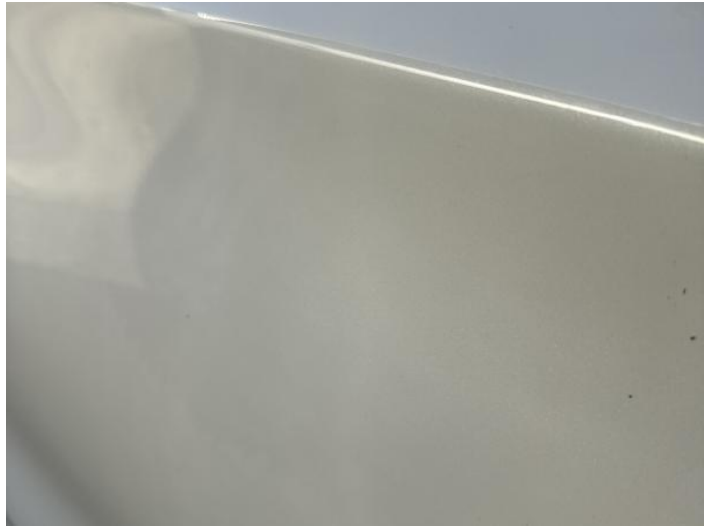
16: Door osf  
Dented  
Over 2 UpTo 10mm

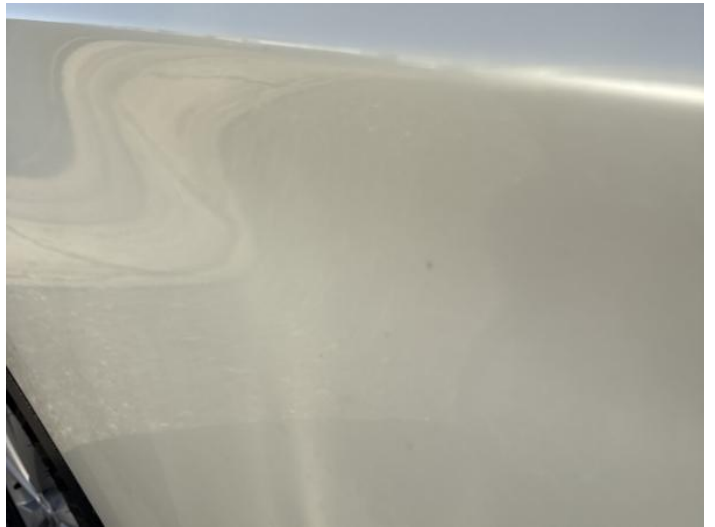
18: Door osr  
Chipped  
1 To 5

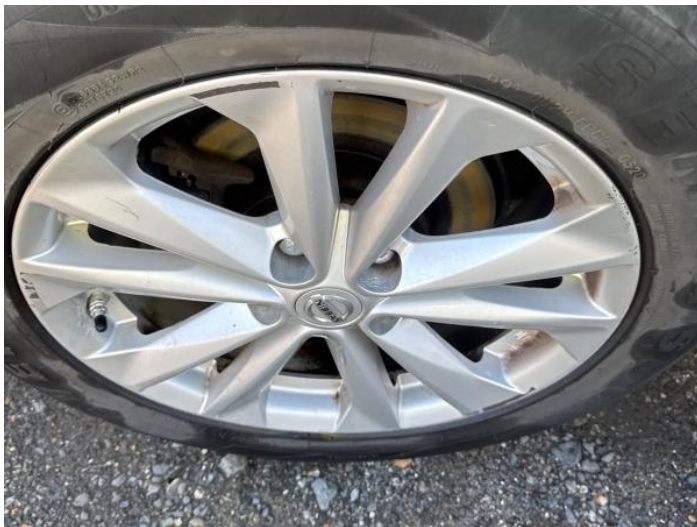
21: Wheel osr  
Scratched  
Over 50mm

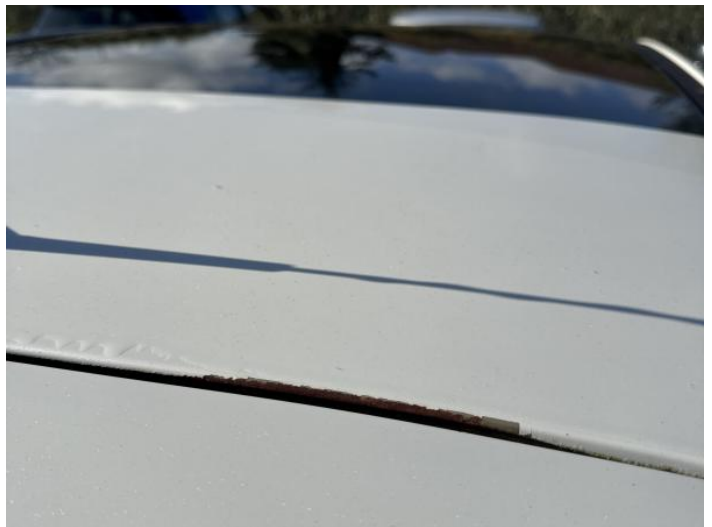
22: Roof  
Poor Previous Repair  
Paint Flake
