# VEHICLE INSPECTION REPORT

RE68OVG

## Hyundai Tucson 1.6 GDi Premium 5dr 2WD

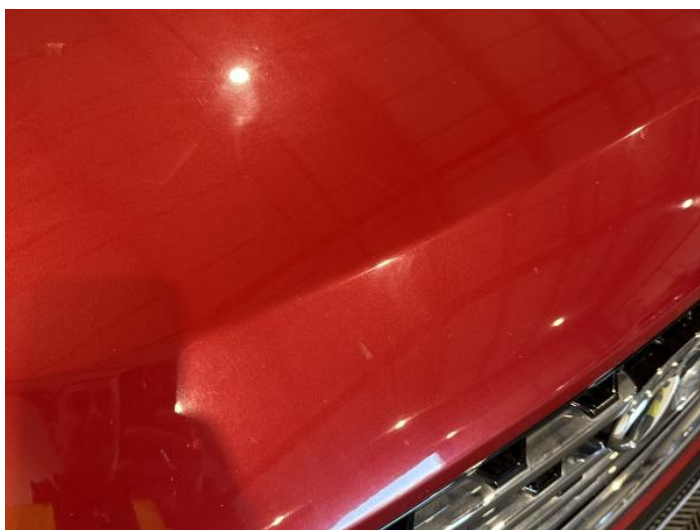
1: Bonnet  
Chipped  
Multiple Chips

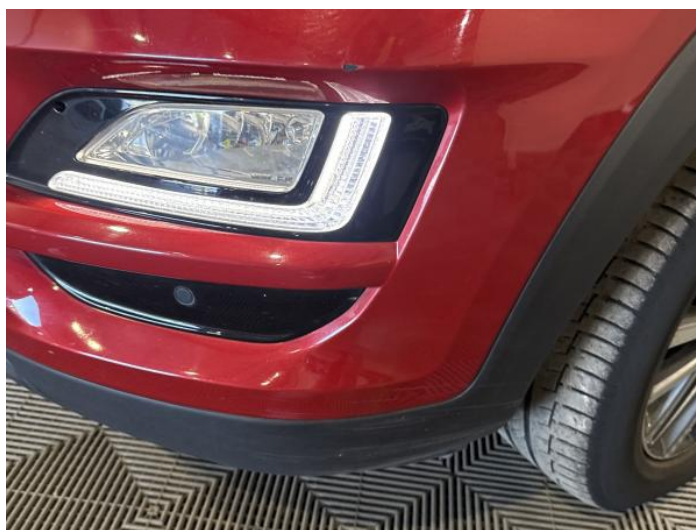
2: Bumper Front  
Scratched  
25 to 100mm Thru Paint

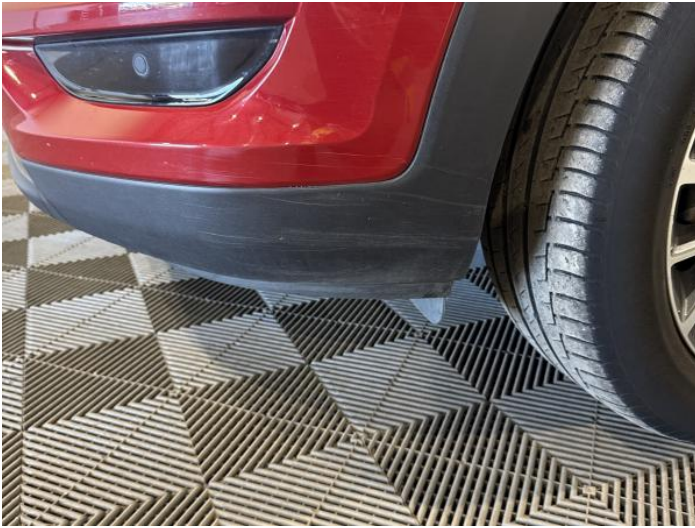
3: Bumper Front Moulding  
Scuffed (Unpainted)  
Over 100mm

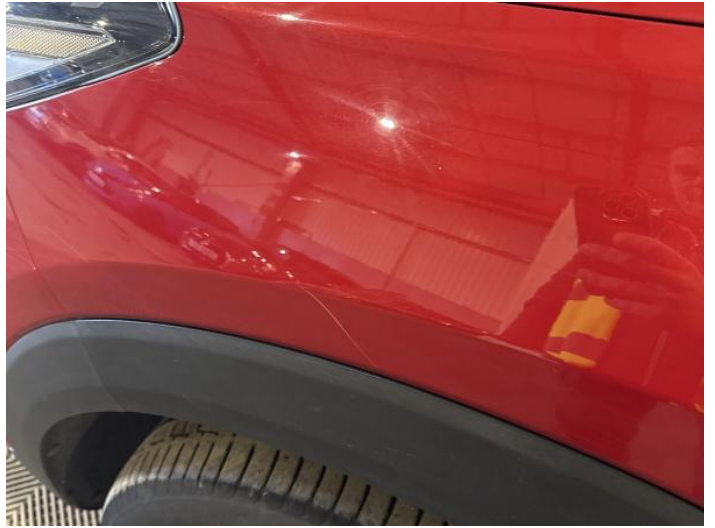
4: Wing nsf  
Scratched  
Over 25mm Thru Paint

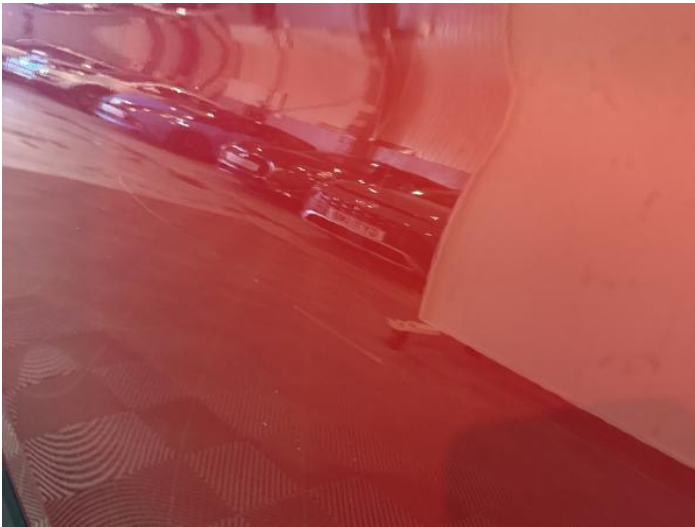
5: Door nsf  
Scratched  
Over 25mm Thru Paint

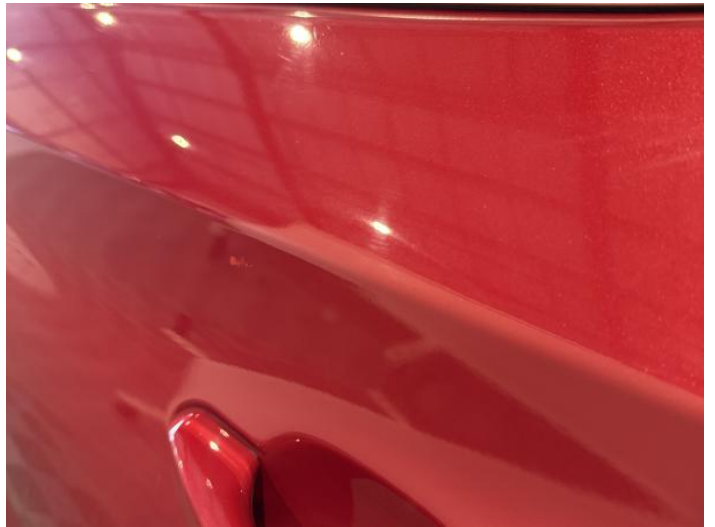
6: Door nsr  
Scratched  
UpTo 25mm Thru Paint

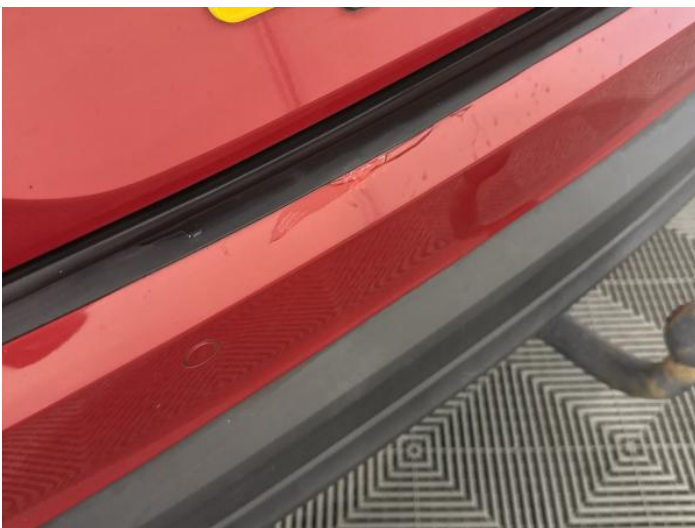
7: Bumper Rear  
Poor Previous Repair  
Paint Flake

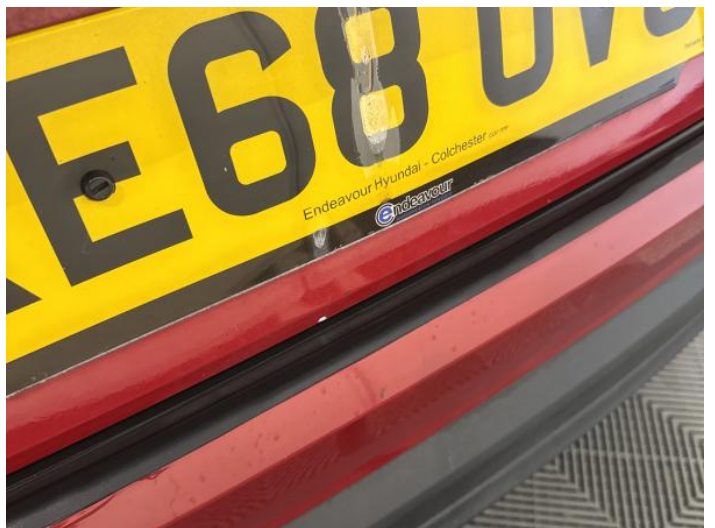
8: Tailgate  
Chipped  
1 To 5

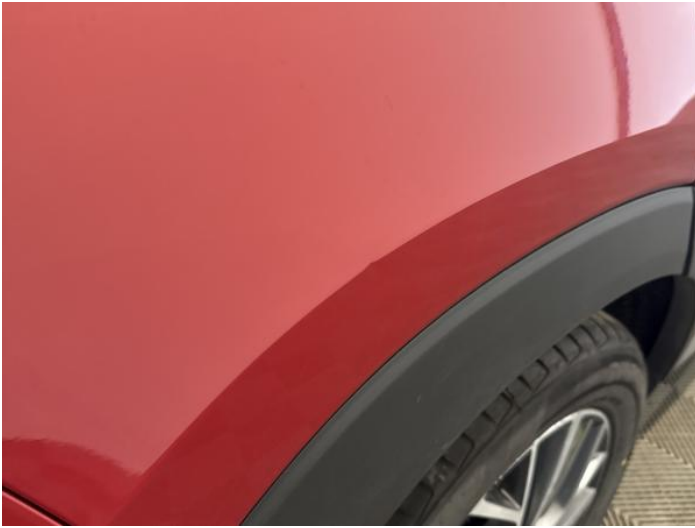
9: Qtr Panel osr  
Dented  
Between 10mm + 30mm

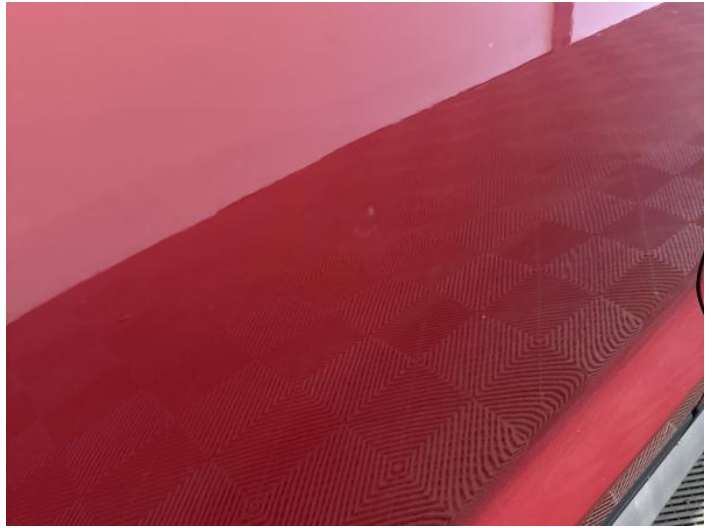
10: Door osr  
Dented  
Between 10mm + 30mm

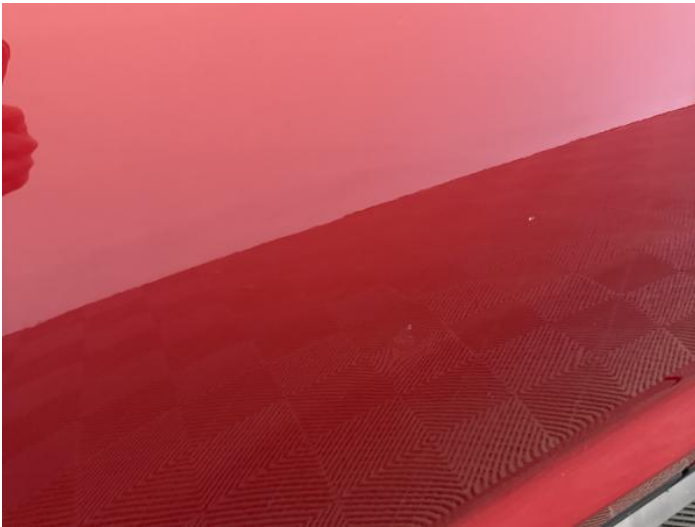
11: Door osr  
Scratched  
UpTo 25mm Thru Paint

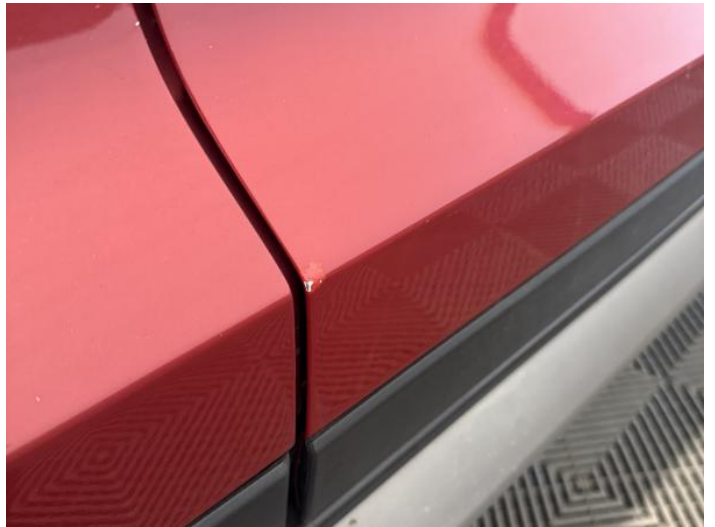
12: Door osf  
Scratched  
UpTo 25mm Thru Paint

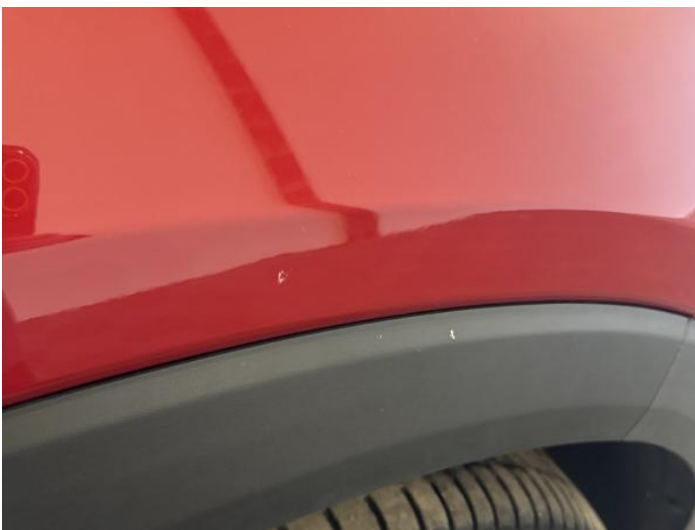
13: Wing osf  
Chipped  
1 To 5

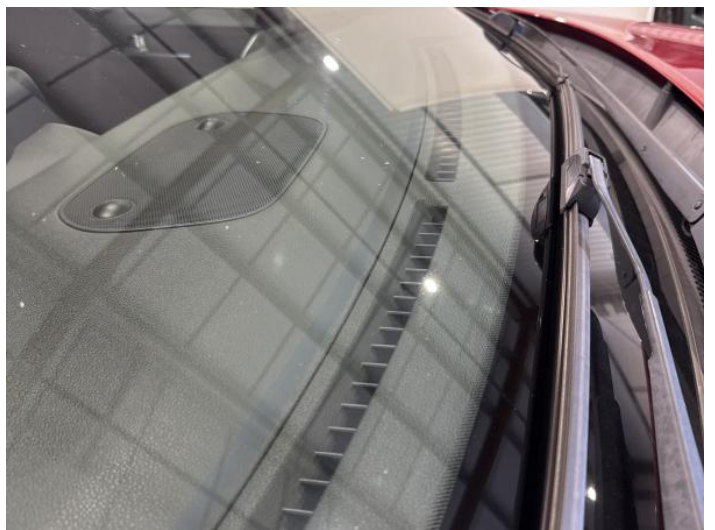
14: Screen Front  
Chipped  
UpTo 10mm

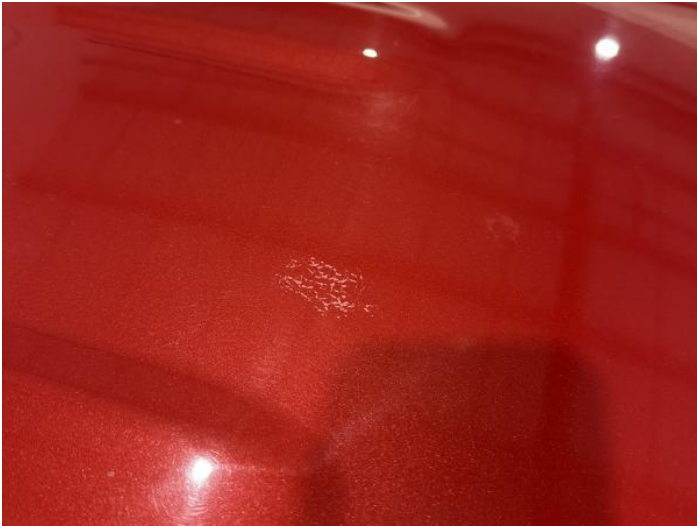
15: Roof  
Scratched  
Over 25mm Thru Paint

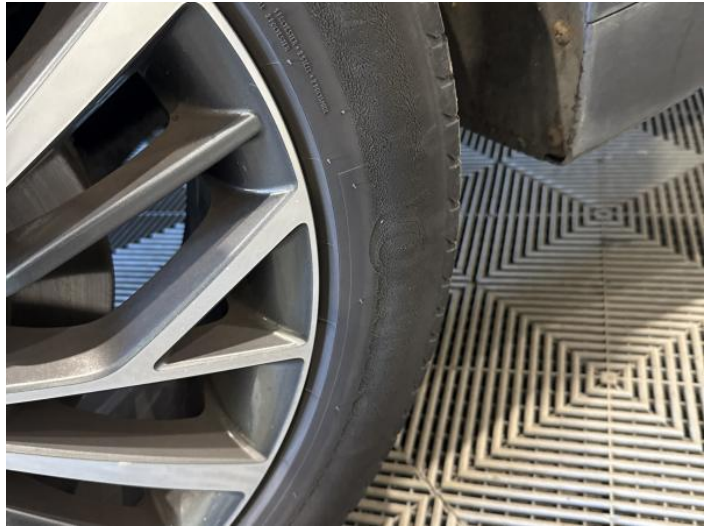
| NSF | CONTINENTAL | Damaged |

16: Tyre nsf  
Damaged  
Replace
