## VEHICLE INSPECTION REPORT

LV22ZLX

### BMW 2 Series 230i M Sport 2dr Step Auto

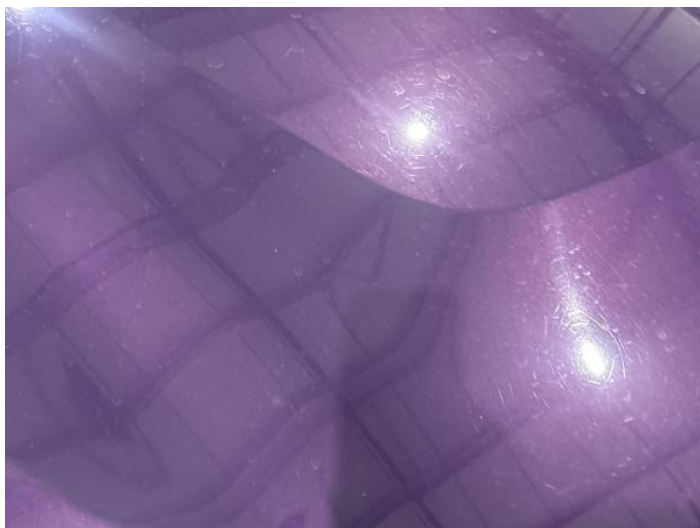
1: Bonnet  
Chipped  
1 To 5

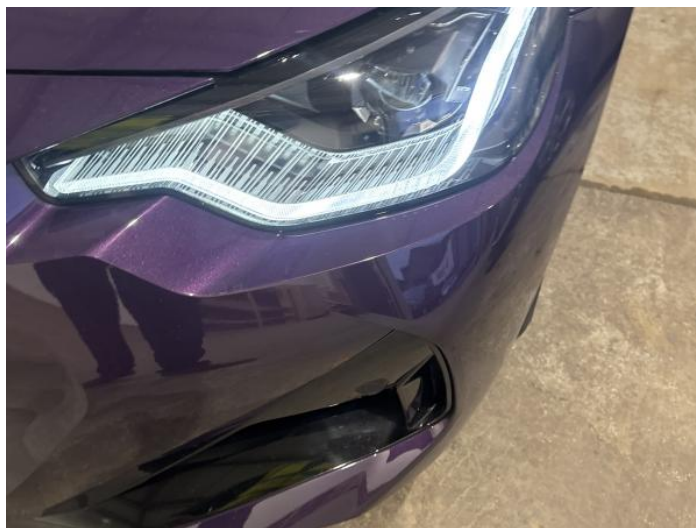
2: Bumper Front  
Chipped  
Multiple Chips

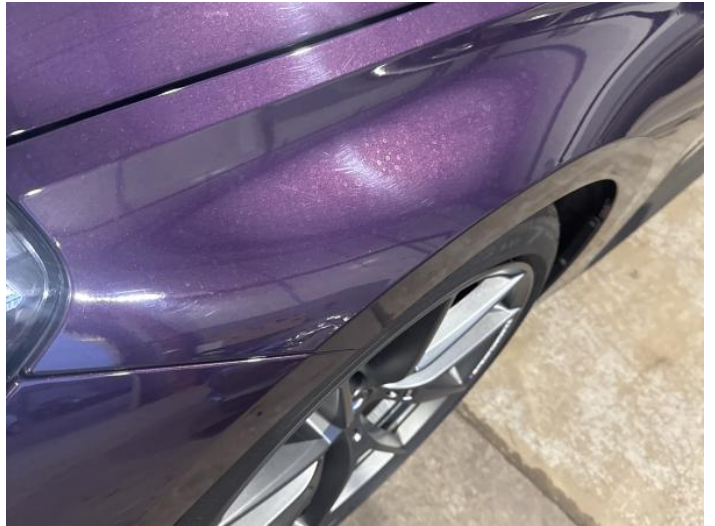
3: Bumper Front  
Scratched  
Over 25mm Not Thru Paint

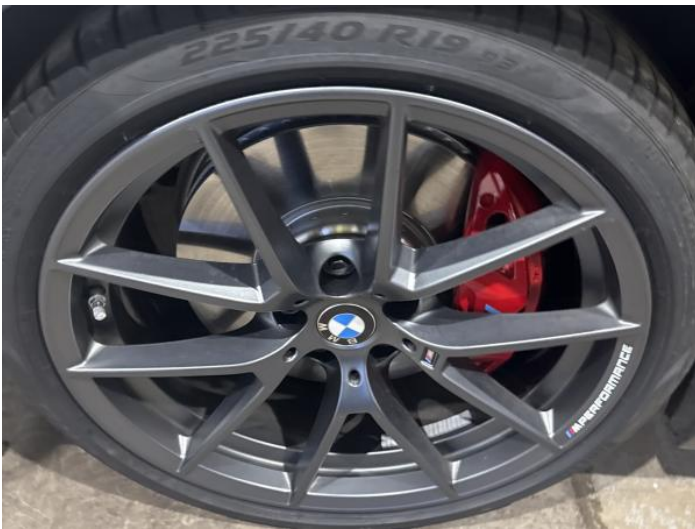
5: Wheel nsf  
Scratched  
Up To 50mm

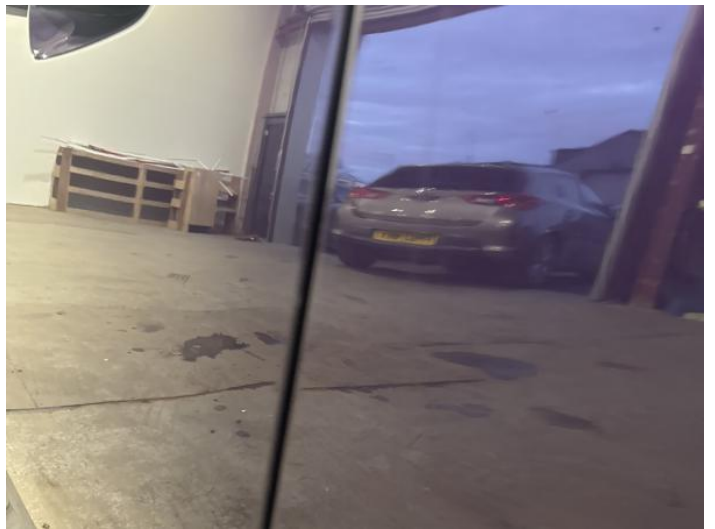
6: Door nsf  
Chipped  
Edge Chip

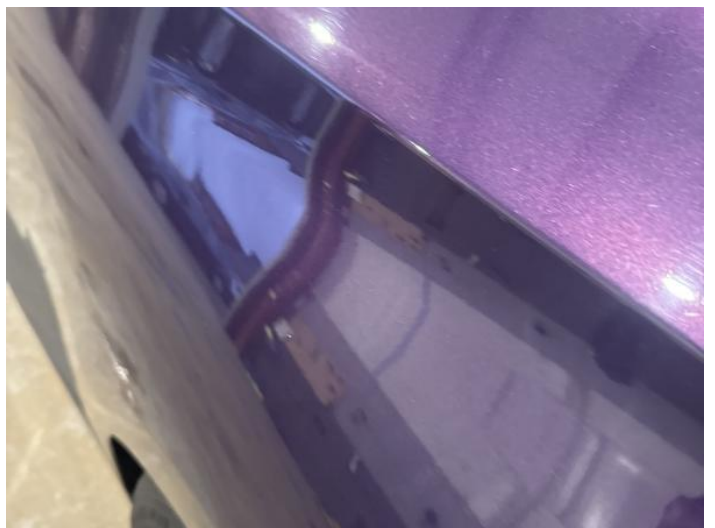
7: Door nsf  
Scratched  
Over 25mm Not Thru Paint

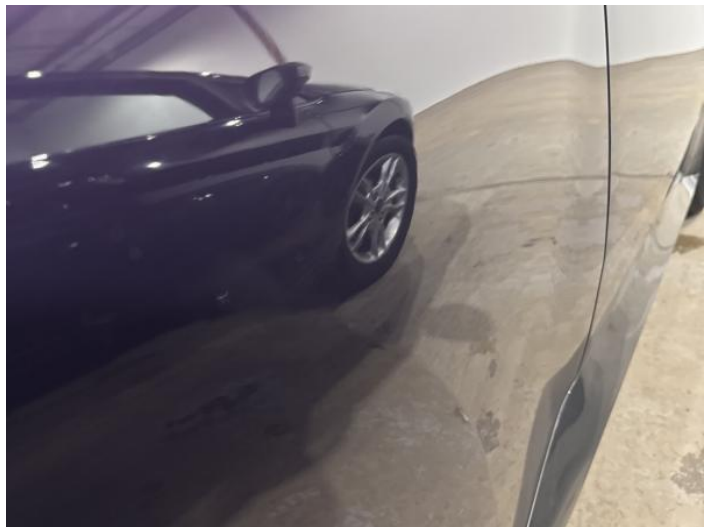
12: Qtr Panel osr  
Chipped  
1 To 5

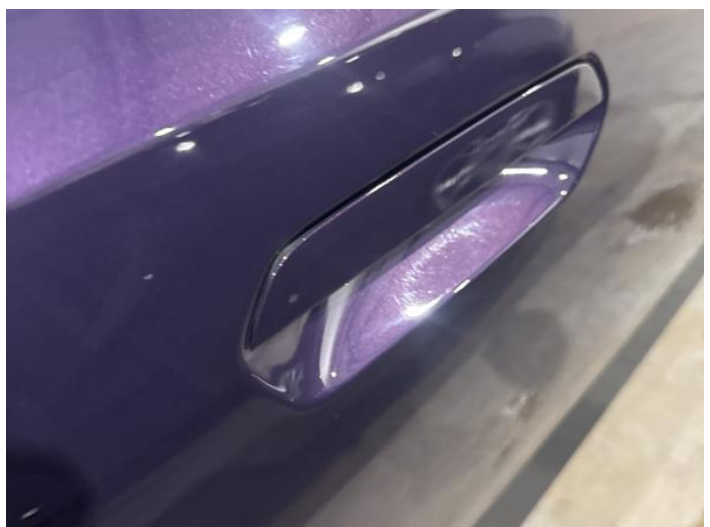
14: Door osf  
Chipped  
1 To 5
