# VEHICLE INSPECTION REPORT

**KF18JXJ**

## Vauxhall Grandland X 1.2 Turbo SE 5dr Auto

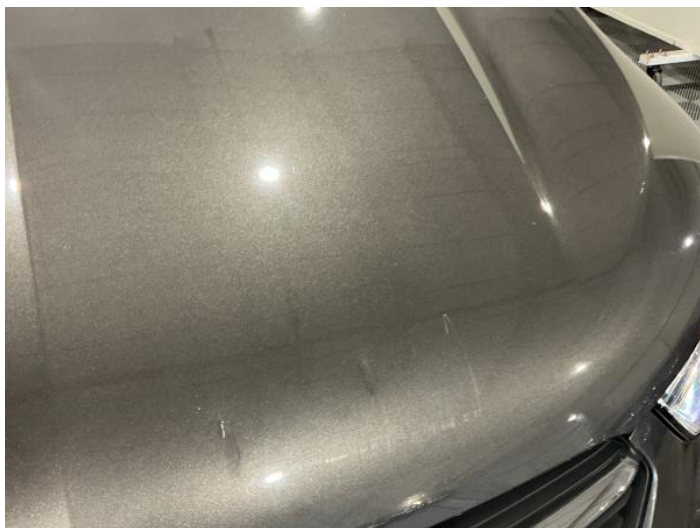
1: Bonnet  
Dented  
With Paint Damage

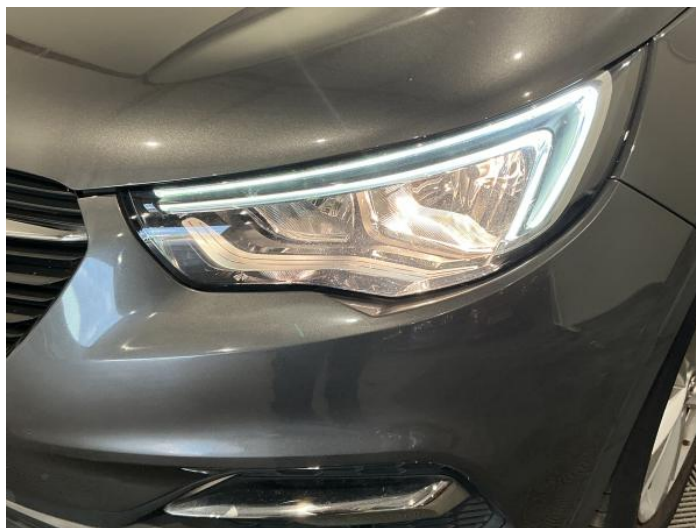
2: Bumper Front  
Dented  
With Paint Damage

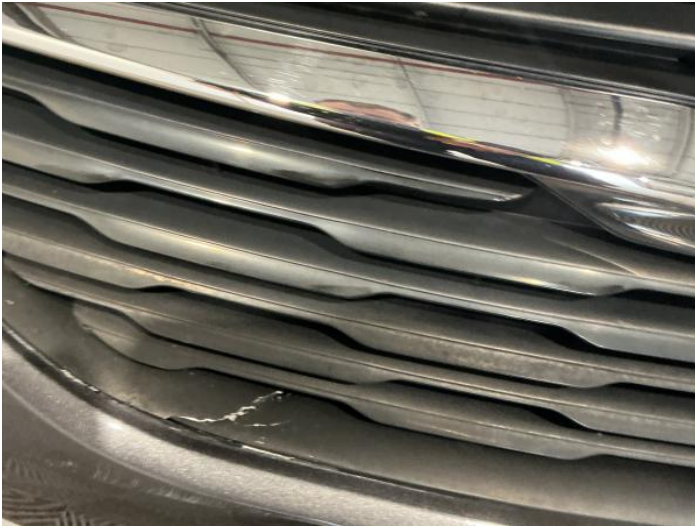
3: Bumper Front Grill  
Broken  
Replace

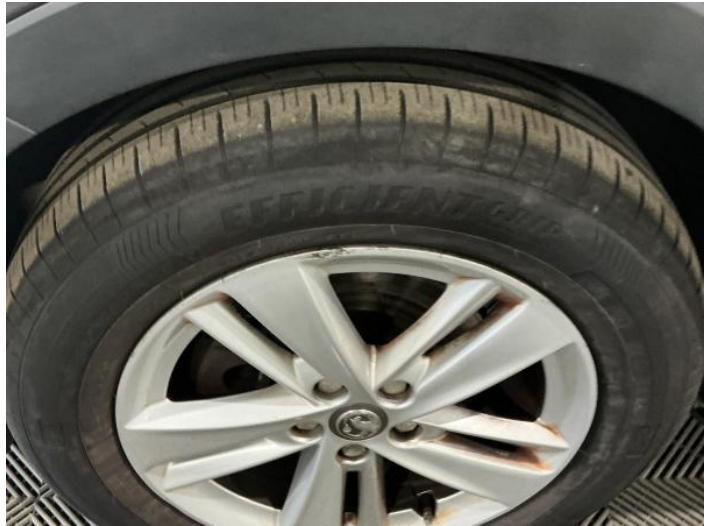
4: Wheel nsf  
Scratched  
Over 50mm

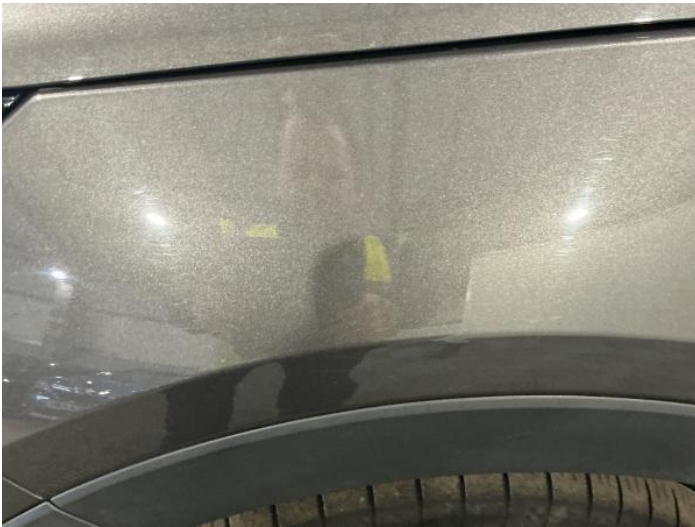
5: Wing nsf  
Chipped  
1 To 5

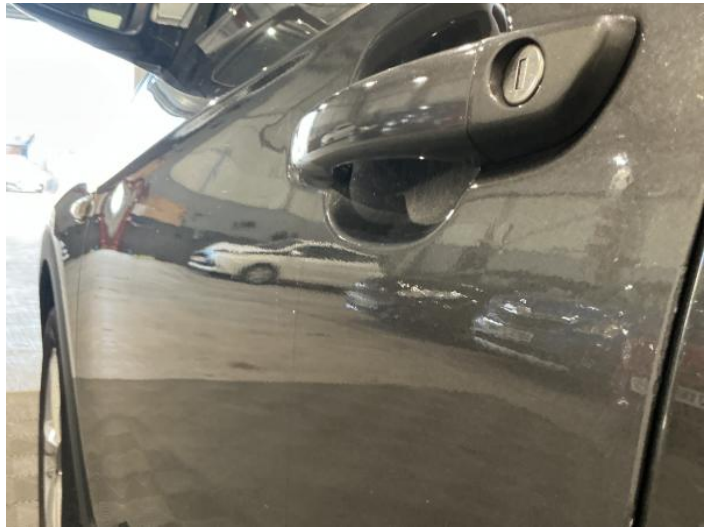
6: Door nsf  
Poor Previous Repair  
Poor Paint

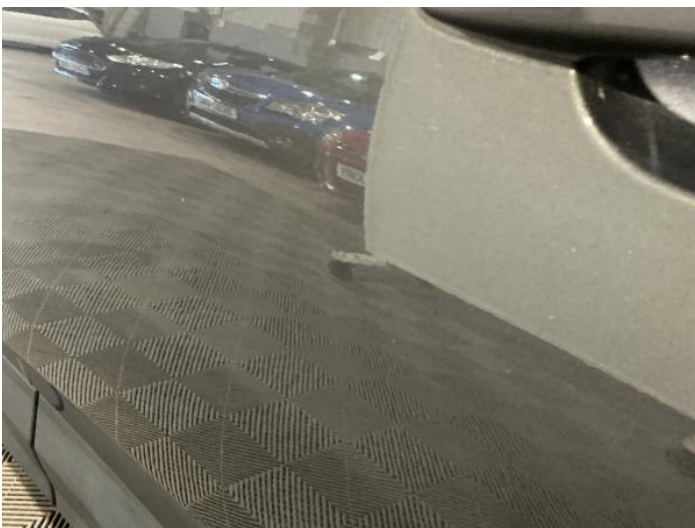
7: Door nsr  
Dented  
2 Or Less UpTo 10mm

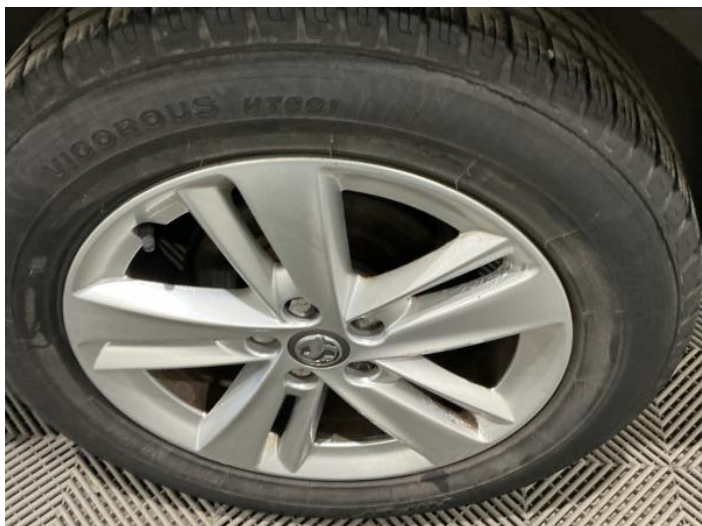
9: Wheel nsr  
Scratched  
Over 50mm

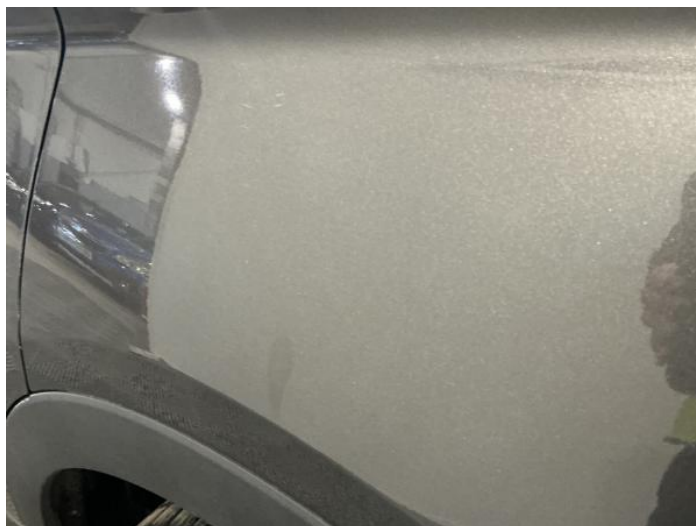
10: Qtr Panel nsr  
Dented  
Over 2 UpTo 10mm

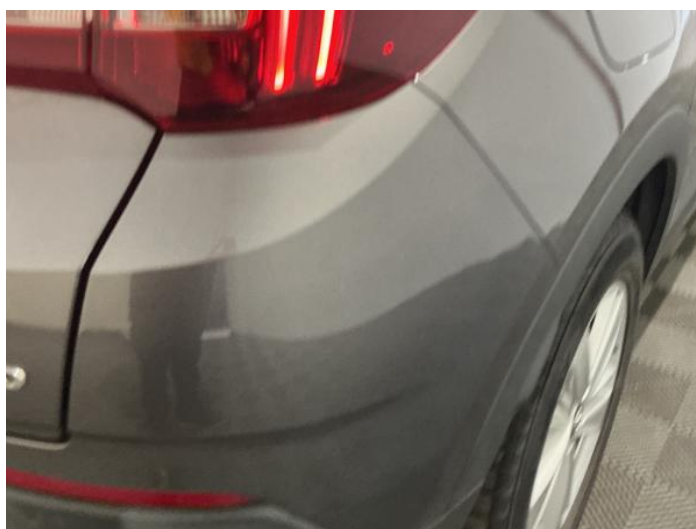
12: Bumper Rear  
Chipped  
Multiple Chips

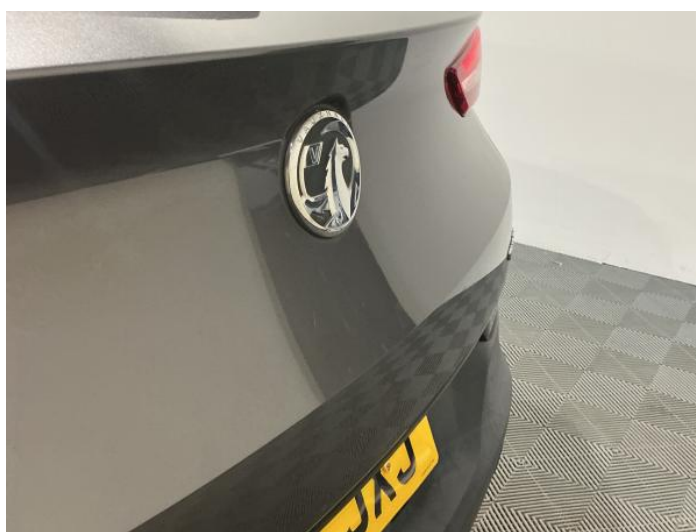
14: Boot Lid  
Chipped  
1 To 5

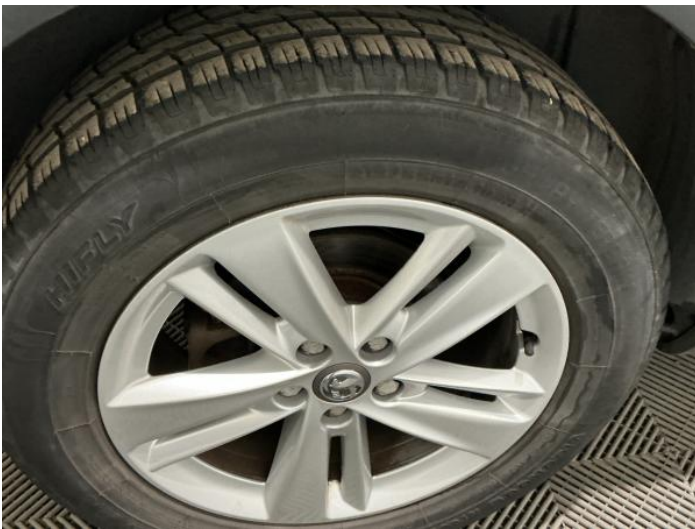
17: Wheel osr  
Scratched  
Up To 50mm

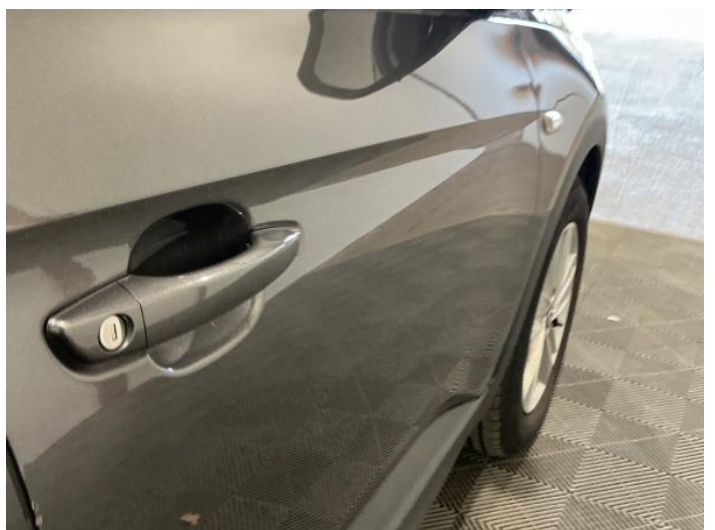
19: Door osr  
Scratched  
Over 25mm Not Thru Paint

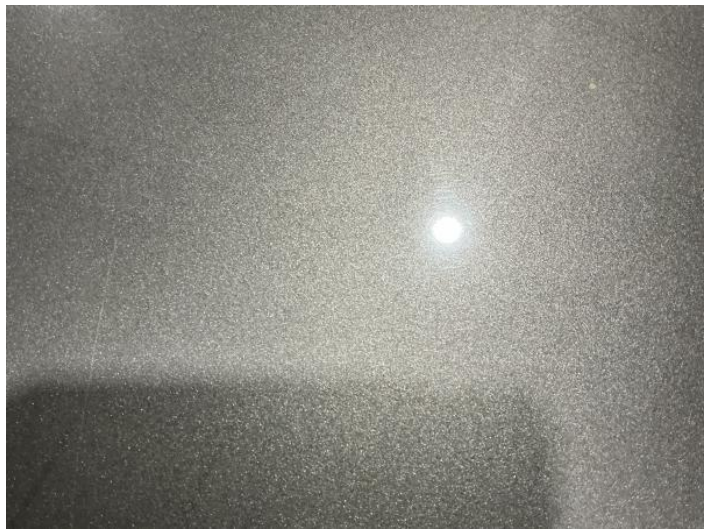
22: Roof  
Scratched  
Over 25mm Thru Paint

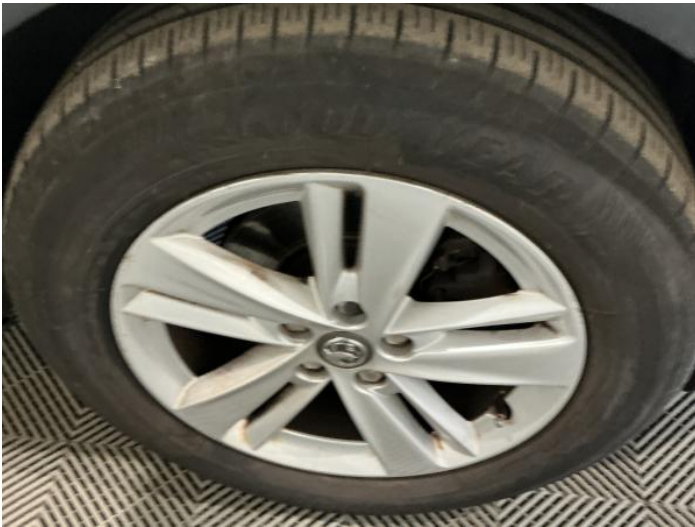
23: Wheel osf  
Scratched  
Over 50mm

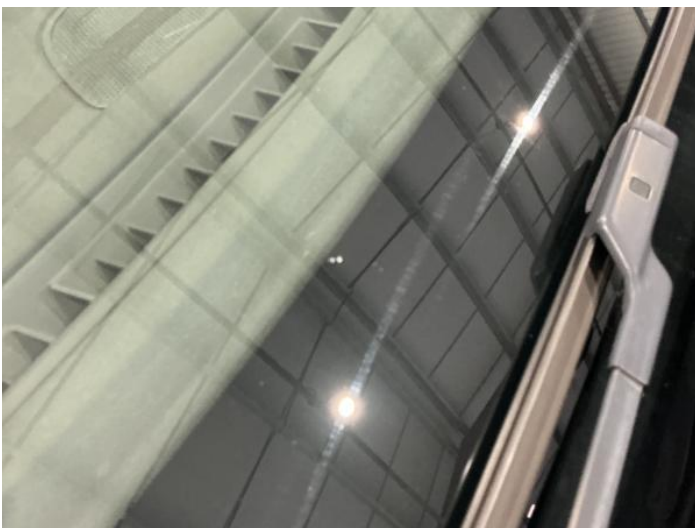
25: Screen Front  
Chipped  
UpTo 10mm
