# VEHICLE INSPECTION REPORT

**GP19DNY**

## Suzuki Vitara 1.0 Boosterjet SZ-T 5dr

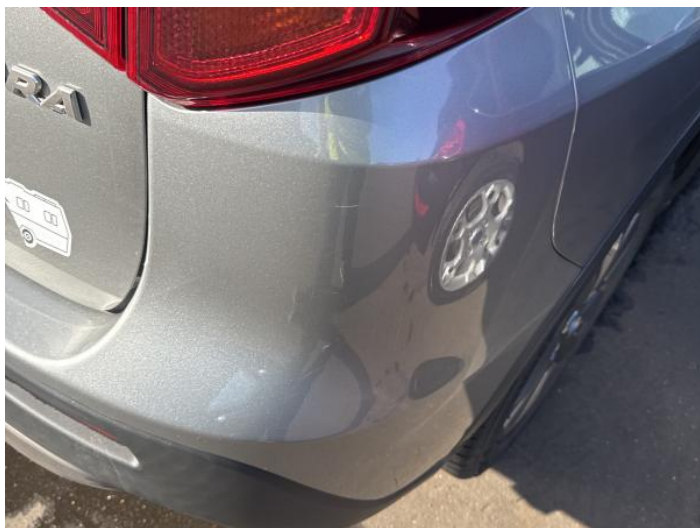
1: Bumper Rear  
Chipped  
Multiple Chips

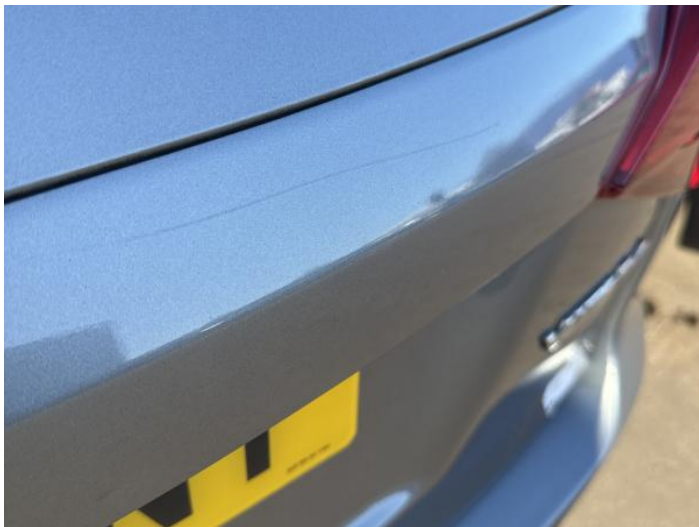
3: Boot Lid  
Scratched  
Over 25mm Thru Paint

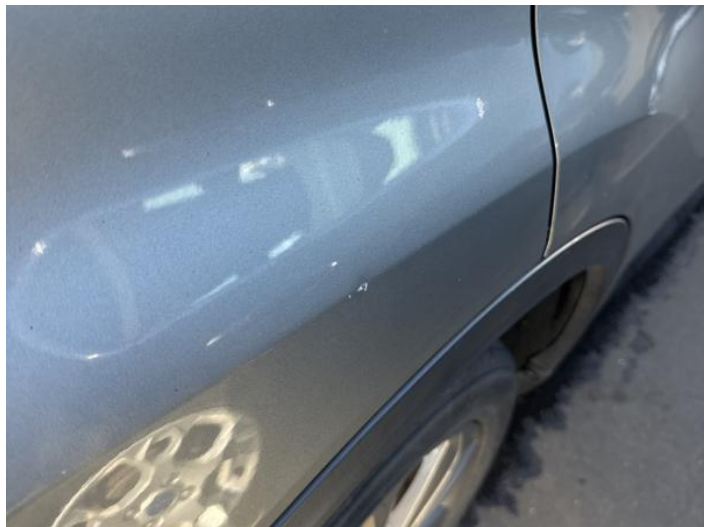
4: Qtr Panel osr  
Chipped  
1 To 5

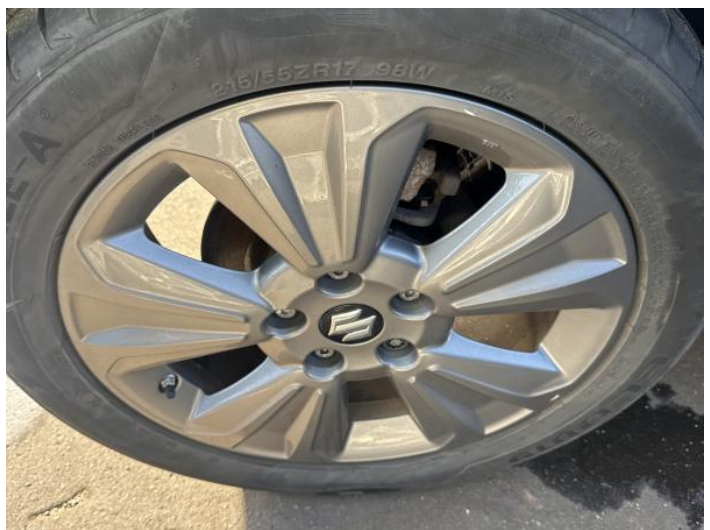
6: Wheel osr  
Scratched  
Up To 50mm

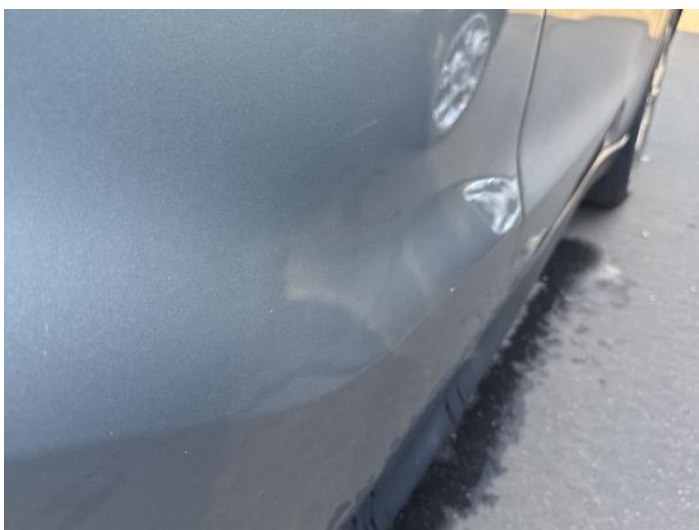
7: Door osr  
Chipped  
1 To 5

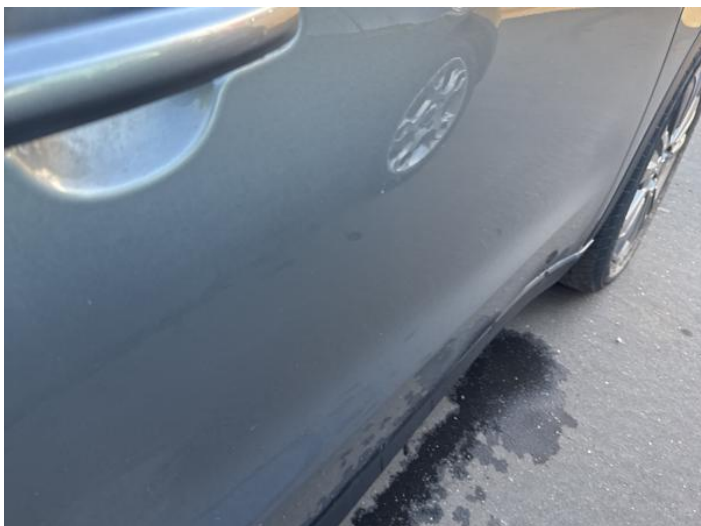
9: Door osf  
Dented  
With Paint Damage

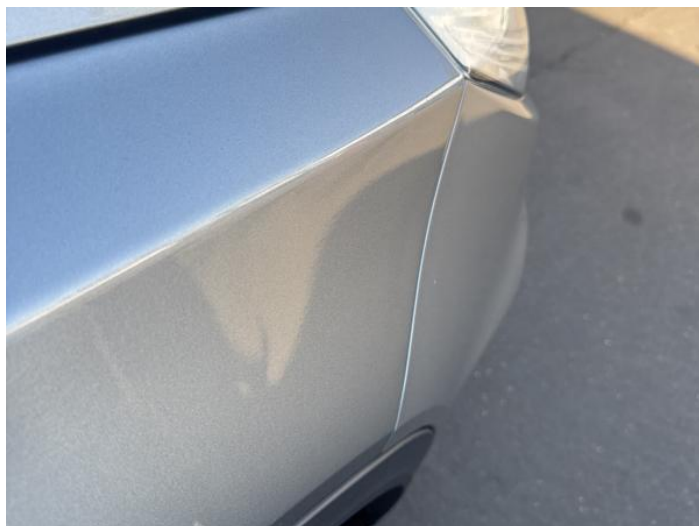
10: Wing osf  
Chipped  
1 To 5

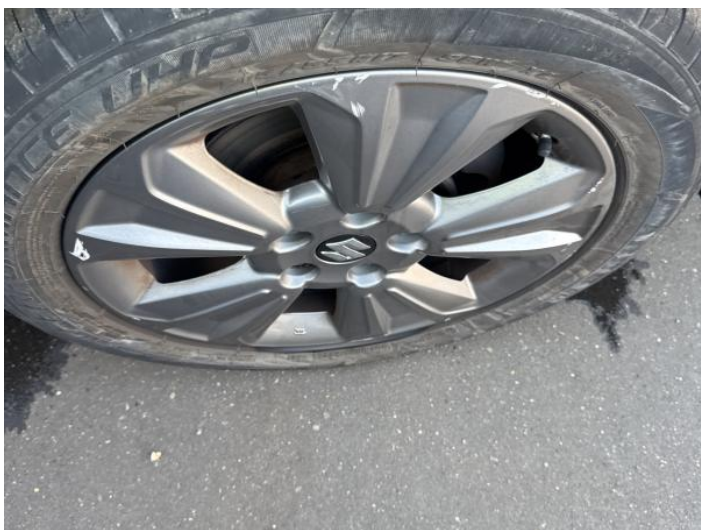
11: Wheel osf  
Scratched  
Over 50mm

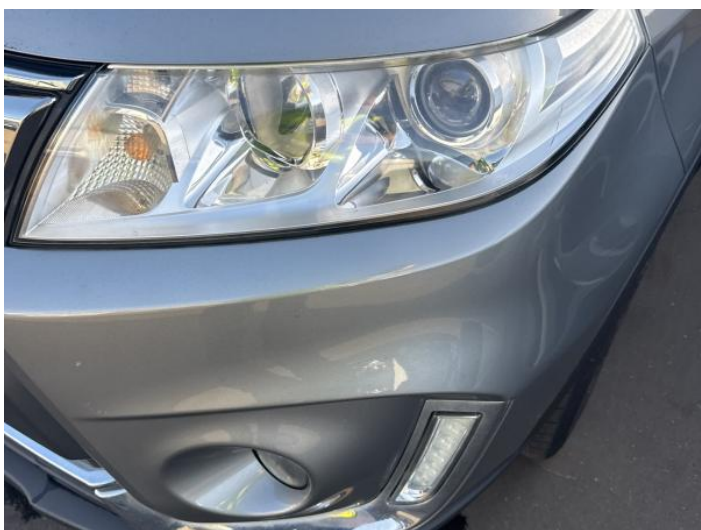
13: Bumper Front  
Chipped  
Multiple Chips

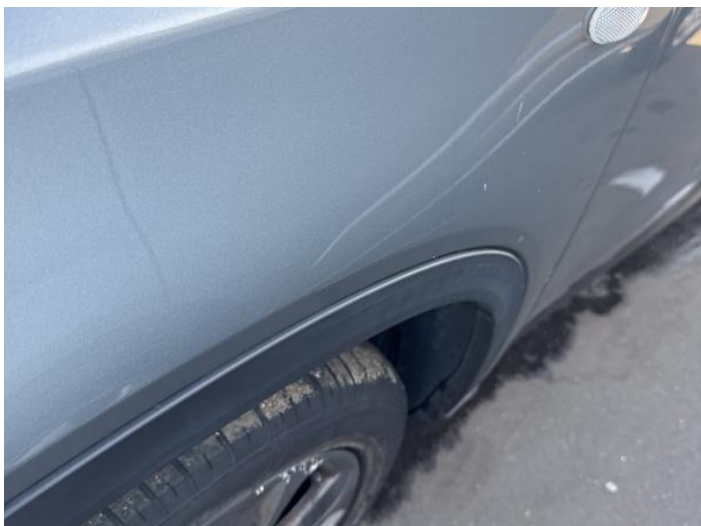
15: Wing nsf  
Chipped  
1 To 5

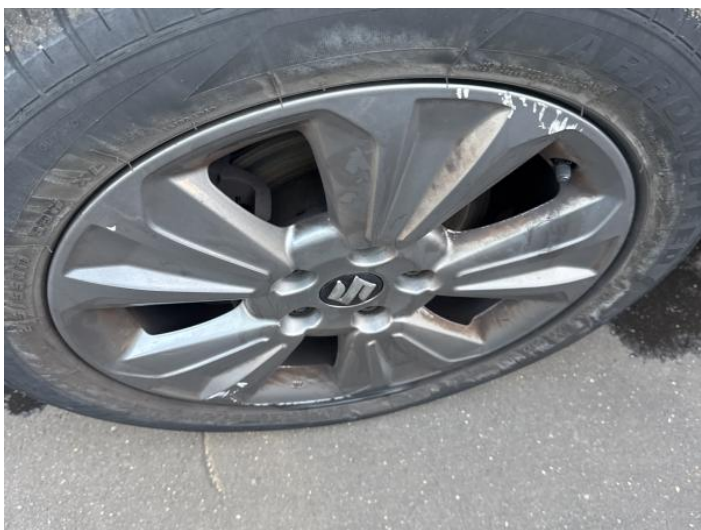
17: Wheel nsf  
Scratched  
Over 50mm

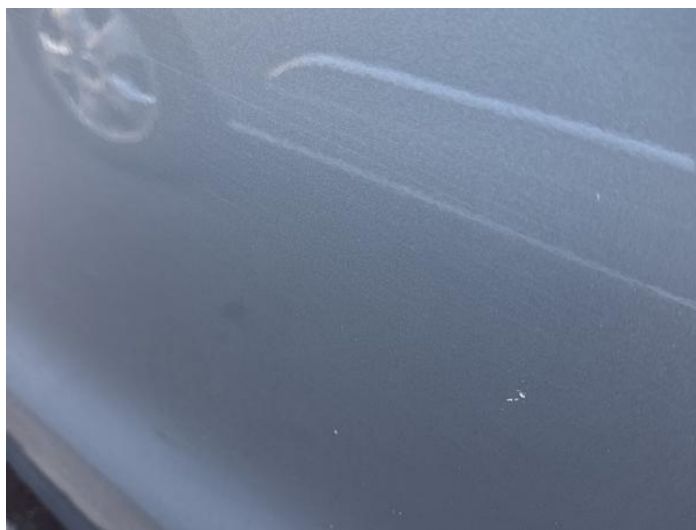
18: Door nsf  
Chipped  
1 To 5

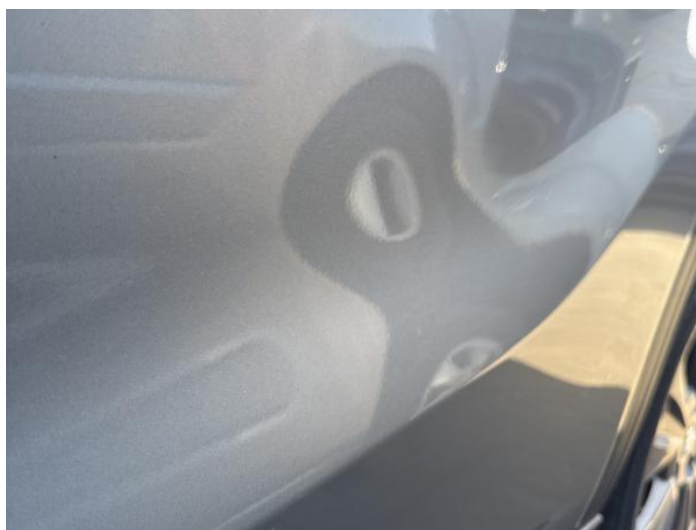
20: Door nsr  
Chipped  
1 To 5

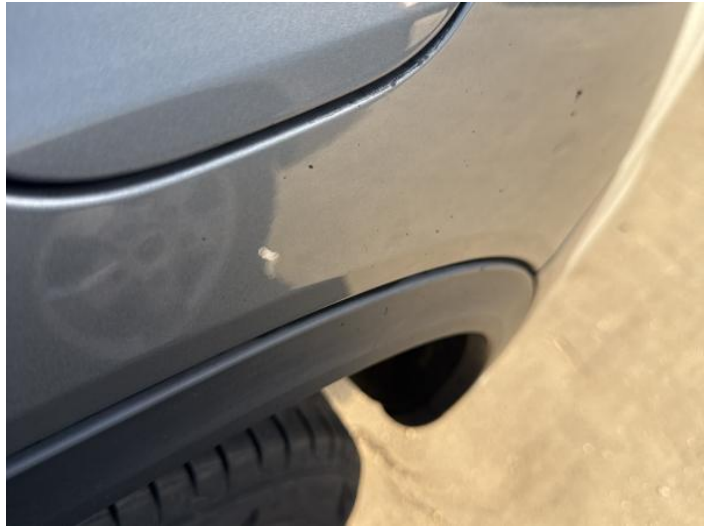
21: Door nsr  
Scratched  
Over 25mm Not Thru Paint
