VEHICLE INSPECTION REPORT

LS66KWD

Peugeot 2008 1.6 BlueHDi 100 Allure 5dr

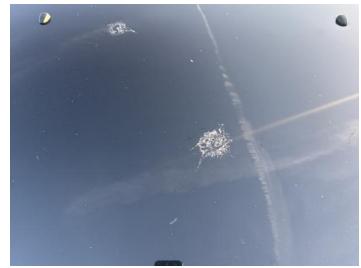
1: Bonnet Chipped Multiple Chips

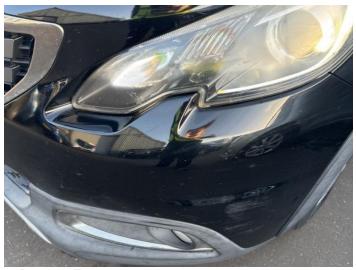
2: Bumper Front Scratched Over 100mm Thru Paint

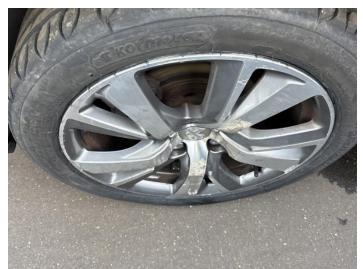
5: Wheel nsf Scratched Over 50mm

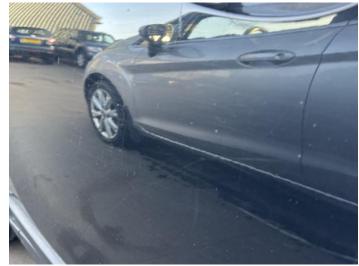
7: Door nsf Chipped Multiple Chips

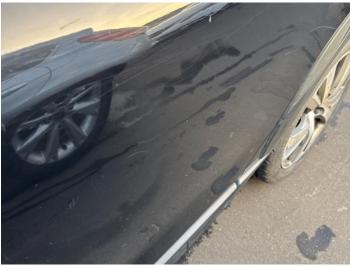
8: Door nsr Chipped Multiple Chips

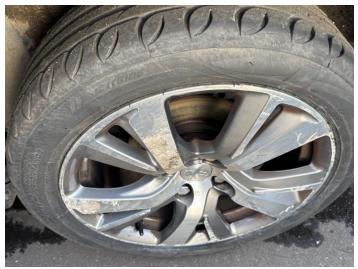
9: Wheel nsr Scratched Over 50mm

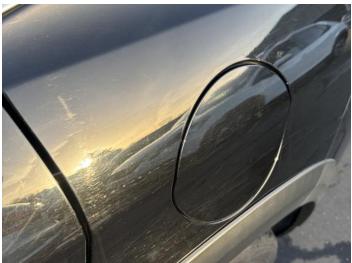
10: Qtr Panel nsr Chipped 1 To 5

11: Qtr Panel nsrScratchedOver 25mm Not Thru Paint

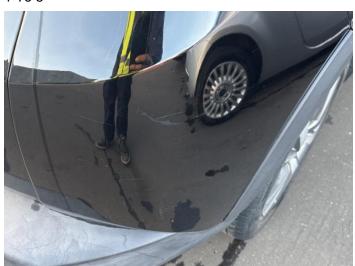
12: Bumper Rear Scratched 25 to 100mm Thru Paint

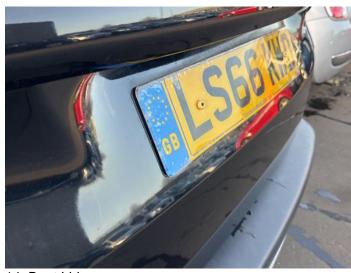
14: Boot Lid Chipped Multiple Chips

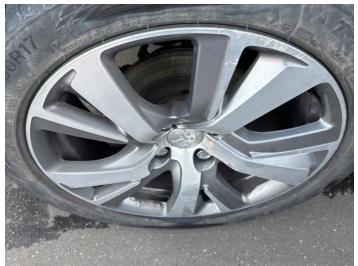
17: Wheel osr Scratched Over 50mm

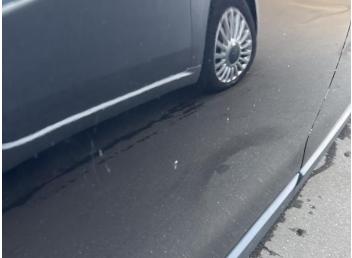
18: Door osr Chipped Multiple Chips

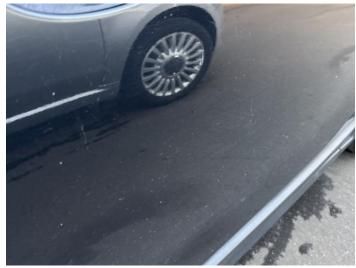
19: Door osf Chipped Multiple Chips

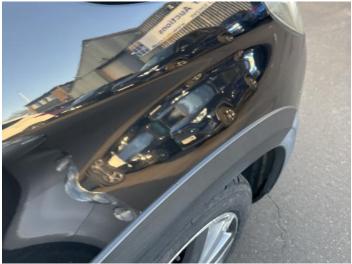
20: Wing osf Chipped 1 To 5

21: Wing osf Scratched Over 25mm Not Thru Paint

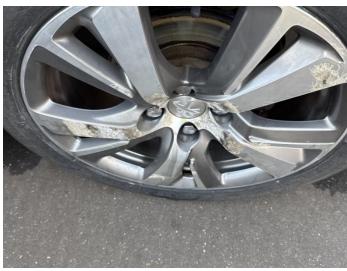
22: Wheel osf Scratched Over 50mm
