# **VEHICLE INSPECTION REPORT**

## **Mercedes-Benz M-Class ML 350 INSPIRATION**

Inspection		Vehicle			nama
Serious Damage?	No	VAT	Margin		<b>3</b>
		V5	TBC		
Details					
Reg. date	24/09/2004	Colour	SILVER	MOT Due	28/04/2026
Year	2004	VIN	WDC1631572A488004	Gearbox	AUTOMATIC
Mileage	99,291 Miles Warranted	Body Style	Estate	Gears	5
		Keys	3		
Fuel Type	Petrol	-

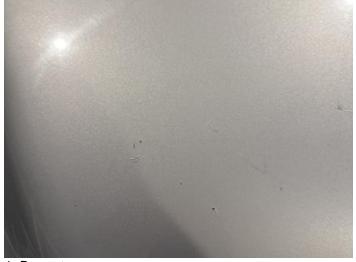
1: Bonnet Chipped Multiple Chips

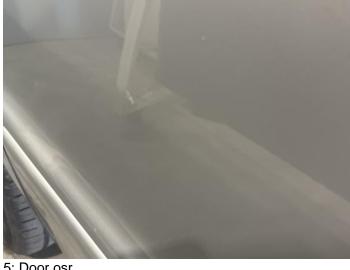
5: Door osr Chipped 1 To 5

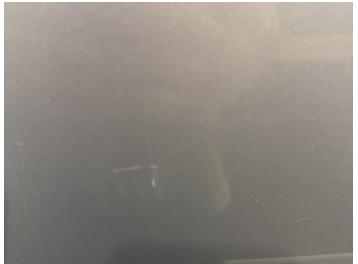
6: Qtr Panel osr Scratched UpTo 25mm Thru Paint

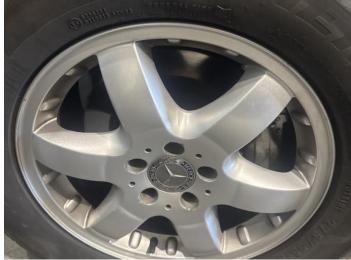
7: Wheel osr Scratched Over 50mm

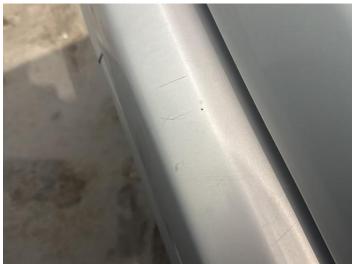
8: Bumper Rear Poor Previous Repair Poor Paint

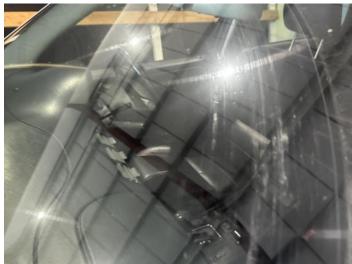
13: Screen Front Chipped UpTo 10mm
