# VEHICLE INSPECTION REPORT

**GU15VWK**

## Mazda 3 2.0 Sport Nav 5dr

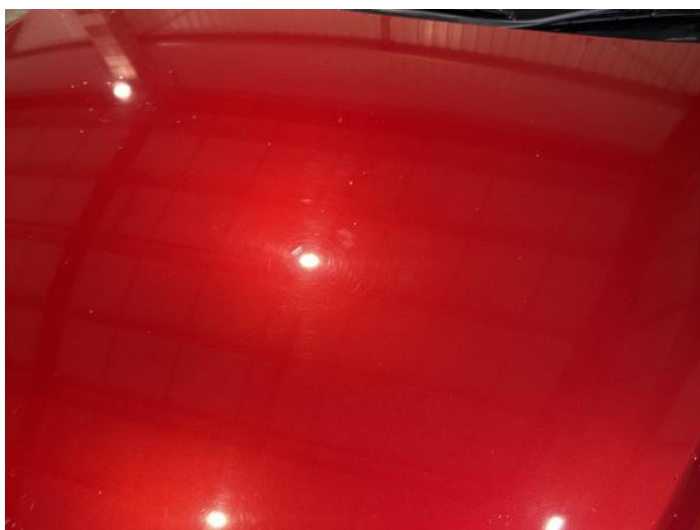
1: Bonnet  
Chipped  
1 To 5

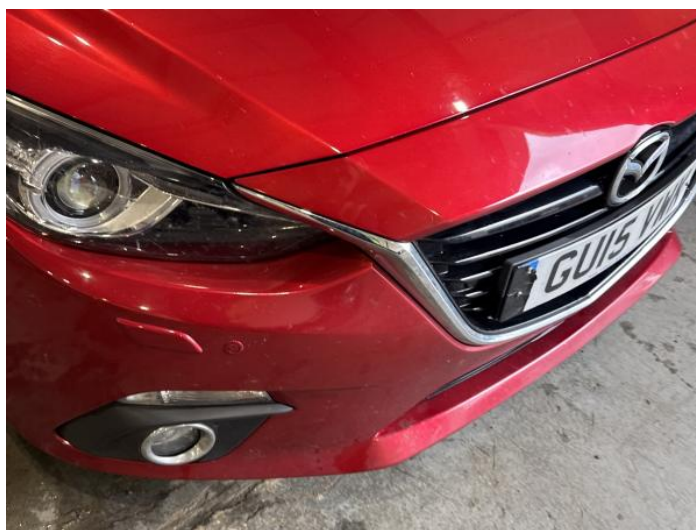
2: Bumper Front  
Poor Previous Repair  
Poor Paint

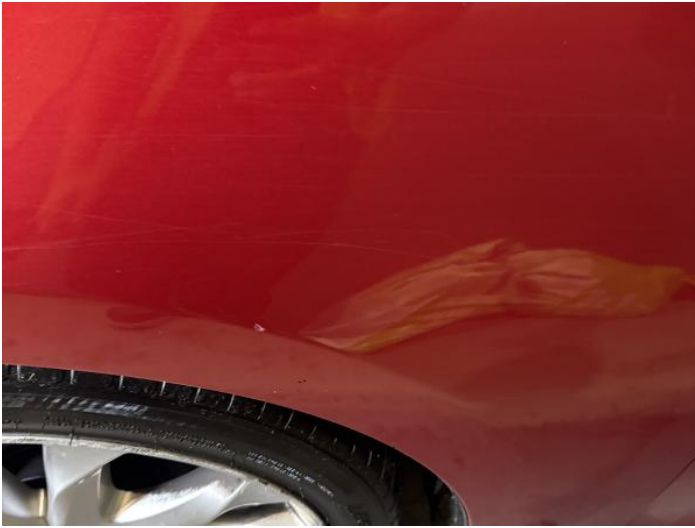
3: Wing nsf  
Chipped  
1 To 5

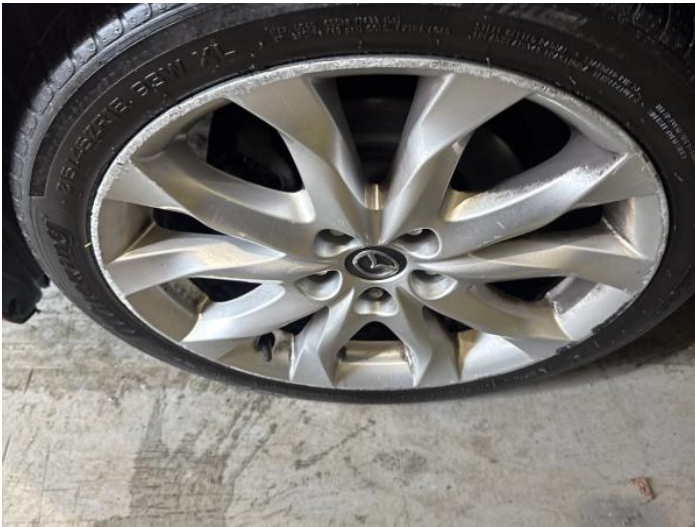
5: Wheel nsf  
Scratched  
Over 50mm

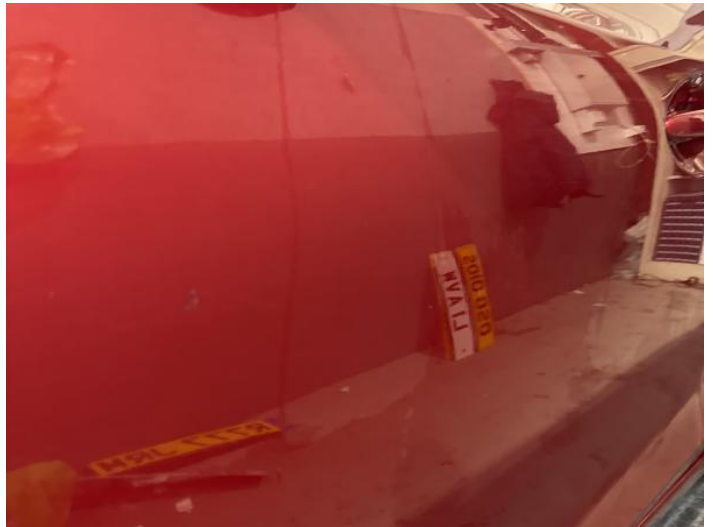
6: Door nsf  
Chipped  
1 To 5

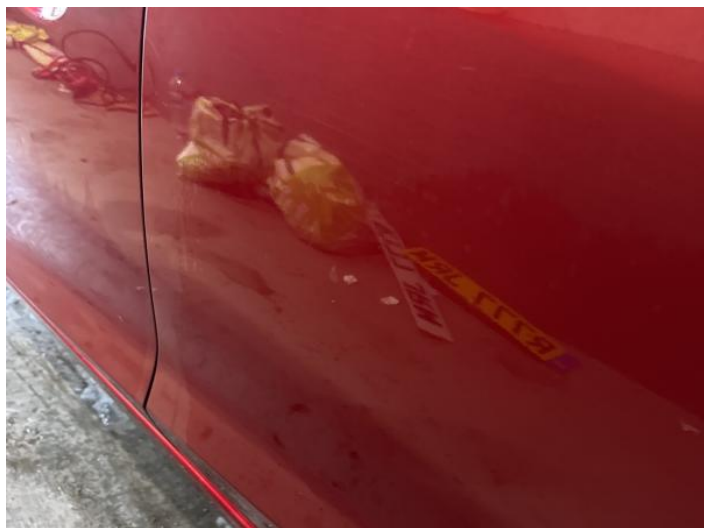
8: Door nsr  
Dented  
2 Or Less UpTo 10mm

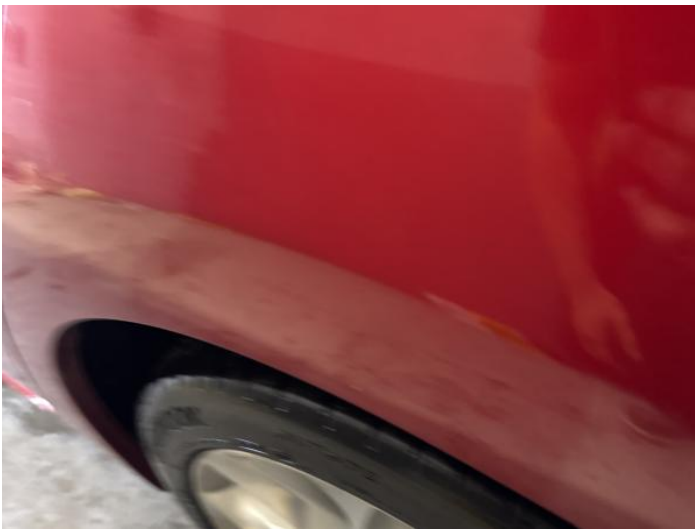
11: Qtr Panel nsr  
Dented  
Over 30mm

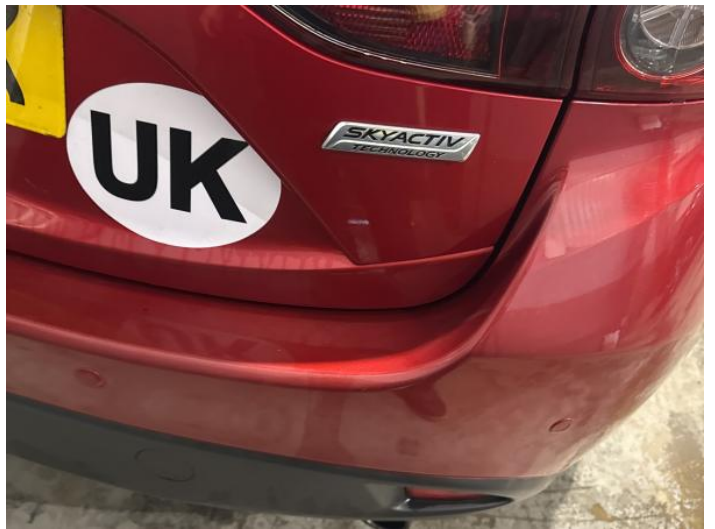
12: Bumper Rear  
Chipped  
Multiple Chips

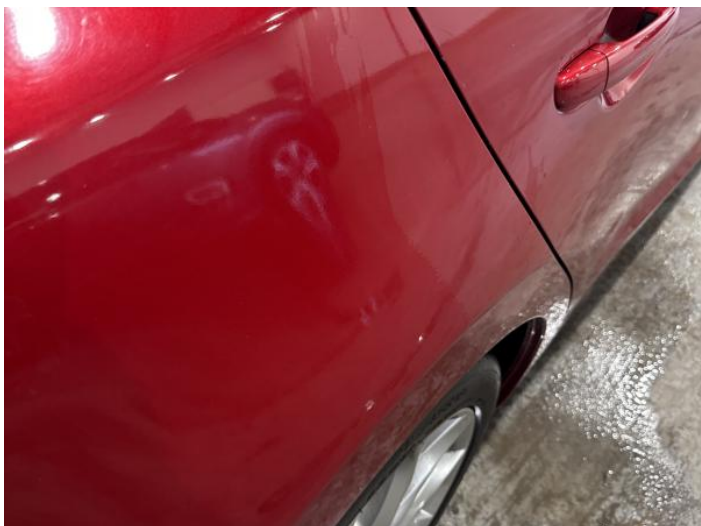
15: Qtr Panel osr  
Dented  
2 Or Less UpTo 10mm

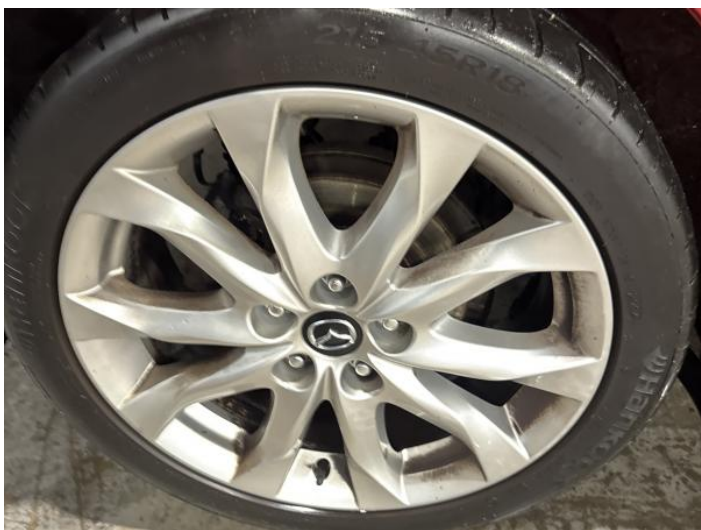
17: Wheel osr  
Scratched  
Up To 50mm

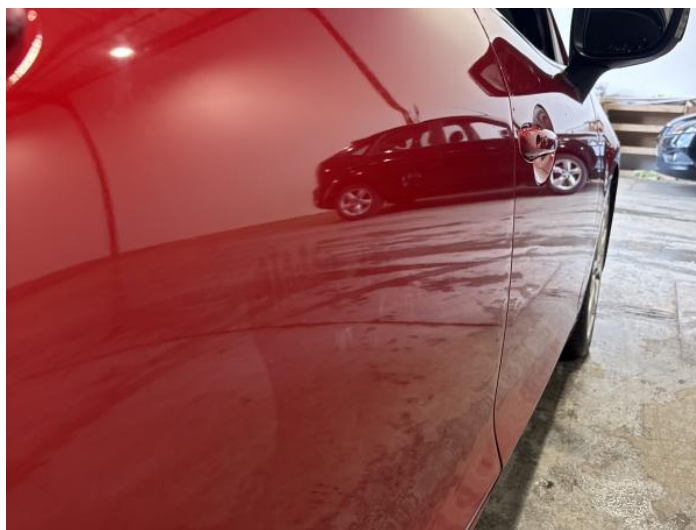
18: Door osr  
Dented  
With Paint Damage

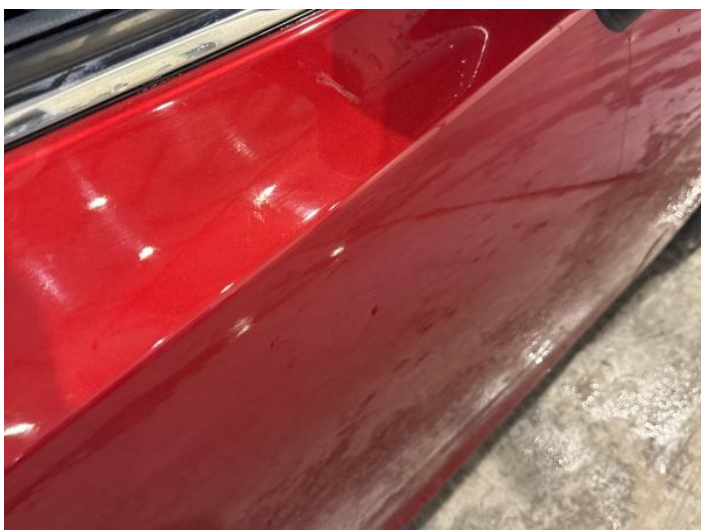
19: Door osr  
Poor Previous Repair  
Poor Paint

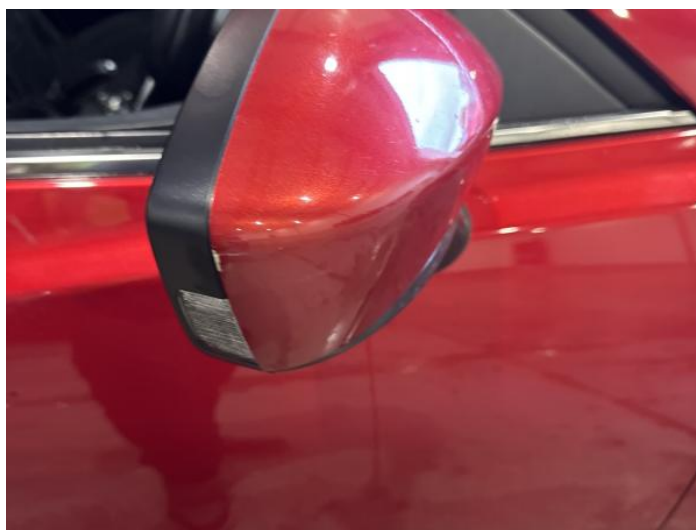
20: Door Mirror Assy osf  
Scratched (Painted)  
UpTo 25mm Thru Paint

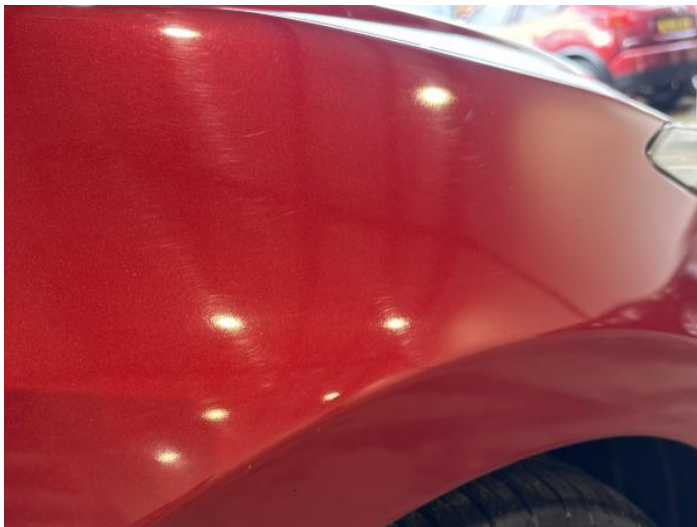
21: Wing osf  
Poor Previous Repair  
Poor Paint

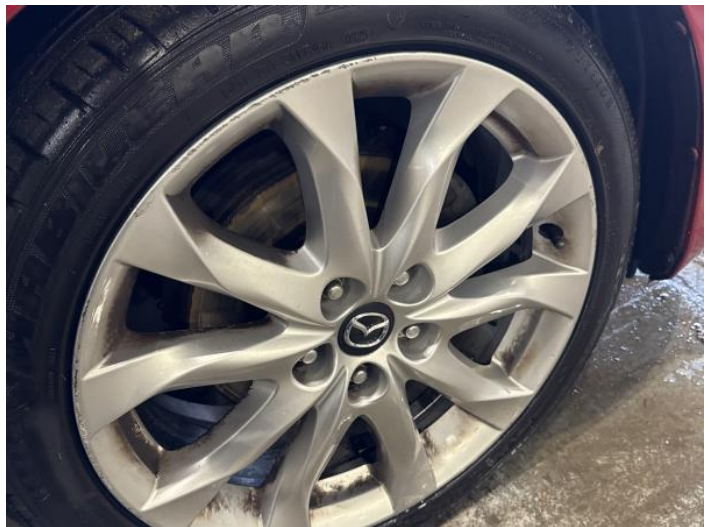
22: Wheel osf  
Scratched  
Over 50mm
