## VEHICLE INSPECTION REPORT

RE14TBU

### Porsche Cayenne Platinum Edition Diesel 5dr Tiptronic S

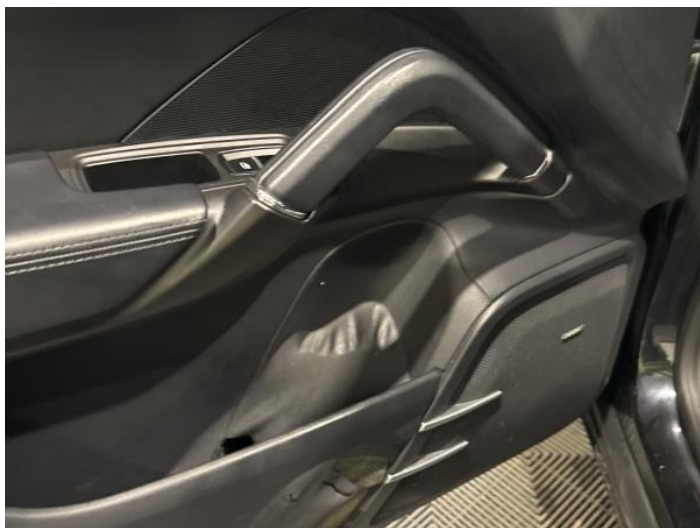
1: Door Pad nsf  
Torn  
Over 10mm

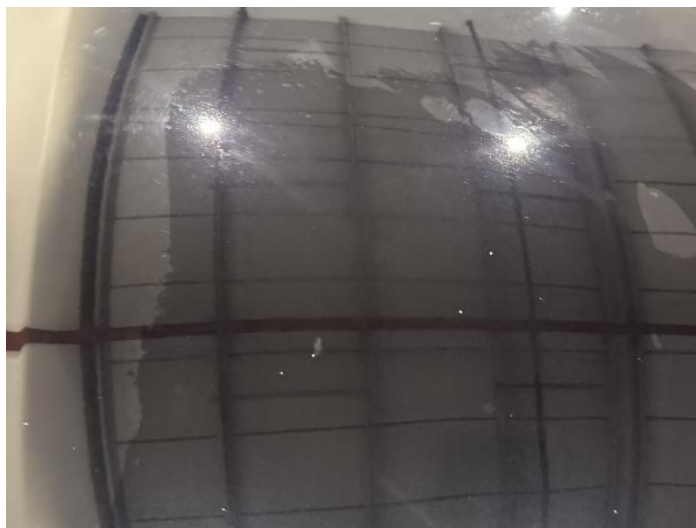
2: Bonnet  
Chipped  
Multiple Chips

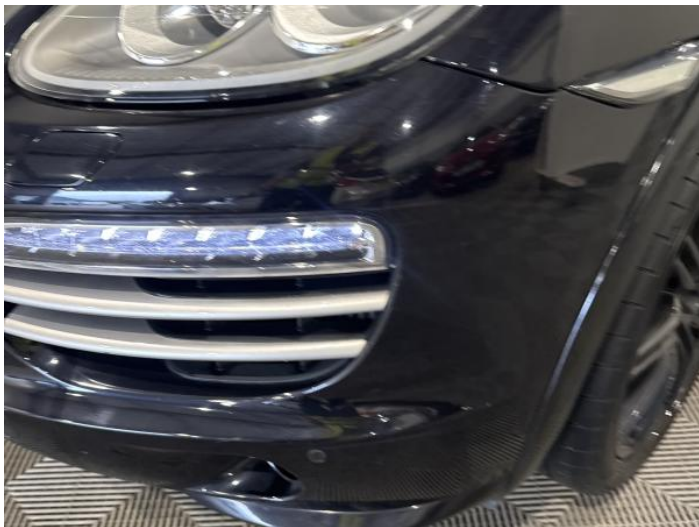
3: Bumper Front  
Scratched  
Over 100mm Thru Paint

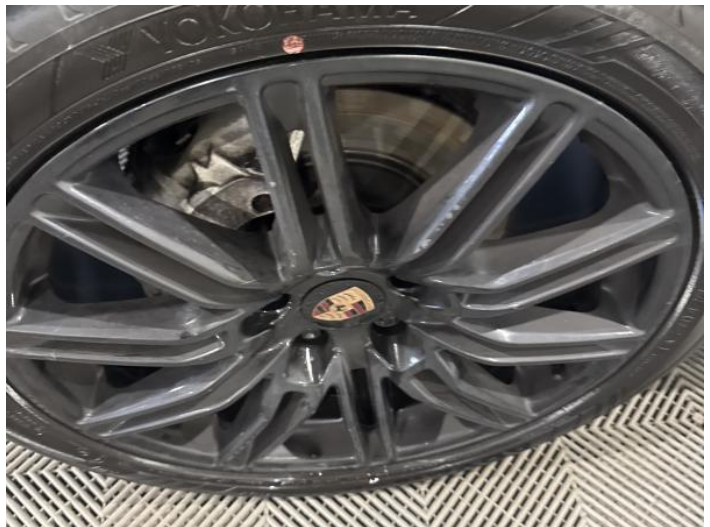
4: Wheel nsf  
Scratched  
Up To 50mm

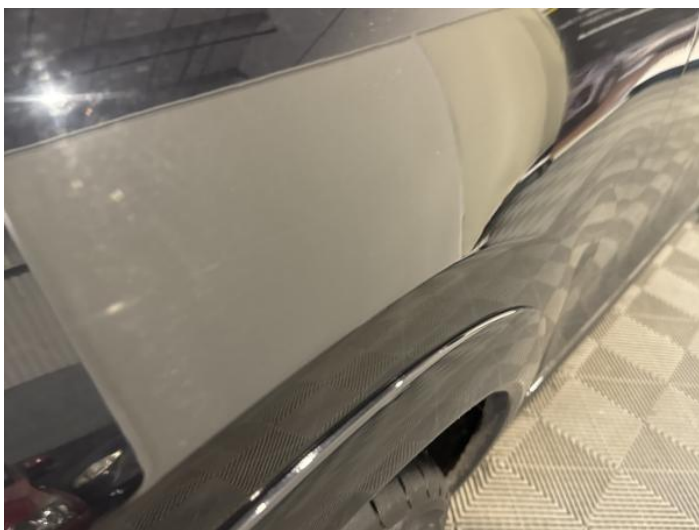
5: Wing nsf  
Chipped  
1 To 5

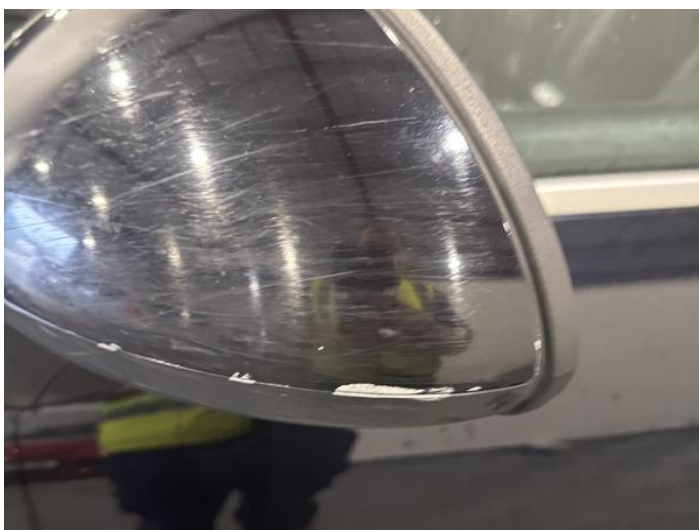
7: Door Mirror Assy nsf  
Scratched (Painted)  
Over 25mm Thru Paint

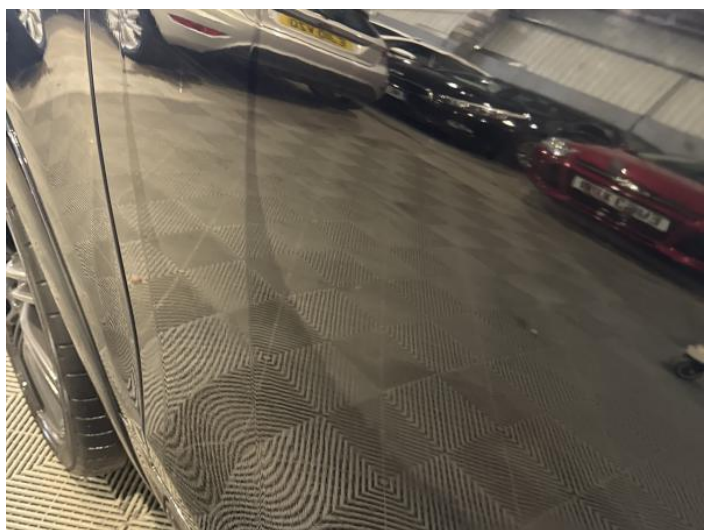
8: Door nsf  
Dented  
Over 30mm

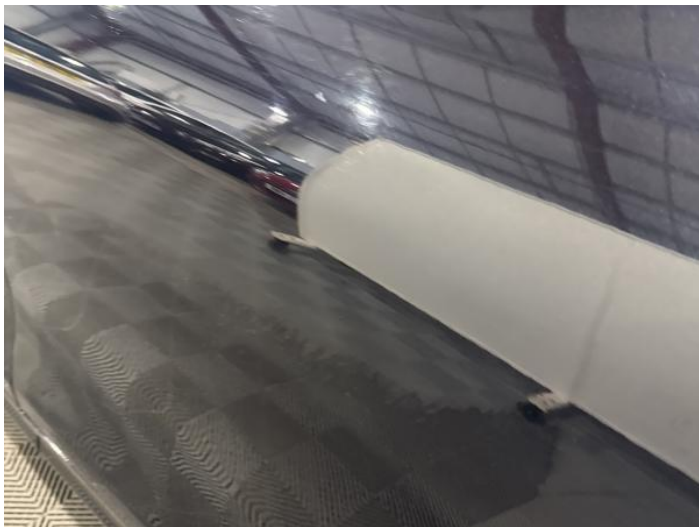
9: Door nsr  
Chipped  
1 To 5

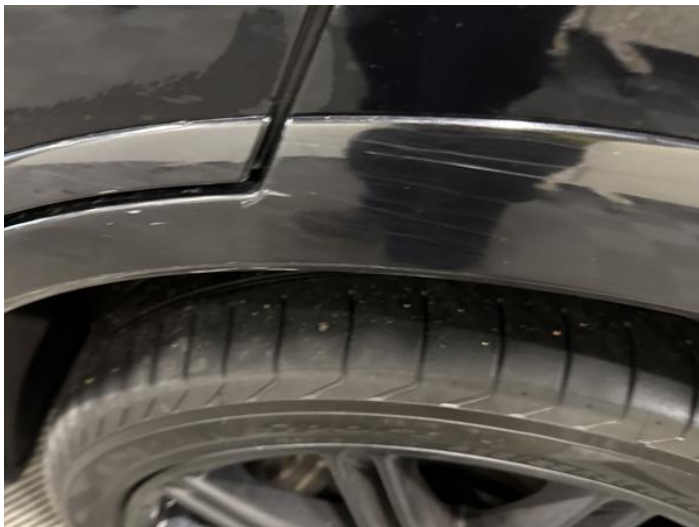
11: Qtr Panel Arch Extension ns  
Scratched (Painted)  
Over 25mm Thru Paint

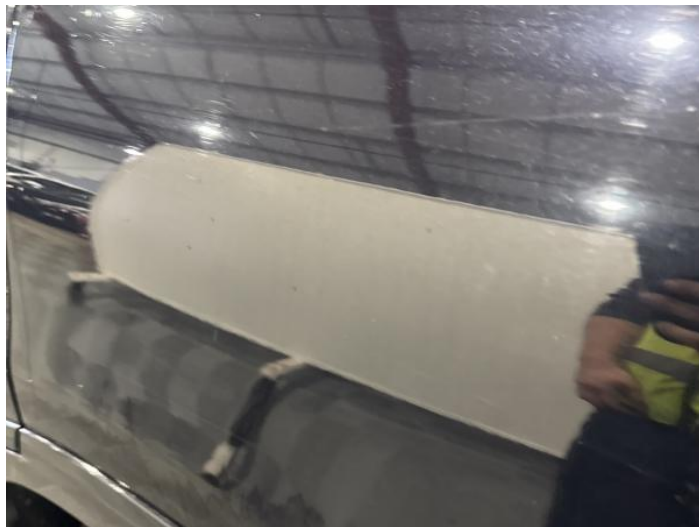
12: Qtr Panel nsr  
Dented  
Over 2 UpTo 10mm

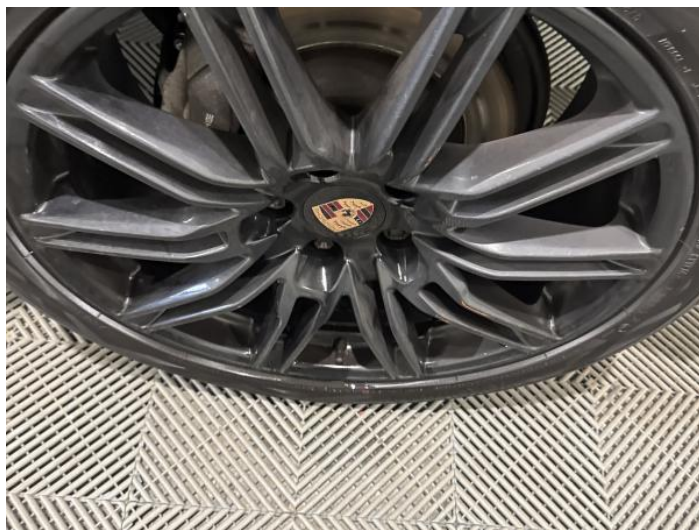
14: Wheel nsr  
Scratched  
Over 50mm

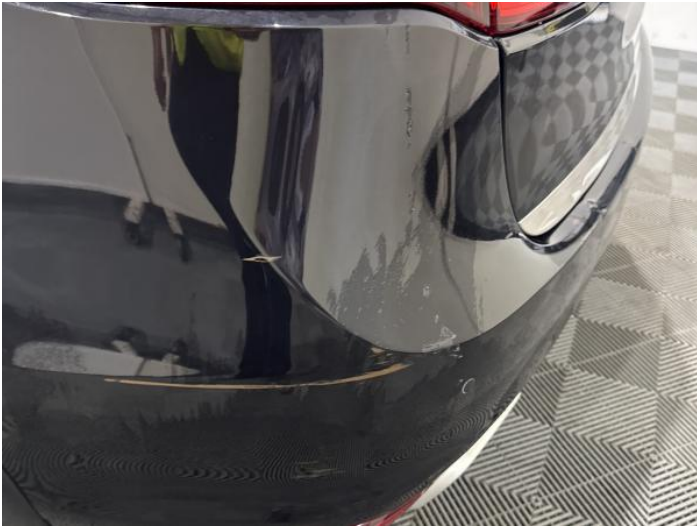
15: Bumper Rear  
Scratched  
Over 100mm Thru Paint

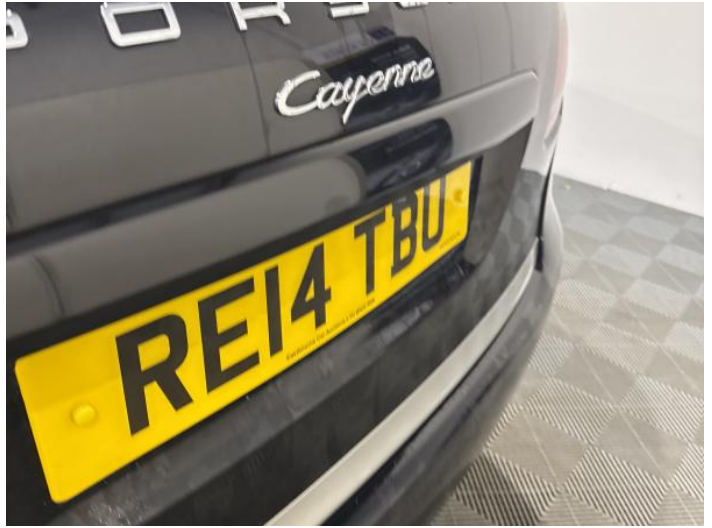
16: Boot Lid  
Scratched  
UpTo 25mm Thru Paint

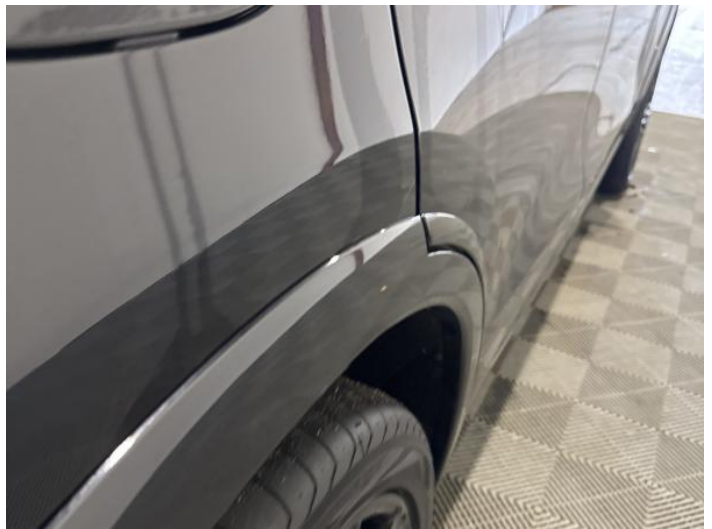
18: Qtr Panel osr  
Scratched  
UpTo 25mm Thru Paint

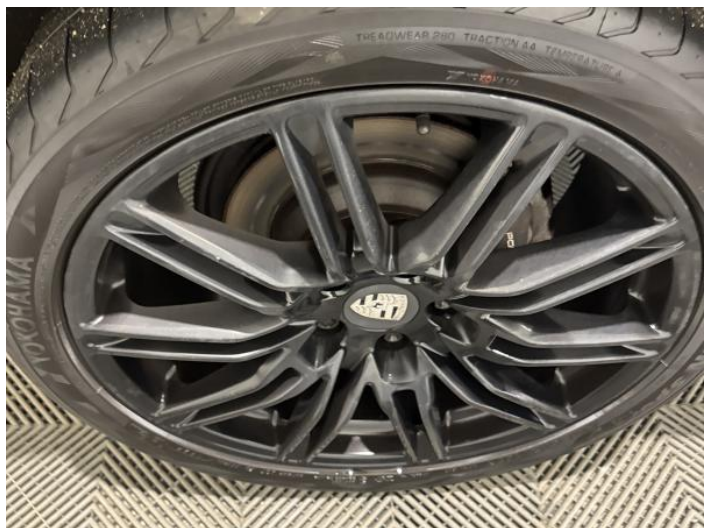
20: Wheel osr  
Scratched  
Up To 50mm

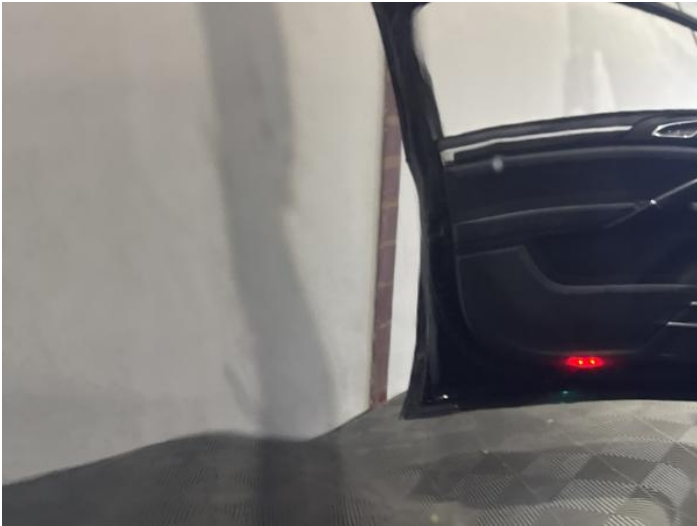
21: Door osr  
Dented  
Over 2 UpTo 10mm

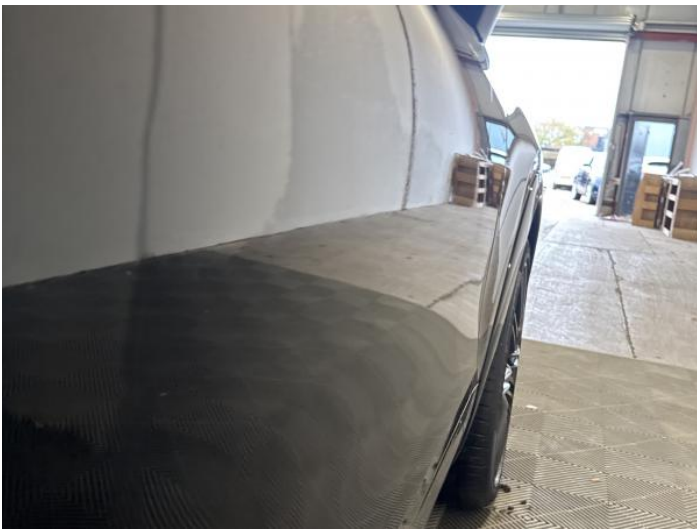
23: Door osf  
Chipped  
1 To 5

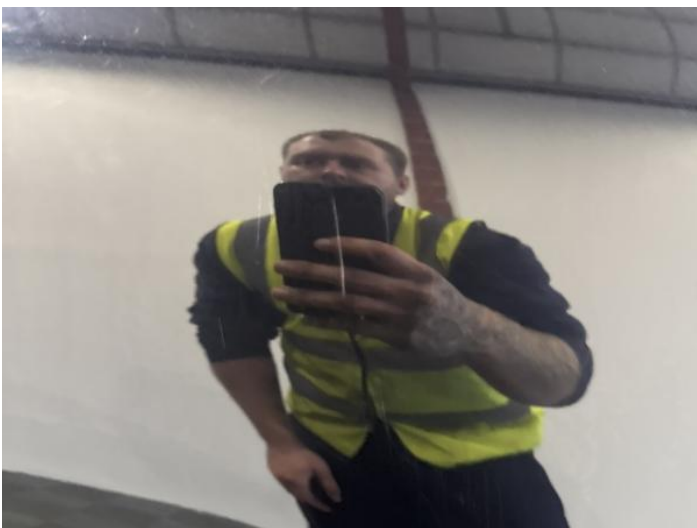
25: Wing osf  
Chipped  
1 To 5

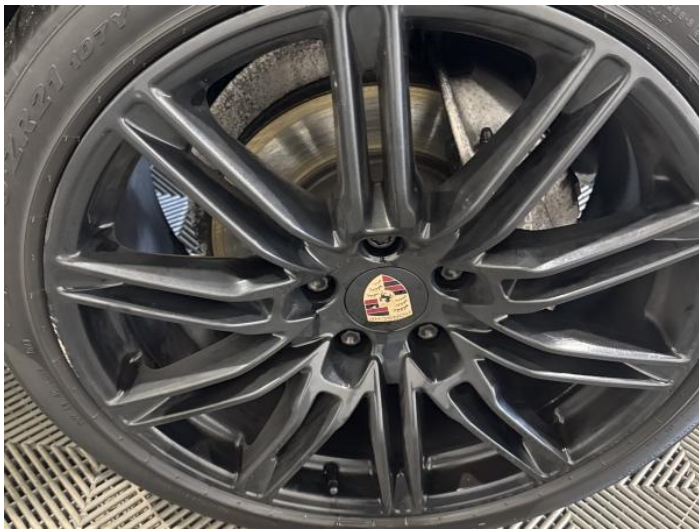
27: Wheel of  
Scratched  
Over 50mm
