VEHICLE INSPECTION REPORT

WR22CFX

Toyota RAV4 2.5 VVT-i Hybrid Design 5dr CVT

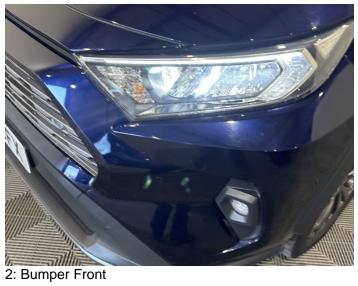
2: Bumper Front
Poor Previous Repair
Poor Paint

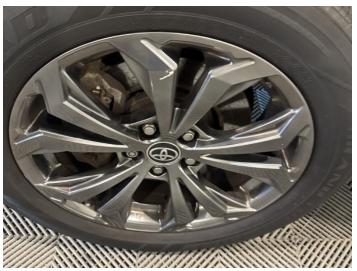
3: Wheel nsf Scratched Over 50mm

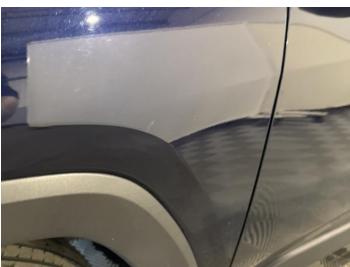
4: Wing nsf Chipped 1 To 5

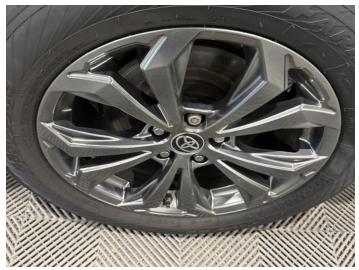
9: Wheel nsr Scratched Up To 50mm

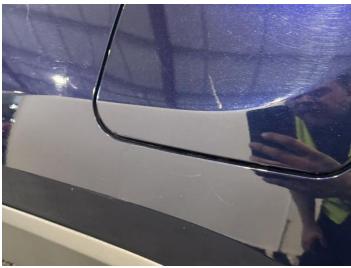
10: Qtr Panel nsr Poor Previous Repair Poor Paint

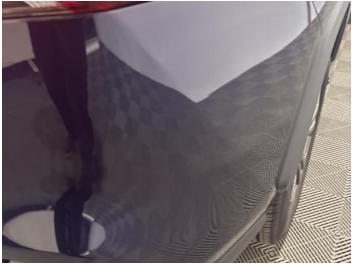
12: Bumper Rear Scratched Over 25mm Not Thru Paint

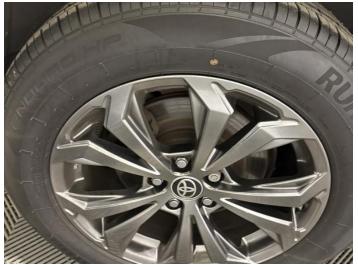
15: Wheel osr Scratched Up To 50mm

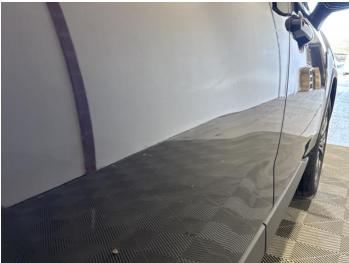
16: Door osr Poor Previous Repair Poor Paint

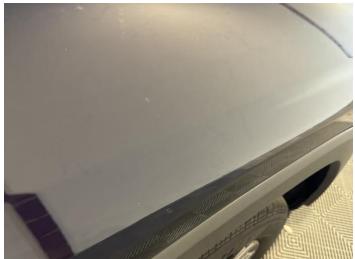
18: Wing osf Chipped 1 To 5

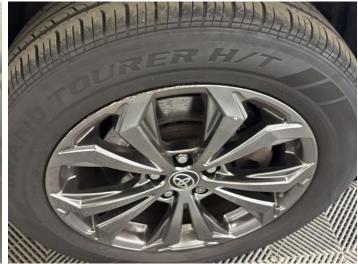
20: Wheel osf Scratched Over 50mm
