# VEHICLE INSPECTION REPORT

**GX64FCG**

## Toyota Auris 1.8 VVTi Hybrid Excel 5dr CVT Auto

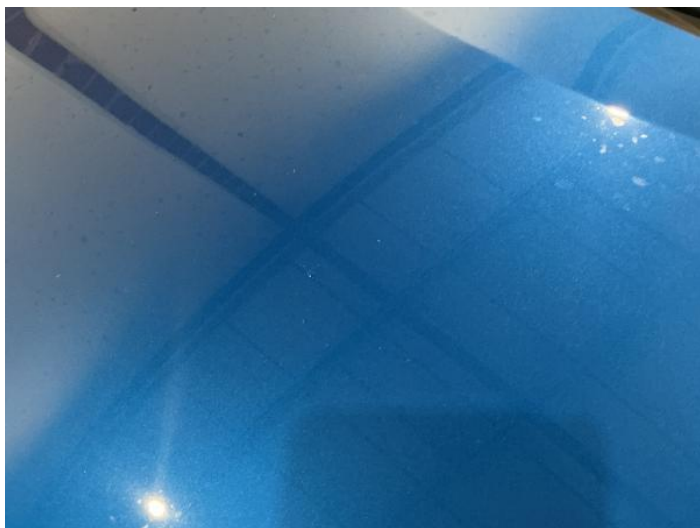
1: Bonnet  
Chipped  
Multiple Chips

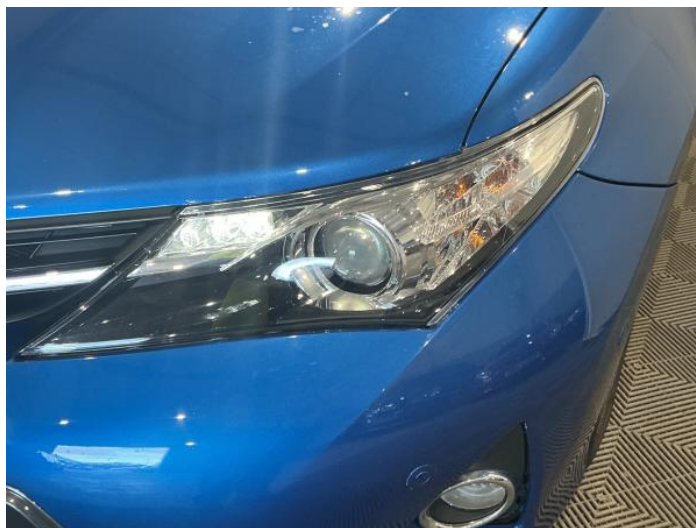
2: Bumper Front  
Poor Previous Repair  
Poor Paint

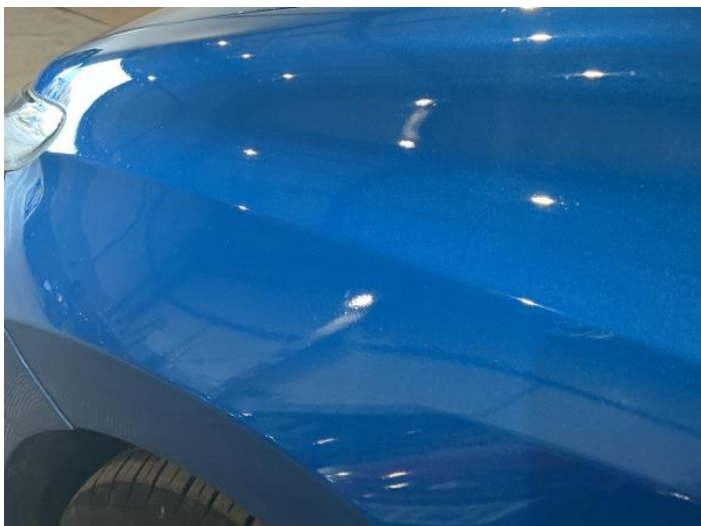
3: Wing nsf  
Poor Previous Repair  
Poor Paint

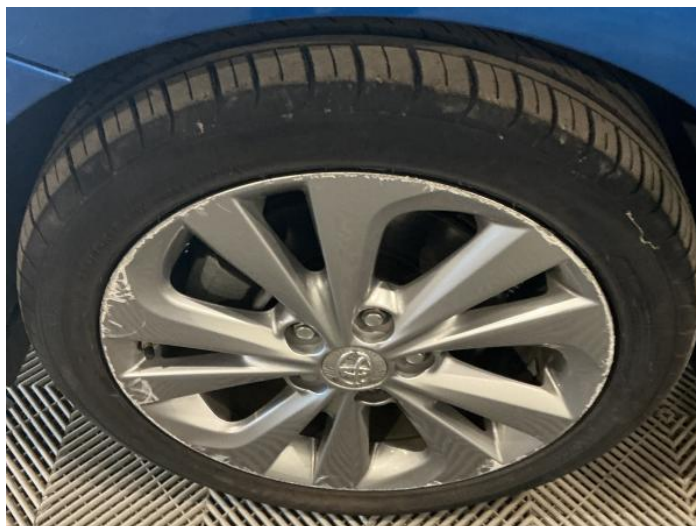
4: Wheel nsf  
Scratched  
Over 50mm

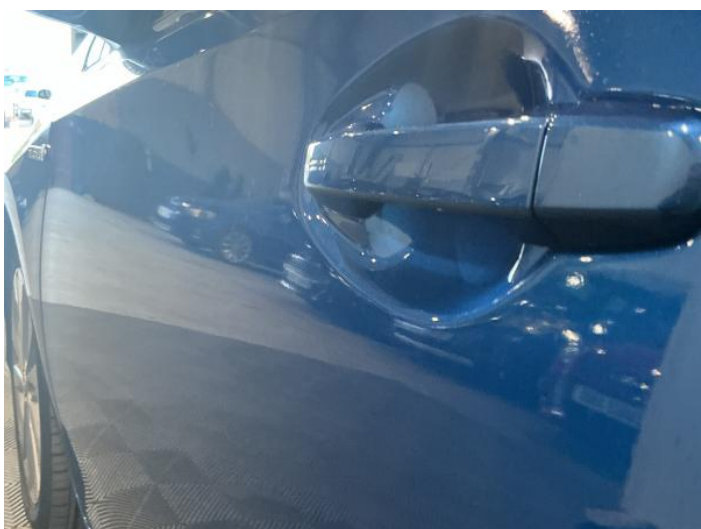
5: Door nsf  
Chipped  
1 To 5

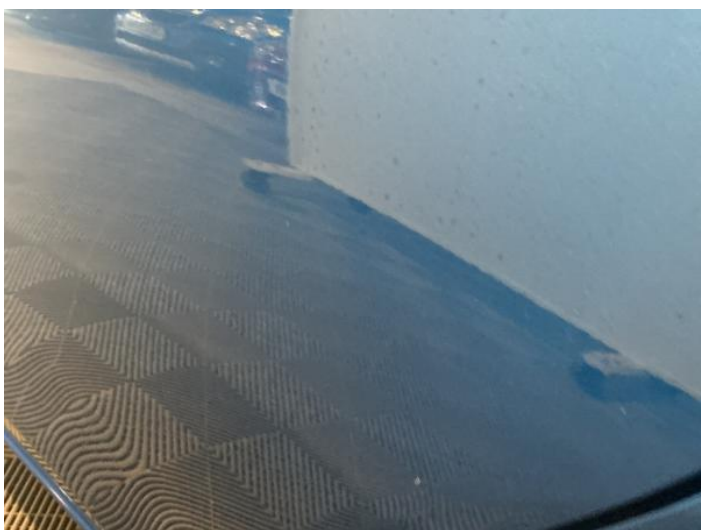
7: Door nsr  
Chipped  
1 To 5

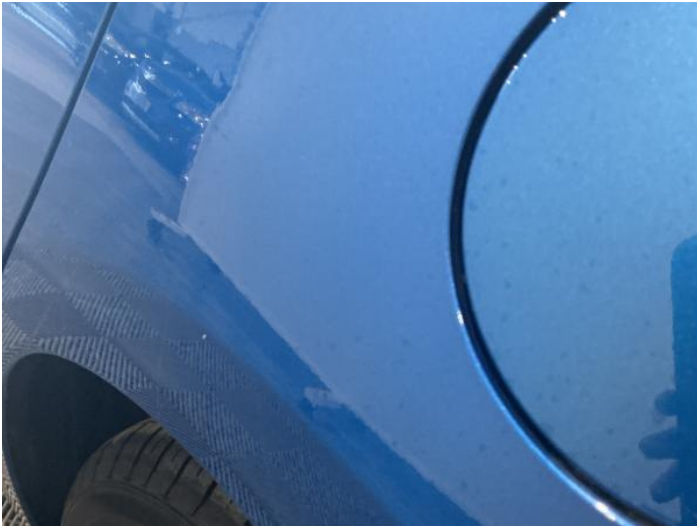
9: Qtr Panel nsr  
Dented  
Over 2 UpTo 10mm

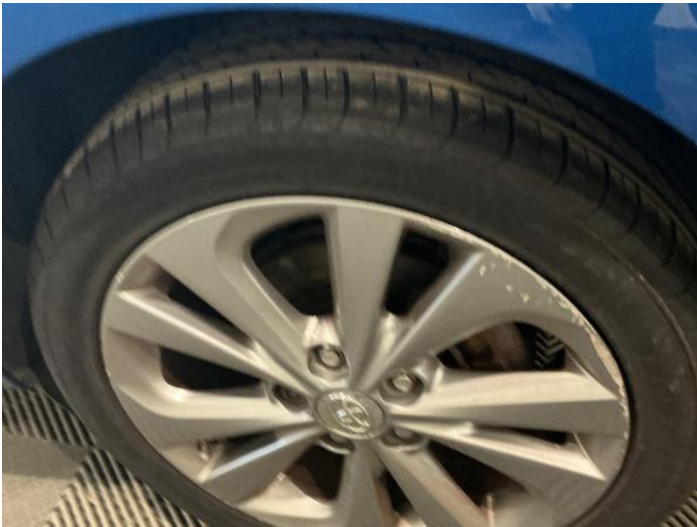
11: Wheel nsr  
Scratched  
Over 50mm

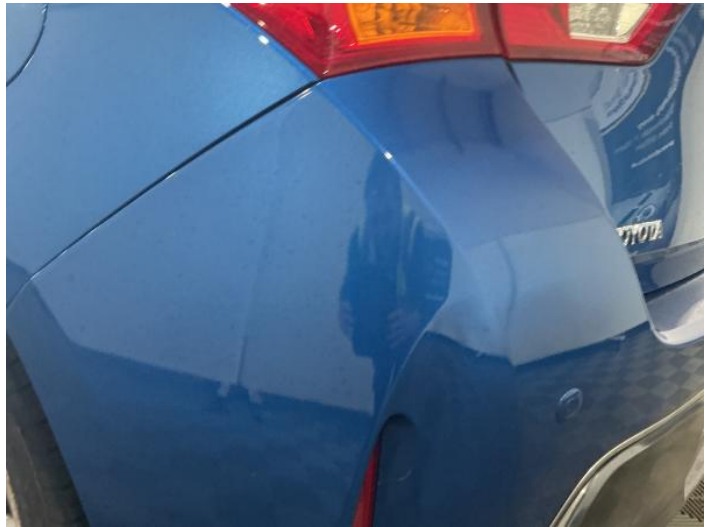
12: Bumper Rear  
Scratched  
Over 100mm Thru Paint

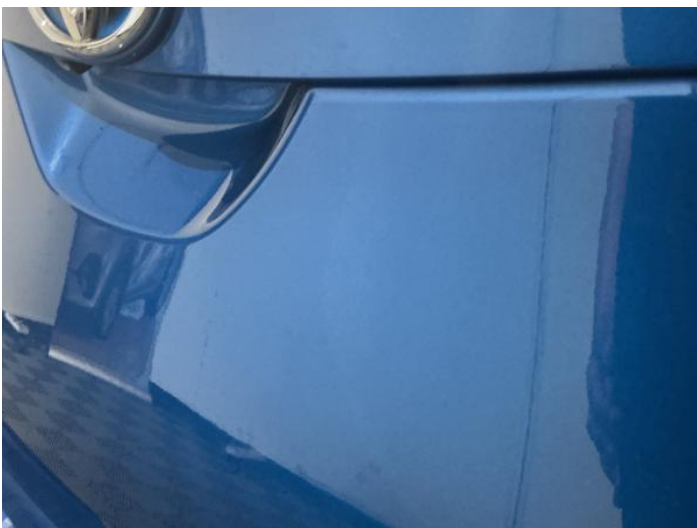
13: Boot Lid  
Chipped  
1 To 5

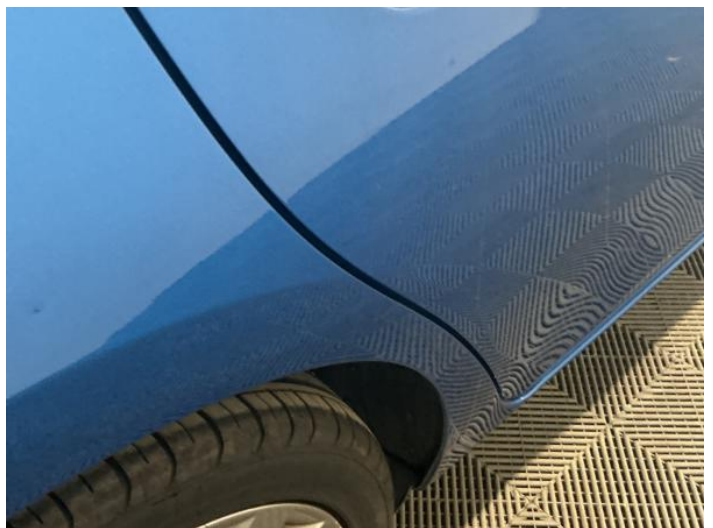
14: Qtr Panel osr  
Scratched  
UpTo 25mm Thru Paint

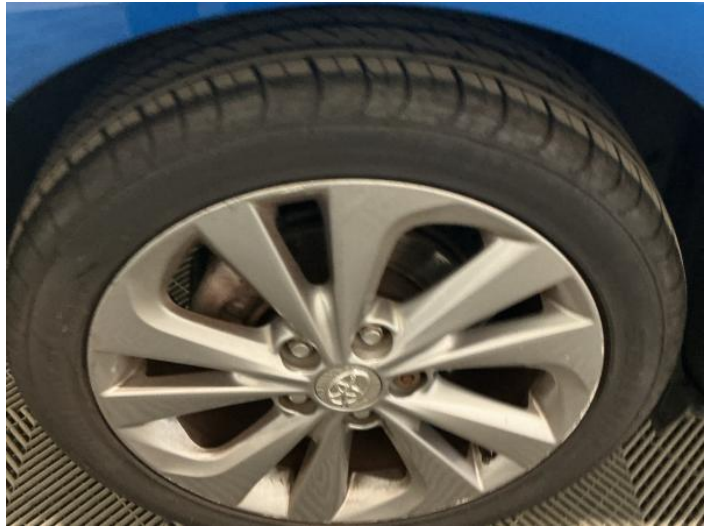
16: Wheel osr  
Scratched  
Over 50mm

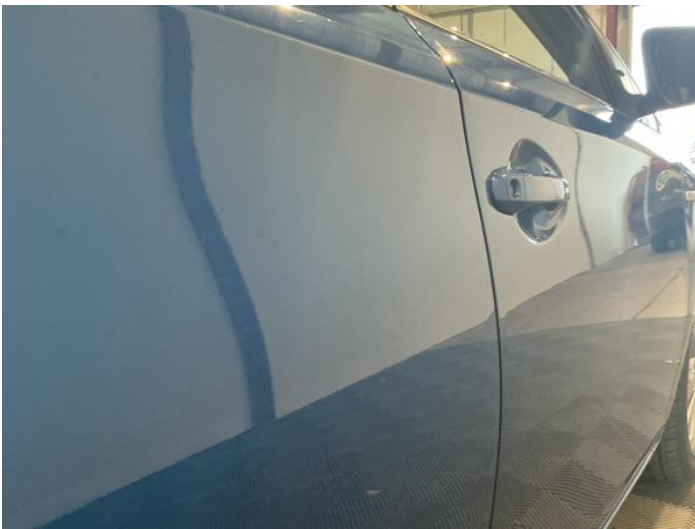
17: Door osr  
Dented  
Between 10mm + 30mm

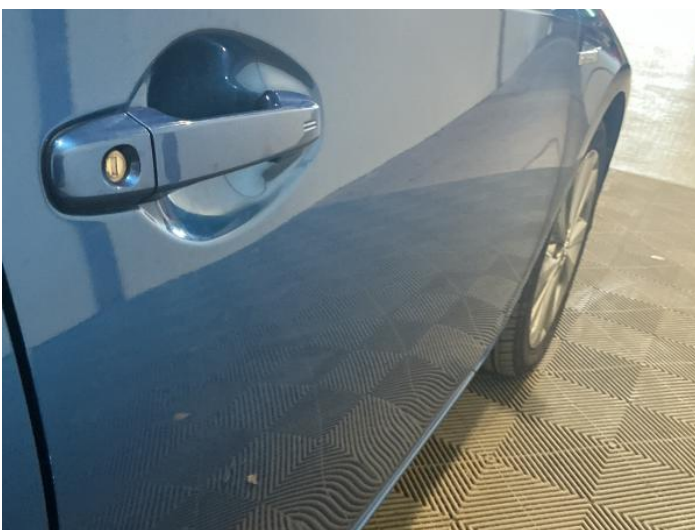
19: Door osf  
Poor Previous Repair  
Poor Paint

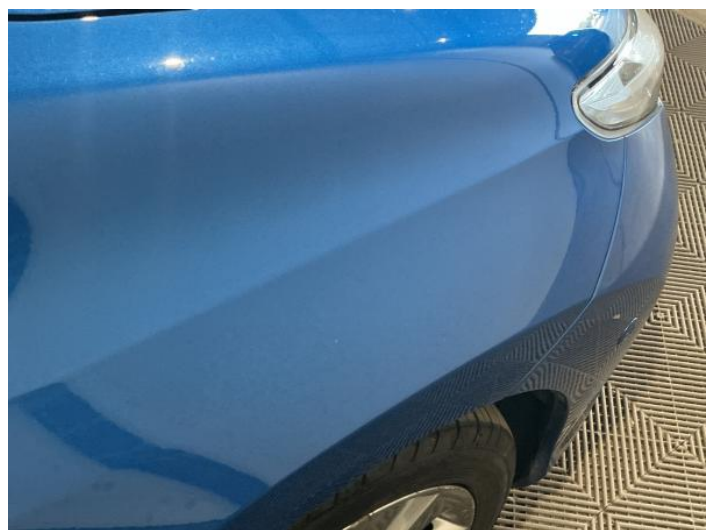
20: Wing osf  
Chipped  
1 To 5

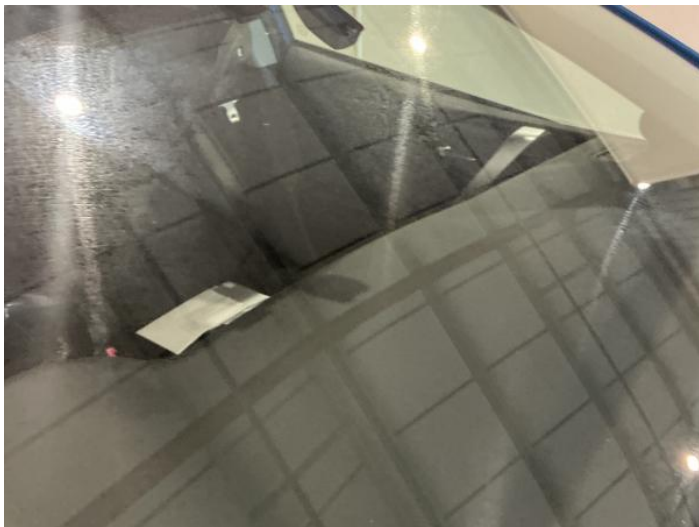
21: Screen Front  
Chipped  
UpTo 10mm

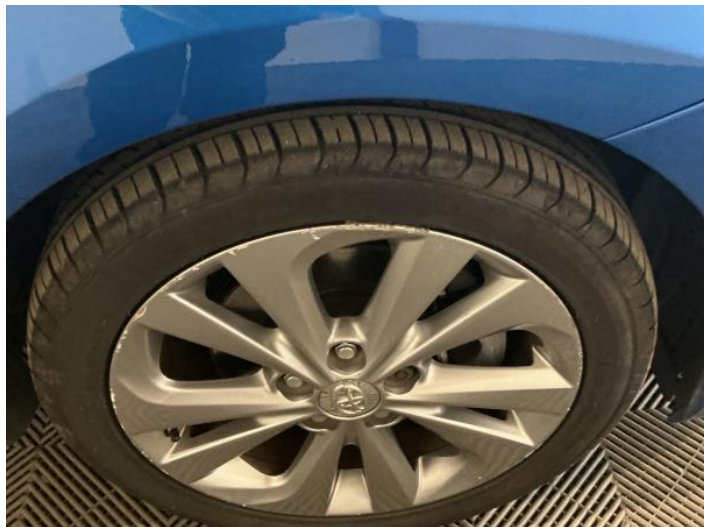
22: Wheel osf  
Scratched  
Over 50mm
