# VEHICLE INSPECTION REPORT

OV70ZKS

## Land Rover Discovery Sport 2.0 D180 HSE 5dr Auto

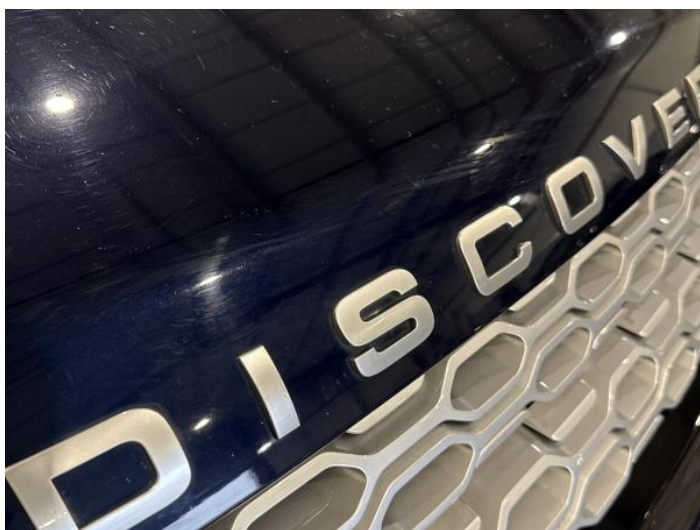
1: Bonnet  
Chipped  
1 To 5

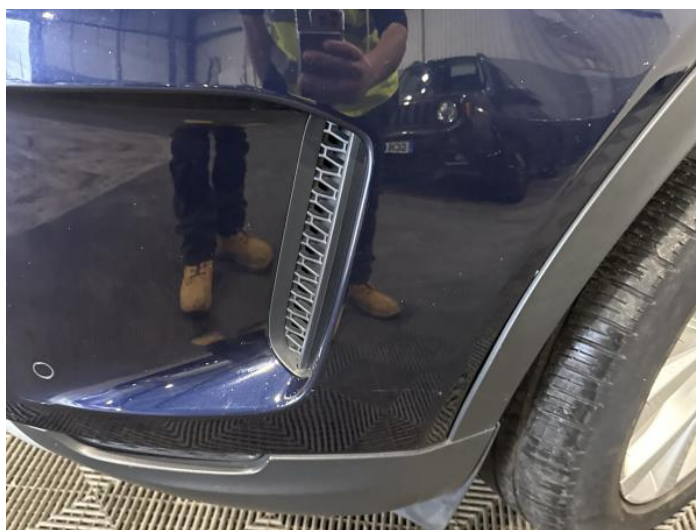
2: Bumper Front  
Scratched  
25 to 100mm Thru Paint

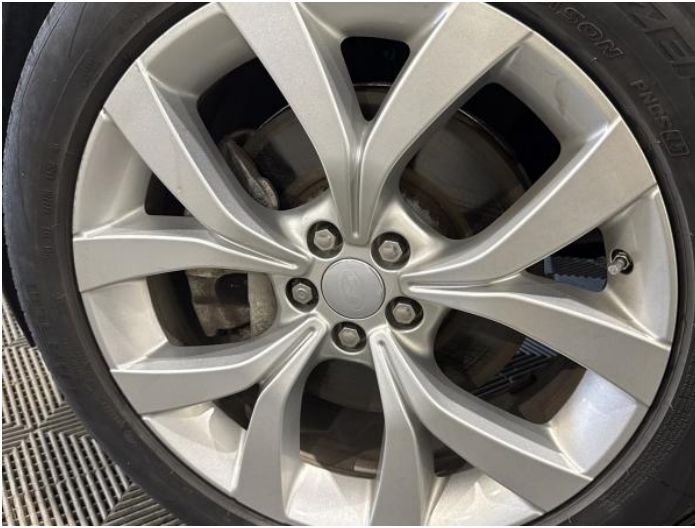
3: Wheel nsf  
Scratched  
Up To 50mm

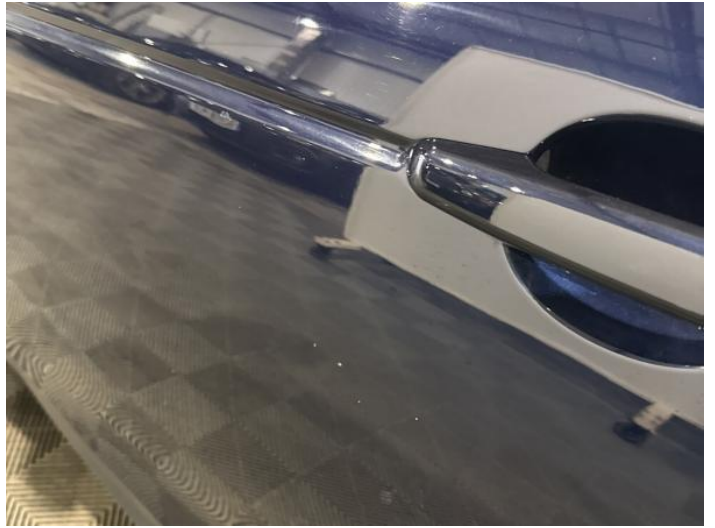
4: Door nsf  
Chipped  
Multiple Chips

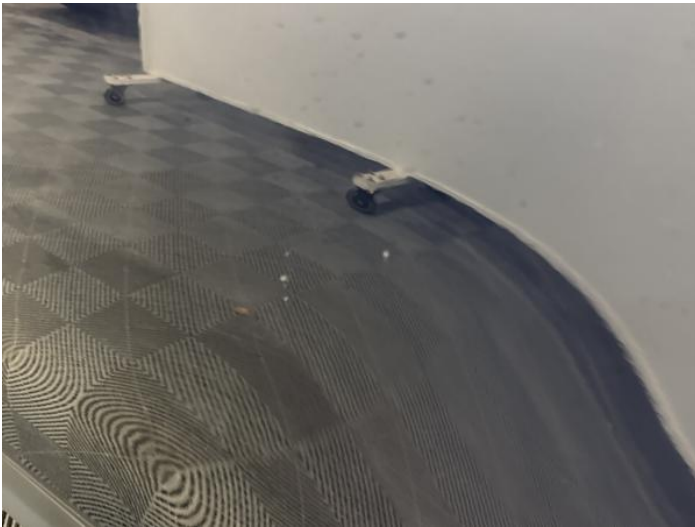
5: Door nsr  
Scratched  
Up To 25mm Thru Paint

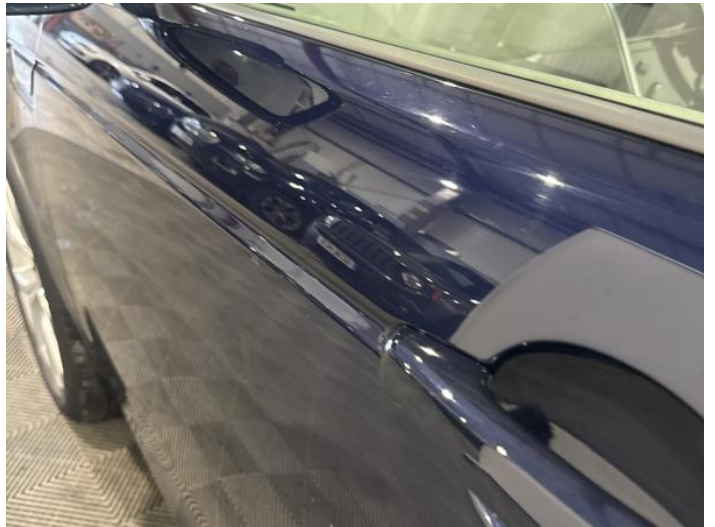
6: Door nsf  
Dented  
Between 10mm + 30mm

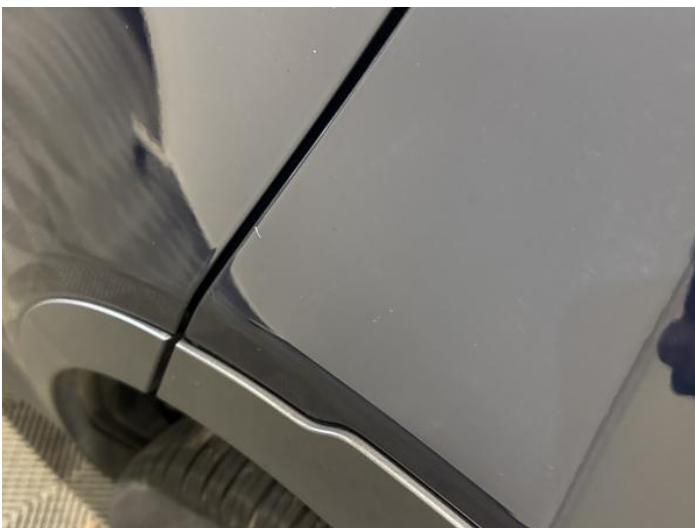
7: Qtr Panel nsr  
Scratched  
Up To 25mm Thru Paint

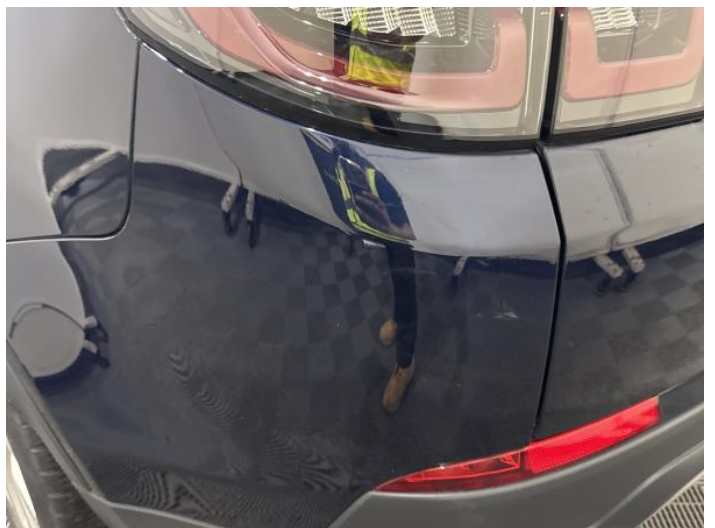
8: Bumper Rear  
Scratched  
25 to 100mm Thru Paint

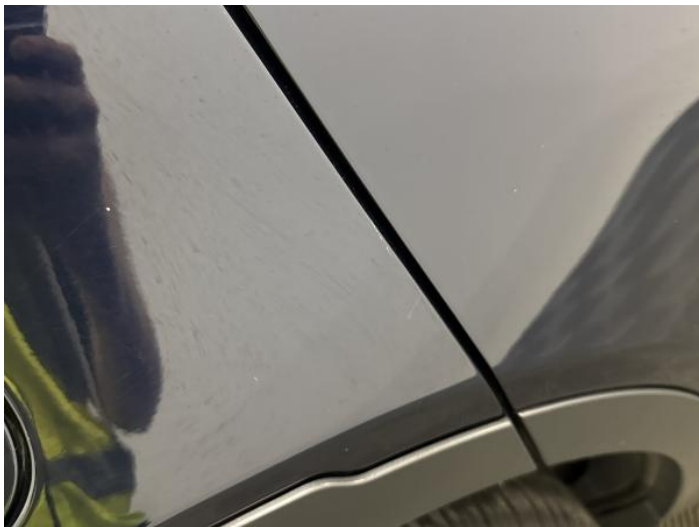
9: Qtr Panel osr  
Scratched  
UpTo 25mm Thru Paint

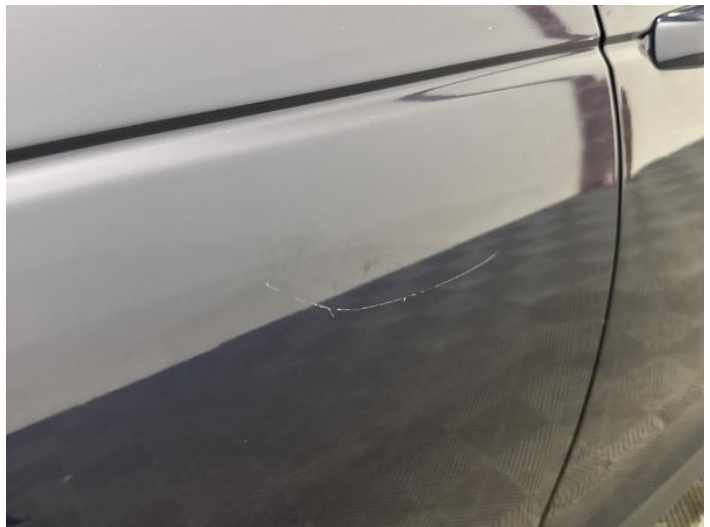
10: Door osr  
Scratched  
Over 25mm Thru Paint

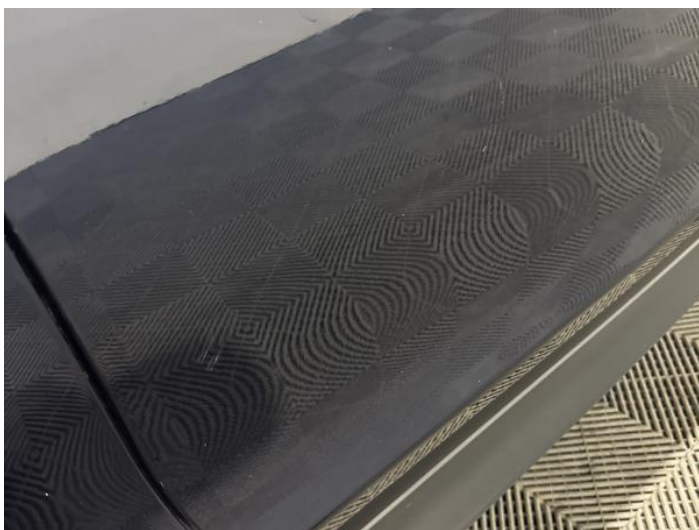
11: Door osf  
Scratched  
Over 25mm Thru Paint
