# VEHICLE INSPECTION REPORT

**LG70EOZ**

## Volkswagen Tiguan 2.0 TSi 190 4Motion SEL 5dr DSG

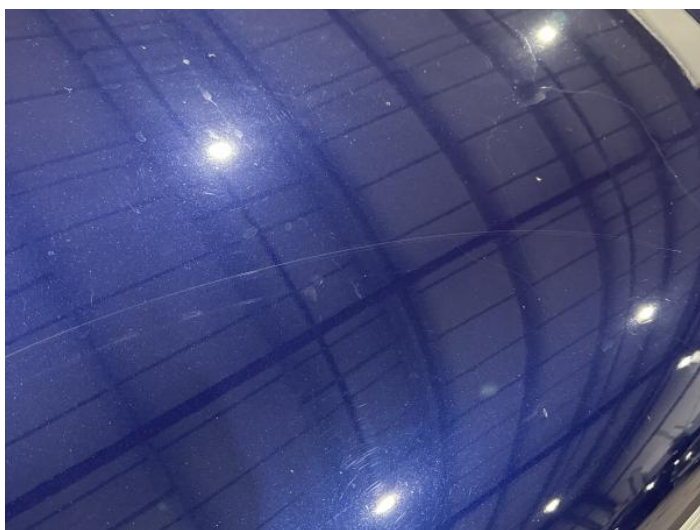
1: Bonnet  
Scratched  
Over 25mm Thru Paint

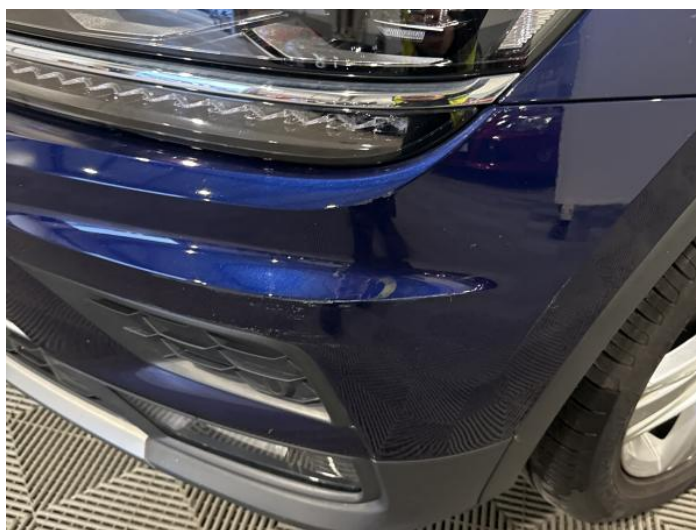
2: Bumper Front  
Scratched  
25 to 100mm Thru Paint

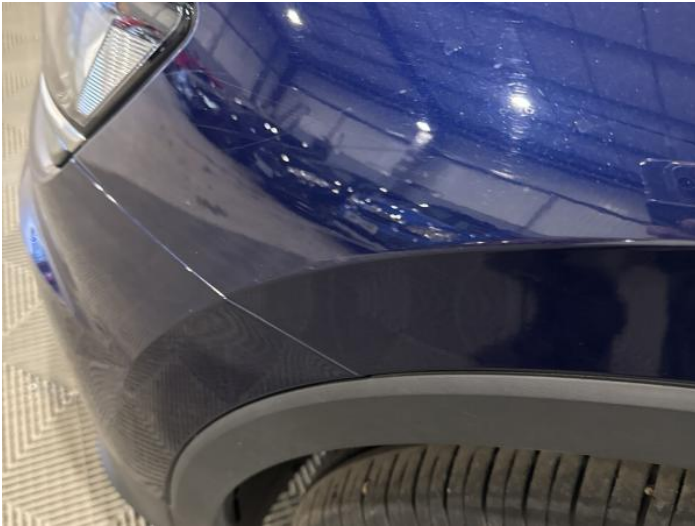
3: Wing nsf  
Scratched  
UpTo 25mm Thru Paint

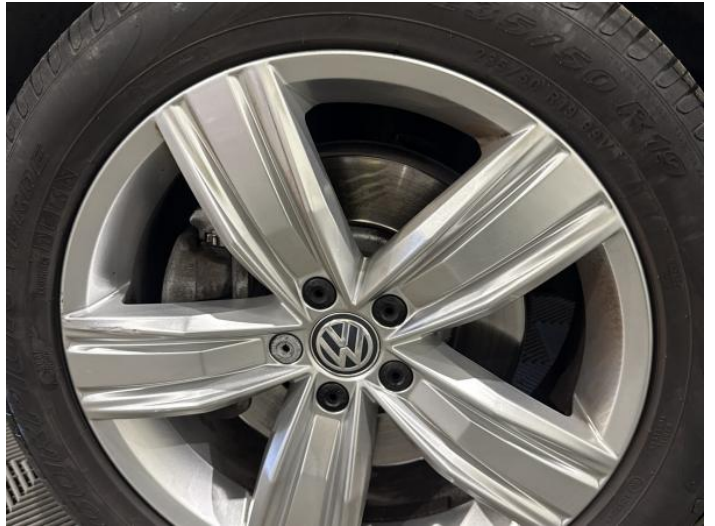
4: Wheel nsf  
Scratched  
Over 50mm

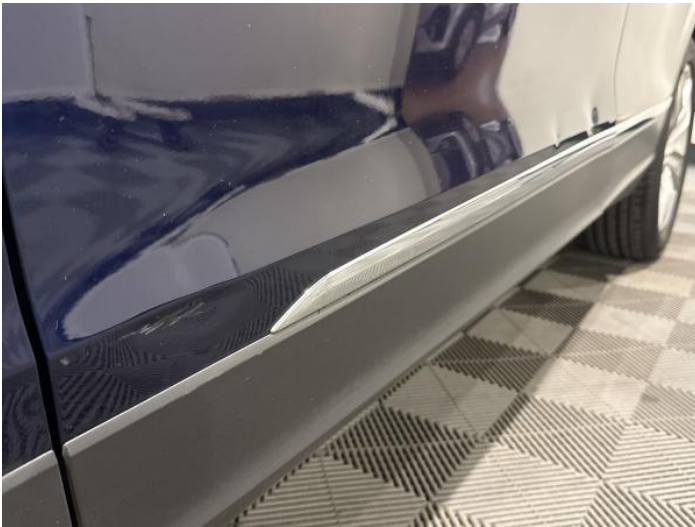
5: Door nsf  
Dented  
With Paint Damage

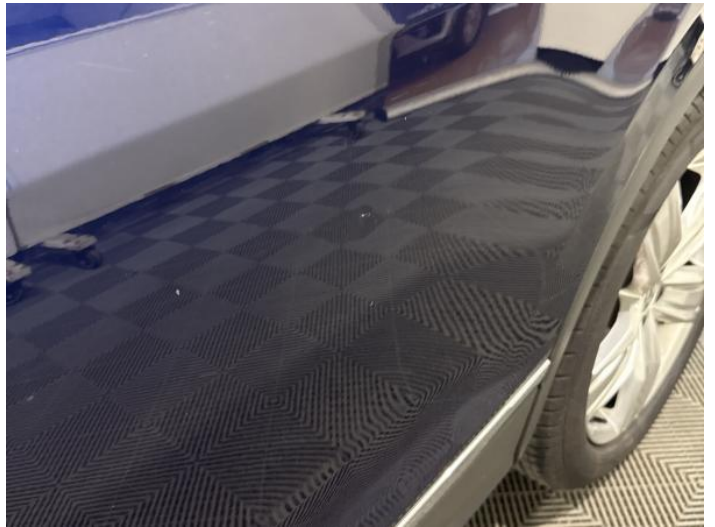
6: Door nsr  
Dented  
Between 10mm + 30mm

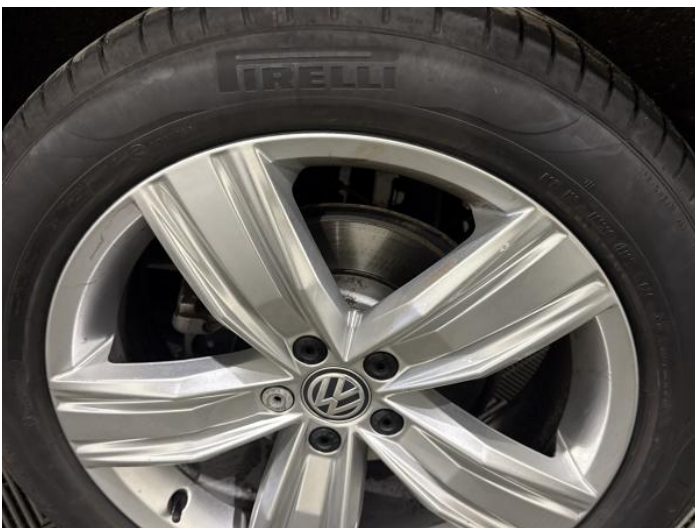
7: Wheel nsr  
Scratched  
Up To 50mm

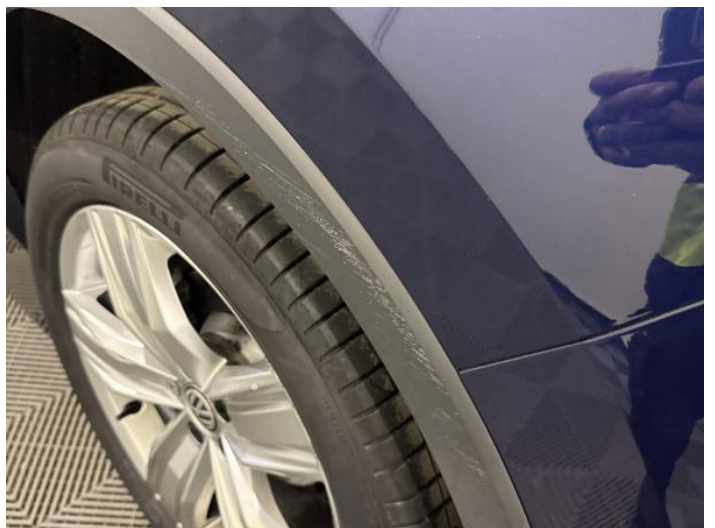
8: Qtr Panel Arch Extension ns  
Scuffed (Unpainted)  
UpTo 100mm

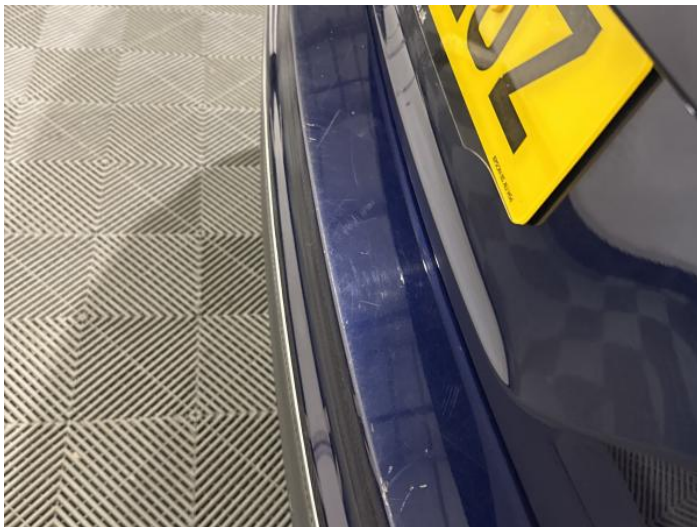
9: Bumper Rear  
Scratched  
25 to 100mm Thru Paint

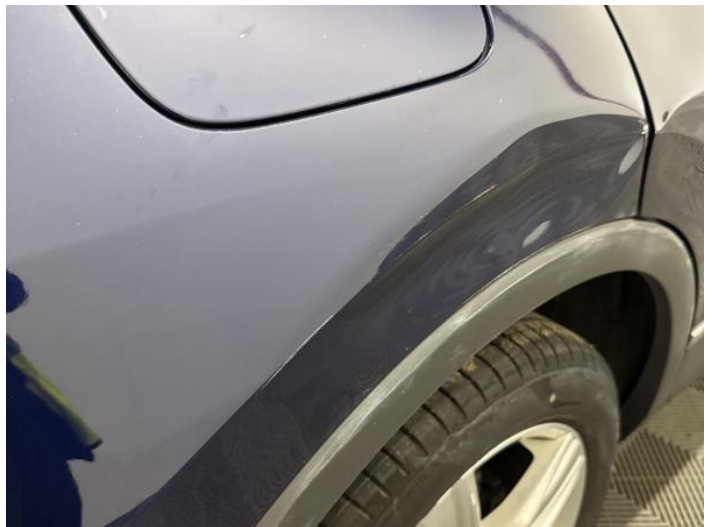
10: Qtr Panel osr  
Dented  
Over 30mm

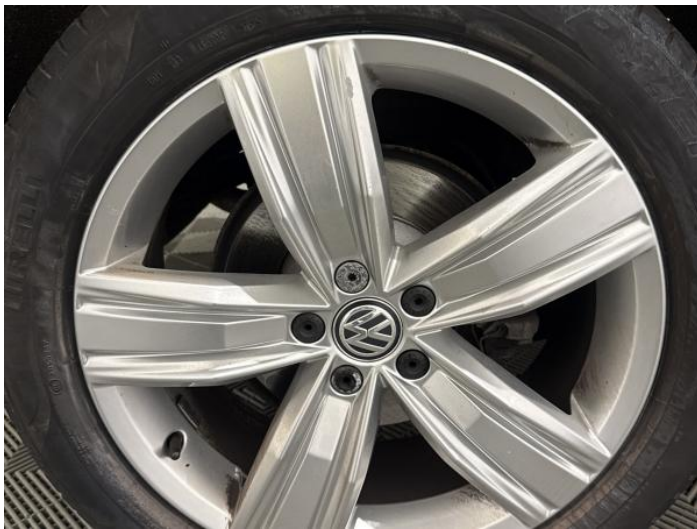
11: Wheel osr  
Scratched  
Up To 50mm

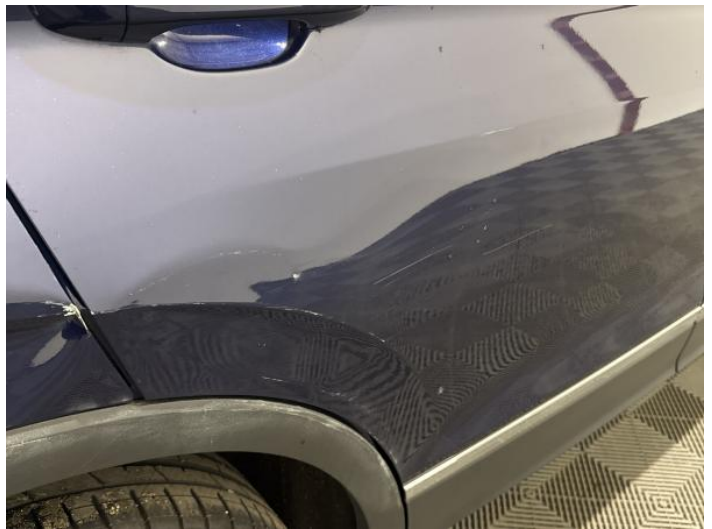
12: Door osr  
Dented  
With Paint Damage

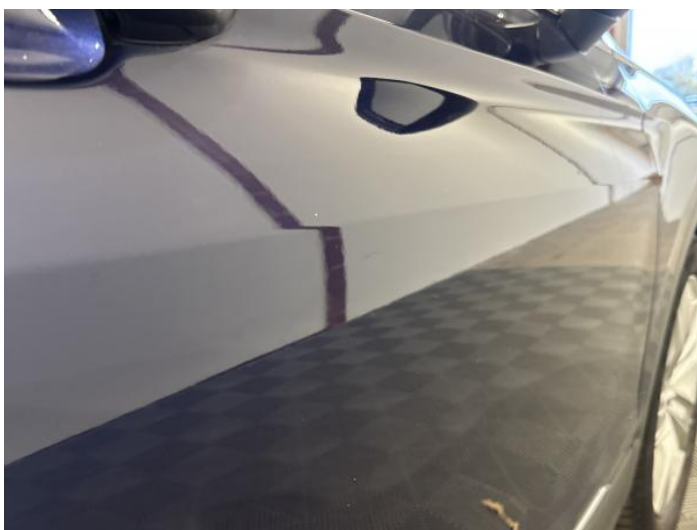
13: Door osf  
Dented  
2 Or Less UpTo 10mm

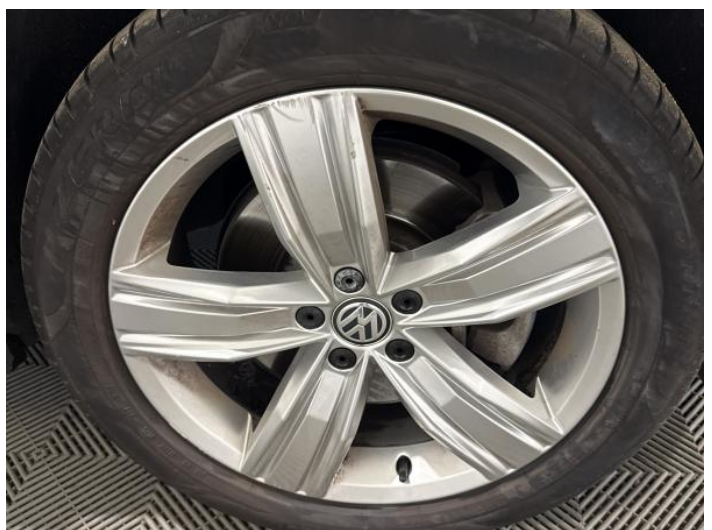
14: Wheel osf  
Scratched  
Over 50mm

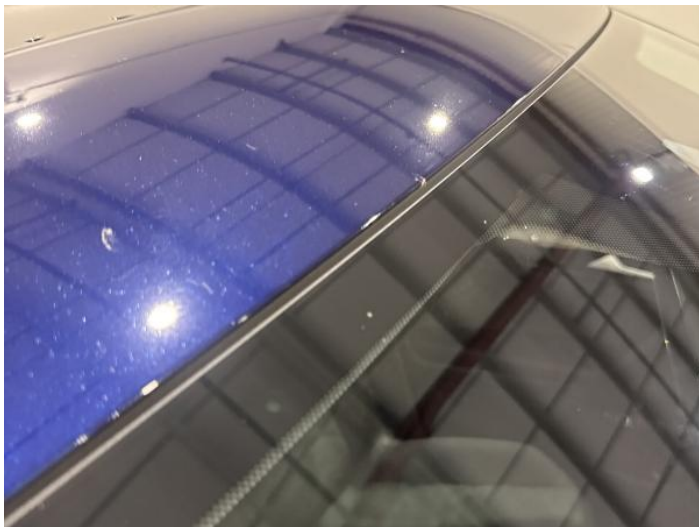
15: Roof  
Chipped  
Edge Chip
