# VEHICLE INSPECTION REPORT

**YA63VCX**

## Nissan Juke 1.5 dCi N-Tec 5dr [Start Stop]

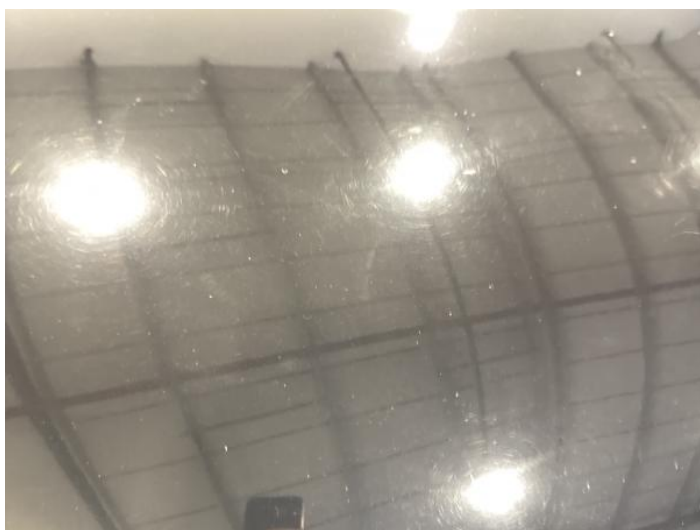
1: Bonnet  
Chipped  
Multiple Chips

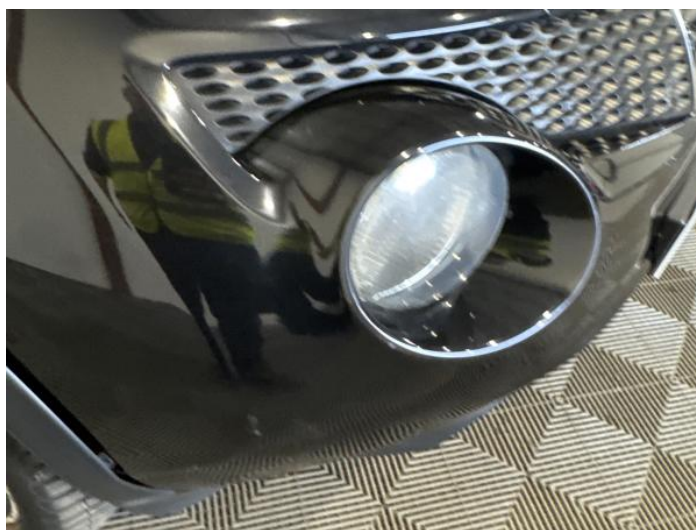
2: Bumper Front  
Scratched  
Over 100mm Thru Paint

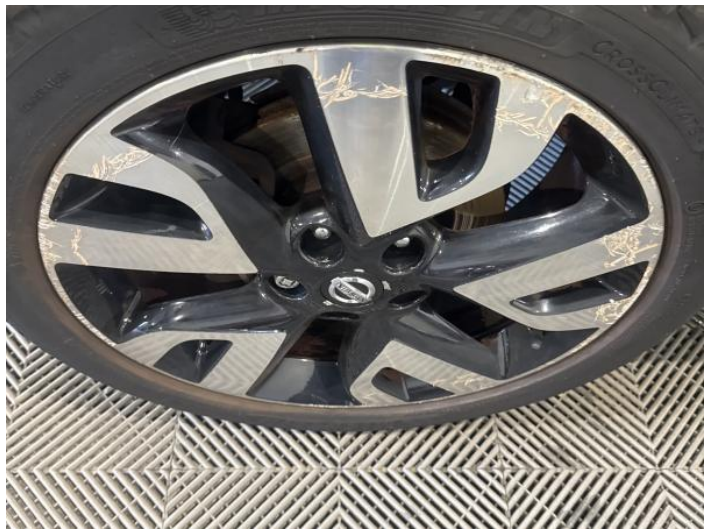
6: Wheel nsf  
Scratched  
Over 50mm

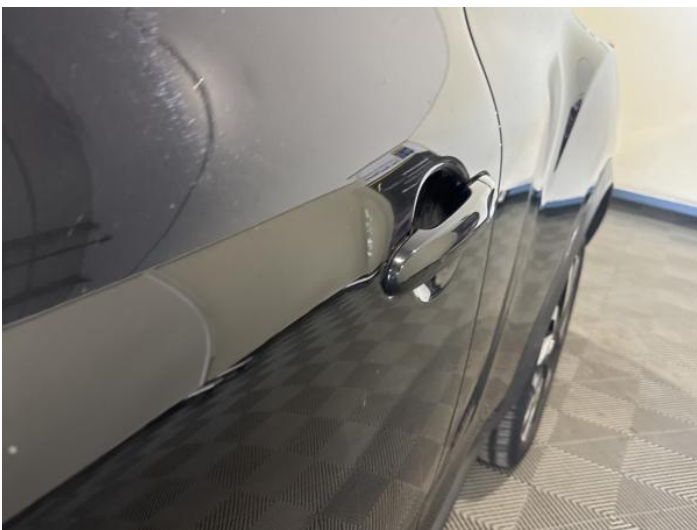
7: Door nsf  
Dented  
With Paint Damage

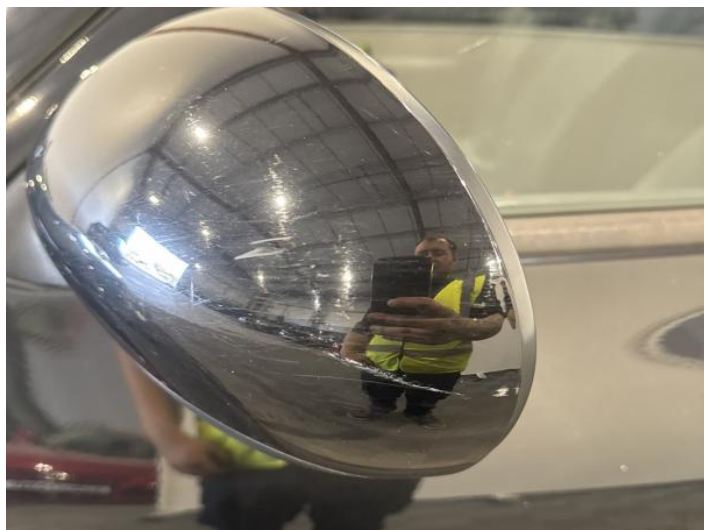
8: Door Mirror Assy nsf  
Scratched (Painted)  
Over 25mm Thru Paint

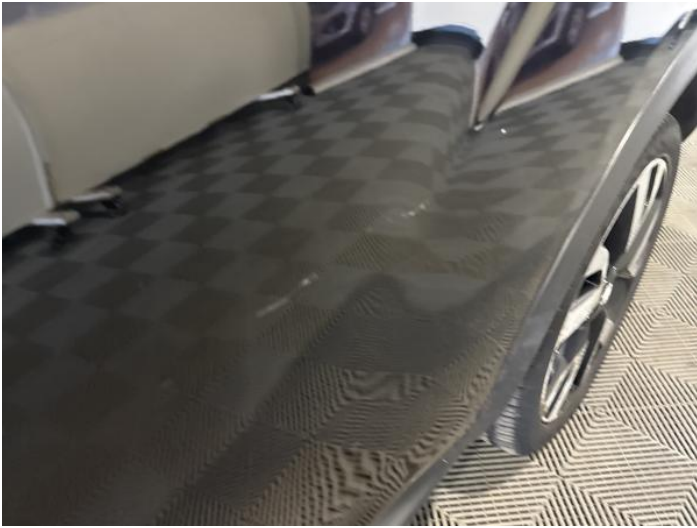
9: Door nsr  
Scratched  
Over 25mm Thru Paint

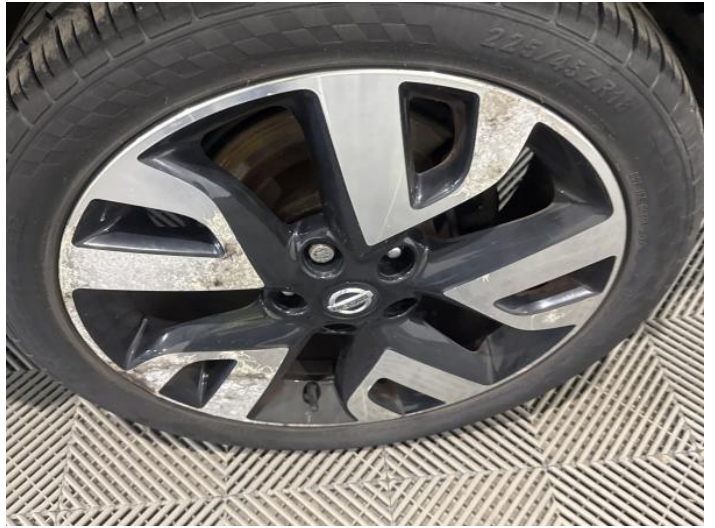
10: Wheel nsr  
Scratched  
Over 50mm

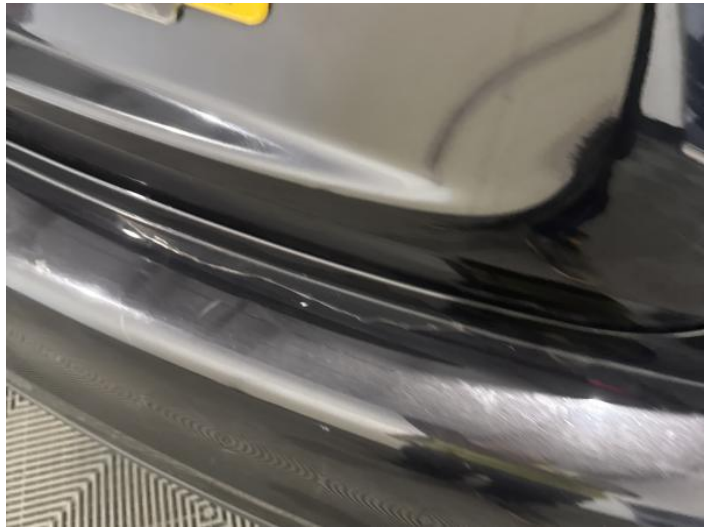
12: Bumper Rear  
Poor Previous Repair  
Paint Flake

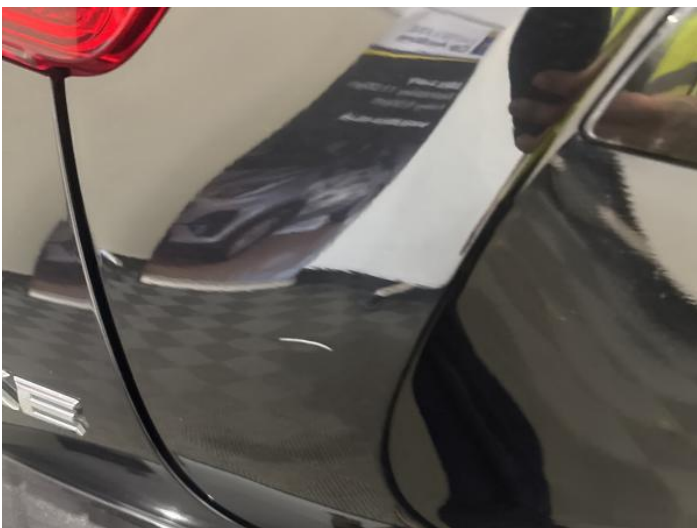
13: Boot Lid  
Scratched  
Over 25mm Thru Paint

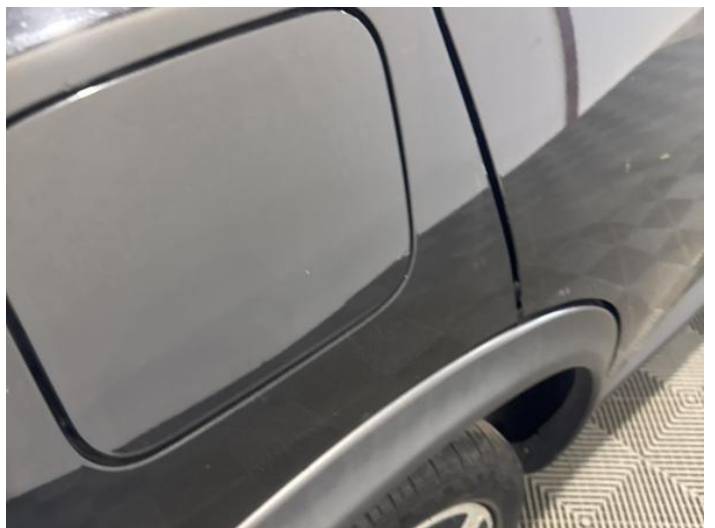
14: Qtr Panel osr  
Chipped  
1 To 5

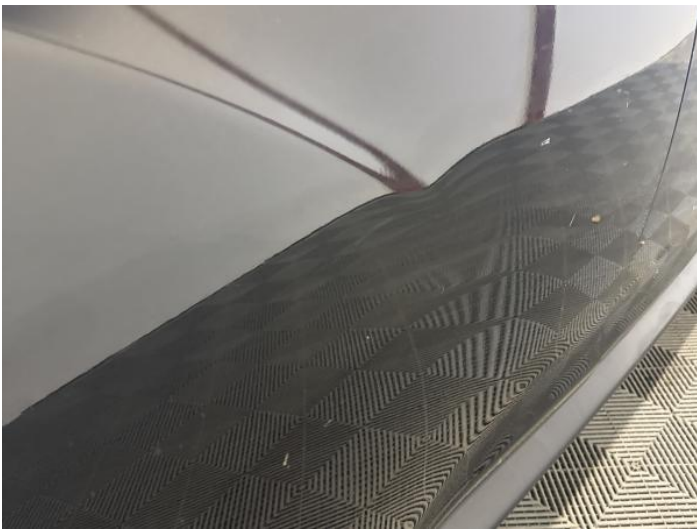
17: Door osf  
Chipped  
Multiple Chips

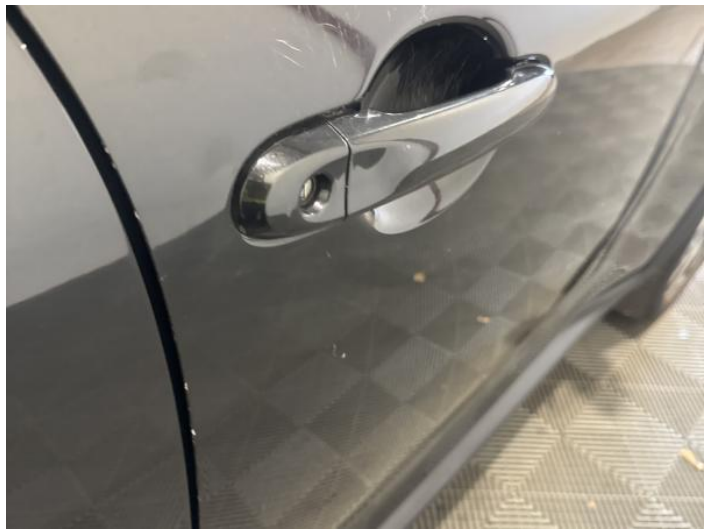
18: Door osf  
Chipped  
Multiple Chips

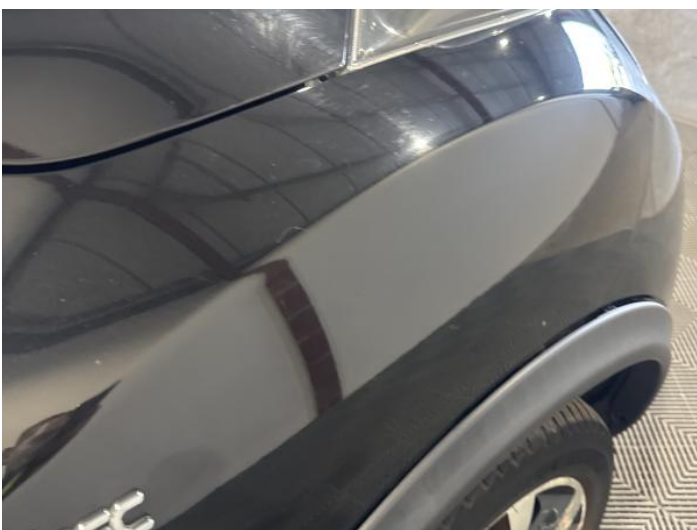
19: Wing osf  
Chipped  
1 To 5

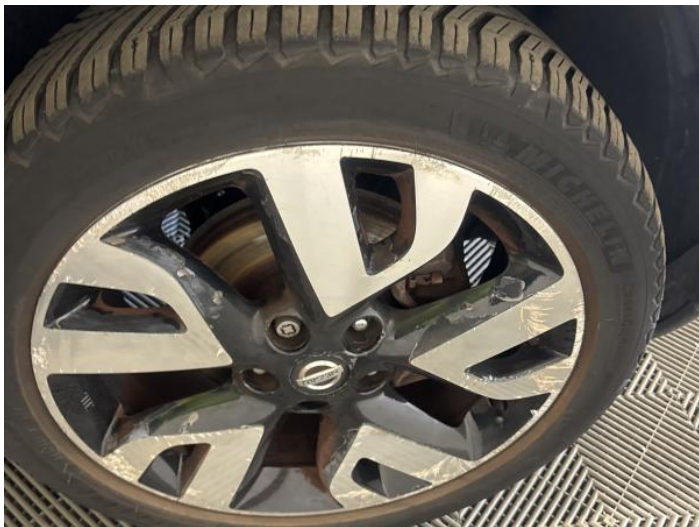
21: Wheel osf  
Scratched  
Over 50mm

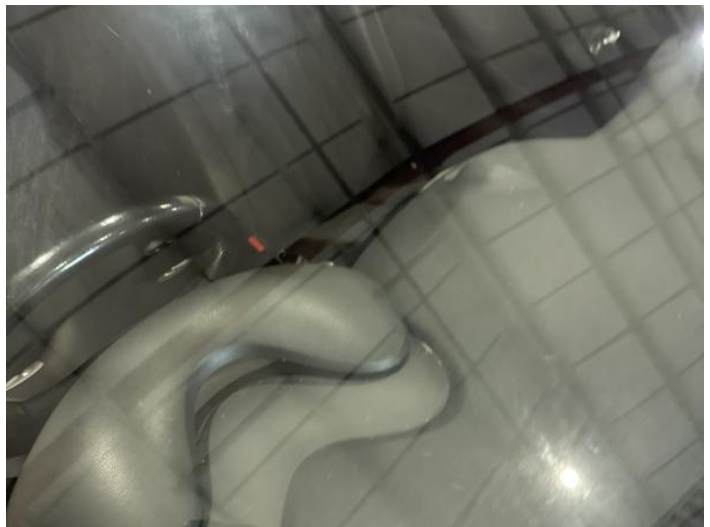
22: Screen Front  
Chipped  
UpTo 10mm

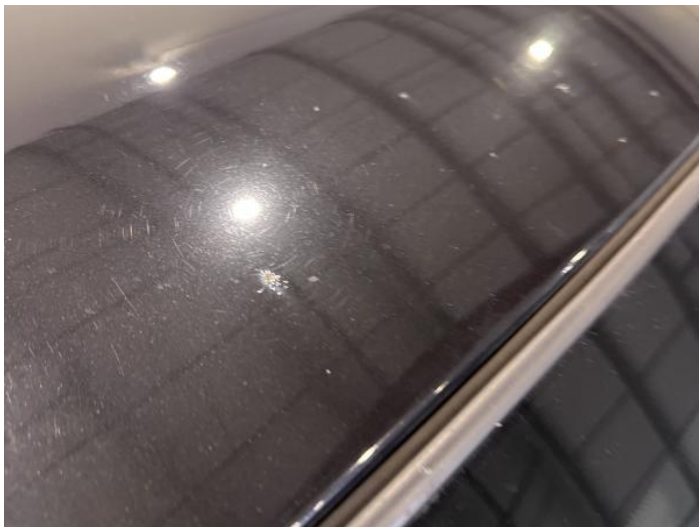
23: Roof  
Rusted  
UpTo 5mm

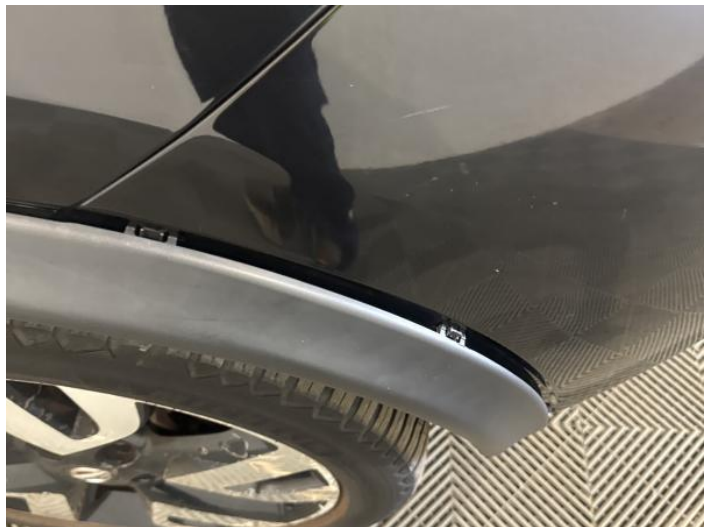
24: Wing Front Arch Extension os  
Broken  
Replace
