# VEHICLE INSPECTION REPORT

**GV14ACF**

## Toyota Auris 1.8 VVTi Hybrid Icon 5dr CVT Auto

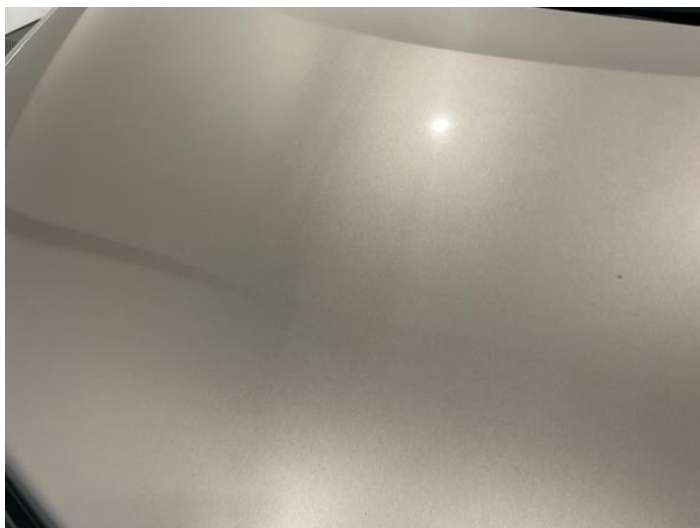
1: Bonnet  
Chipped  
1 To 5

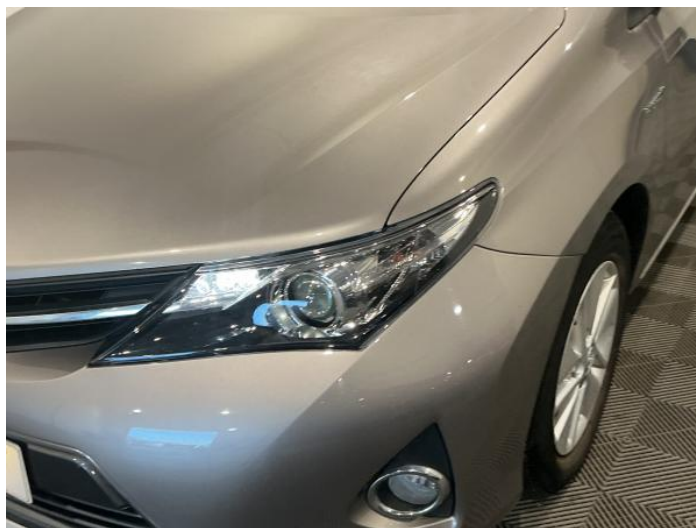
2: Bumper Front  
Chipped  
Multiple Chips

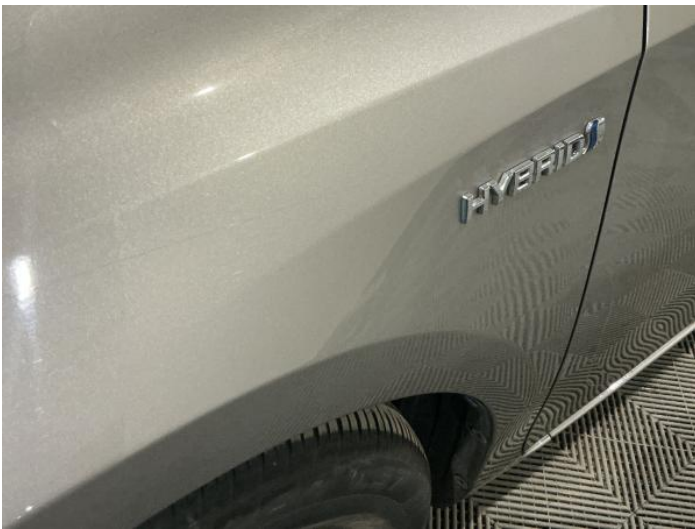
5: Wing nsf  
Dented  
Over 2 UpTo 10mm

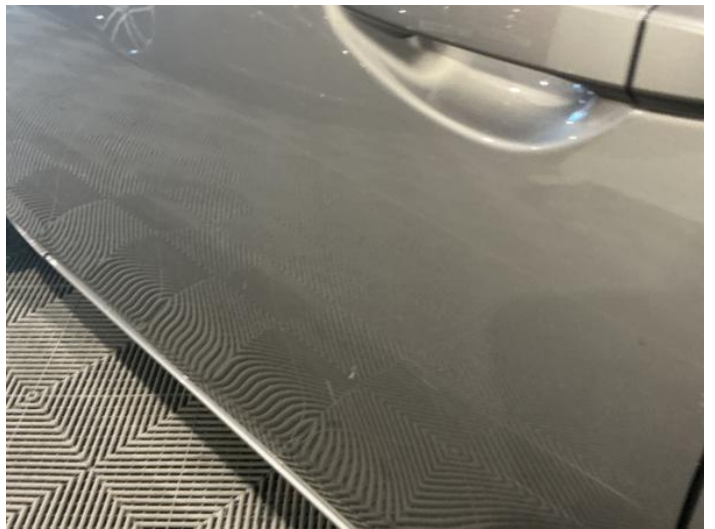
6: Door nsf  
Scratched  
Over 25mm Thru Paint

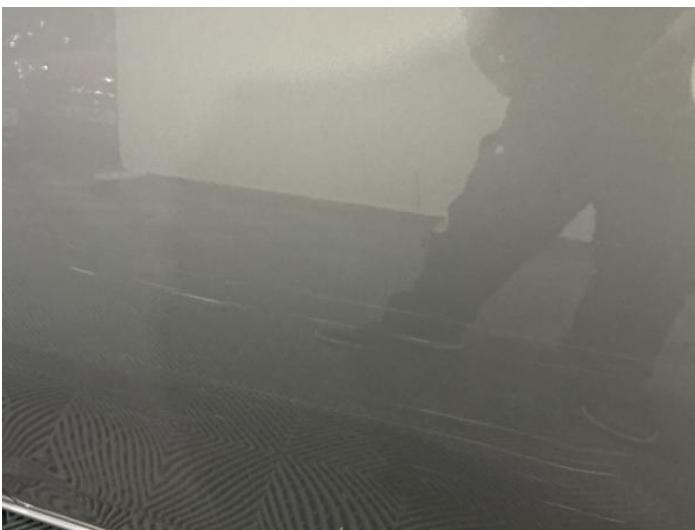
7: Door nsr  
Scratched  
Over 25mm Thru Paint

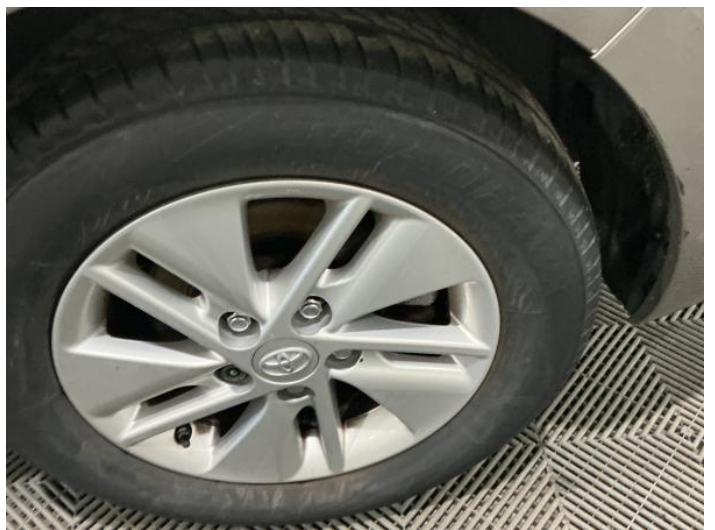
8: Wheel nsr  
Scratched  
Over 50mm

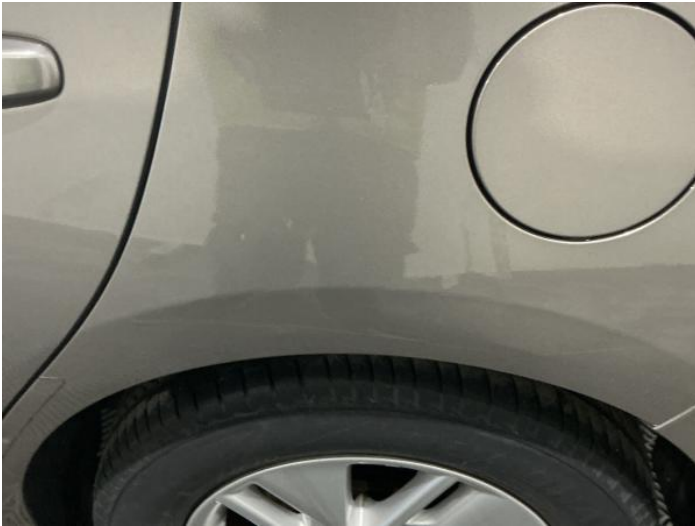
9: Qtr Panel nsr  
Dented  
With Paint Damage

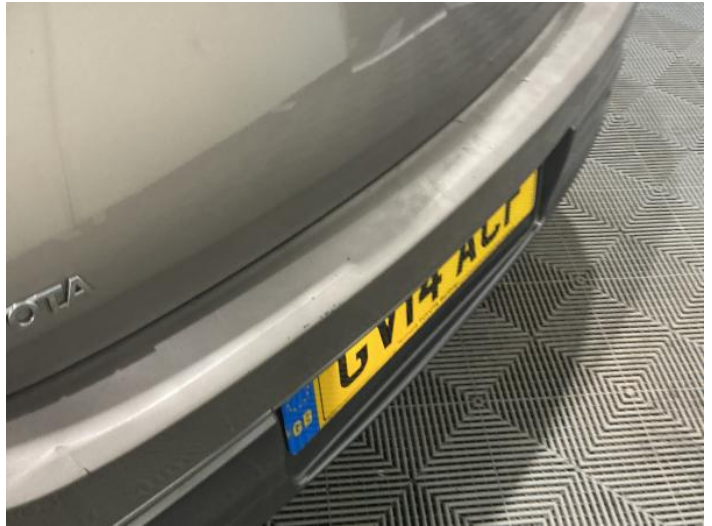
10: Bumper Rear  
Poor Previous Repair  
Poor Paint

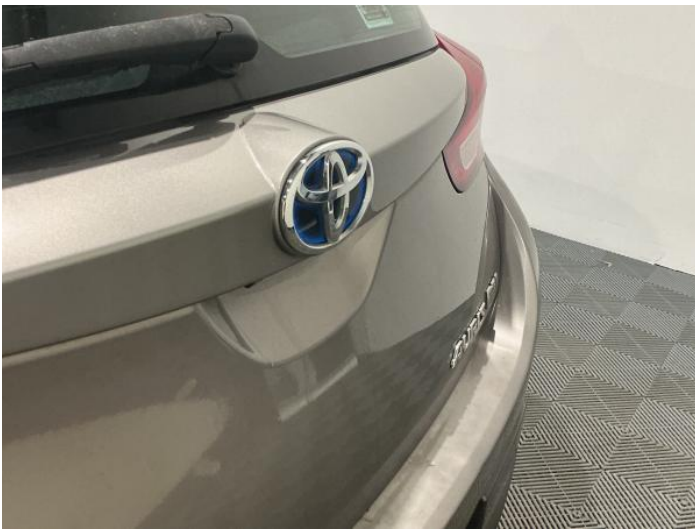
11: Boot Lid  
Dented  
Over 2 UpTo 10mm

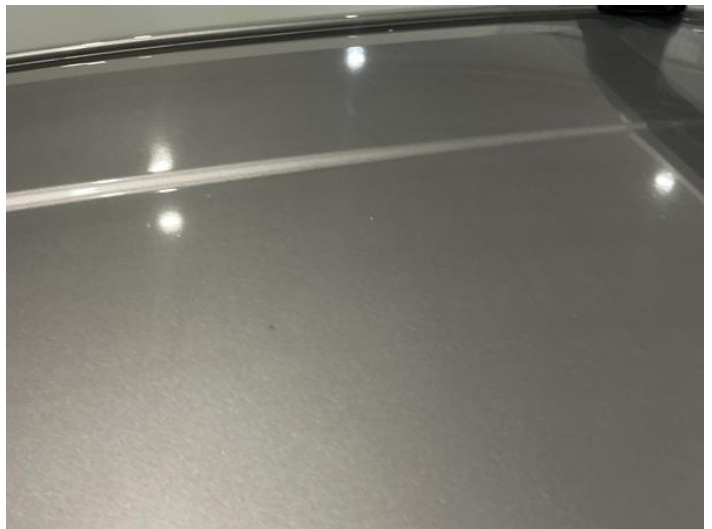
12: Roof  
Dented  
Between 10mm + 30mm

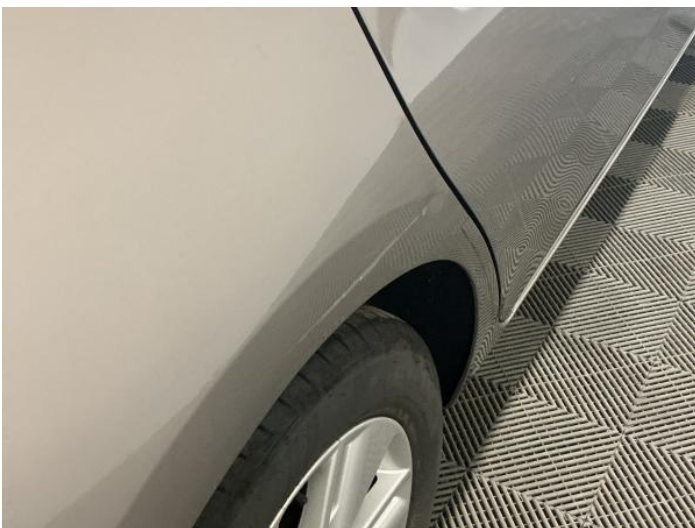
13: Qtr Panel osr  
Dented  
With Paint Damage

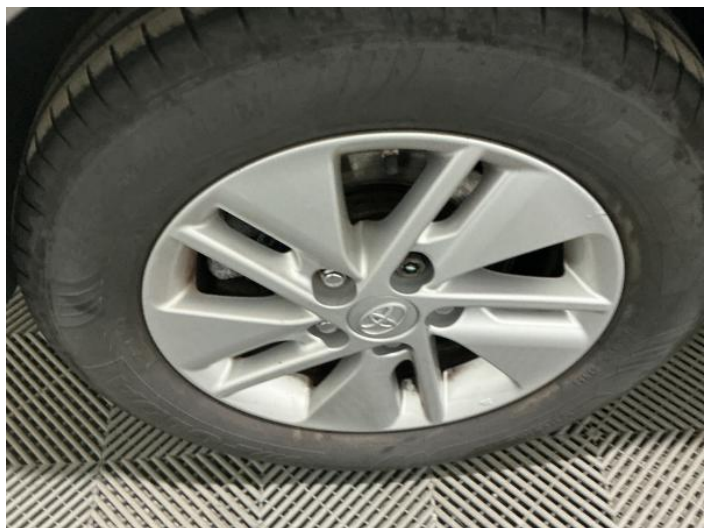
14: Wheel osr  
Scratched  
Up To 50mm

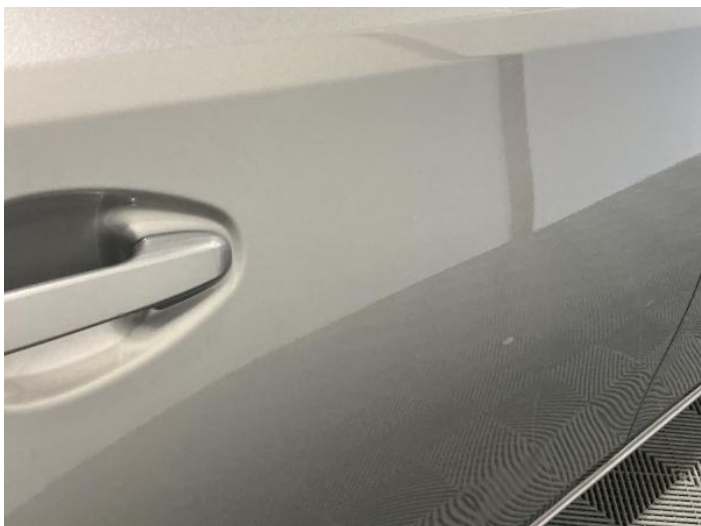
15: Door osr  
Chipped  
1 To 5

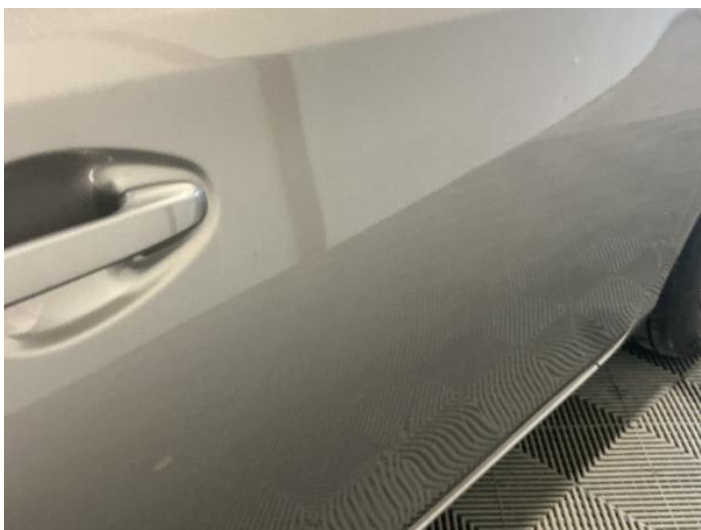
17: Door osf  
Chipped  
1 To 5

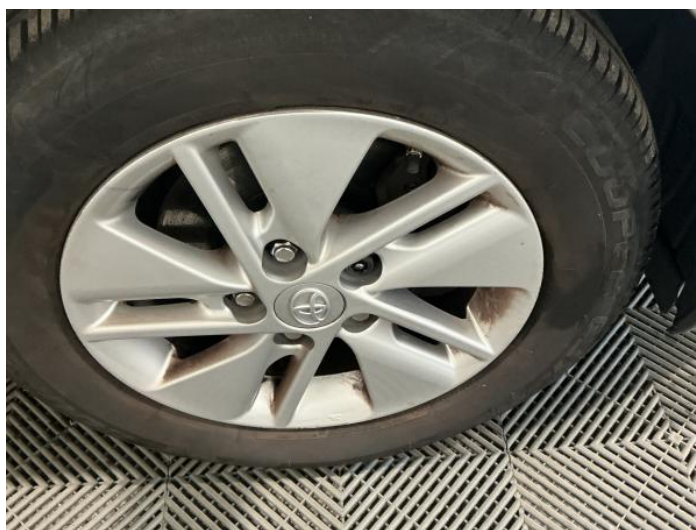
20: Wheel osf  
Scratched  
Over 50mm

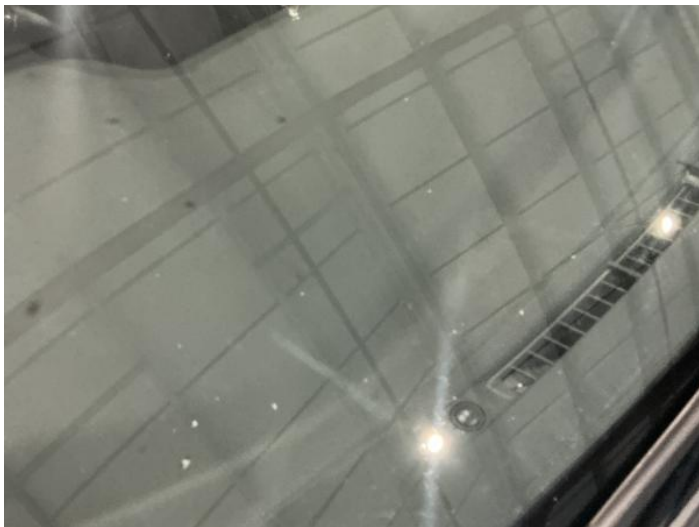
21: Screen Front  
Chipped  
UpTo 10mm
