# VEHICLE INSPECTION REPORT

**LD57AEF**

## Toyota Auris 1.6 VVTi TR 5dr

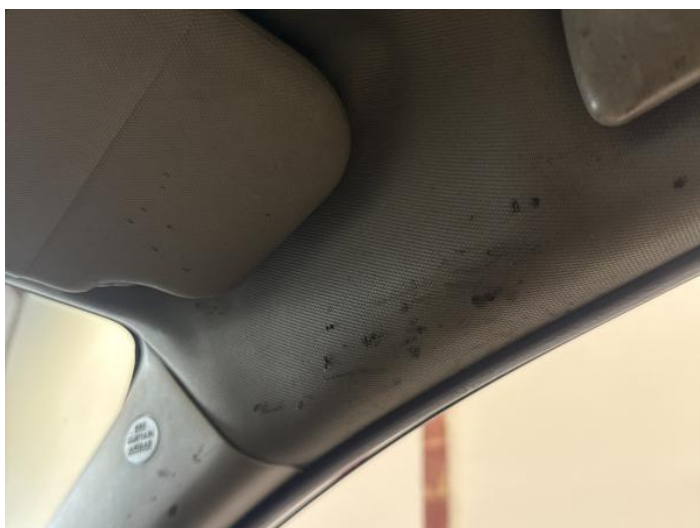
1: Roof Lining  
Burn  
UpTo 3mm

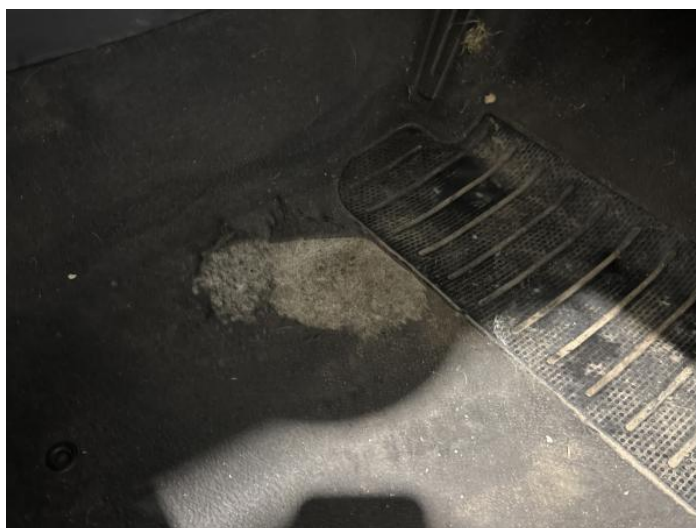
2: Carpets Front  
Scuffed  
Over 25mm

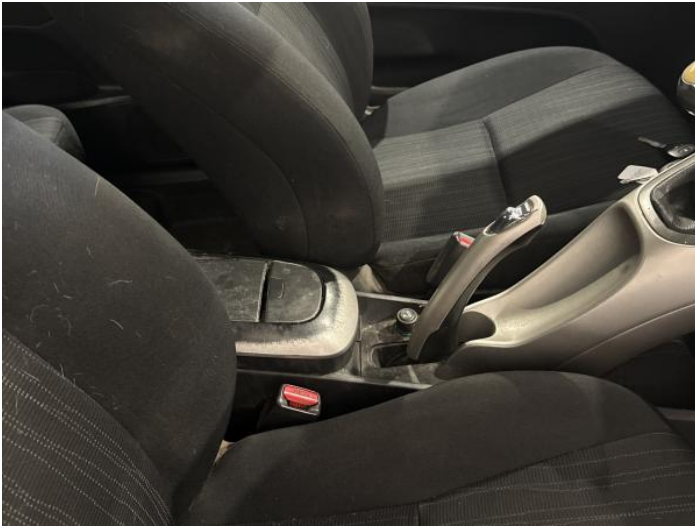
3: Centre Console Front  
Scuffed  
Over 25mm

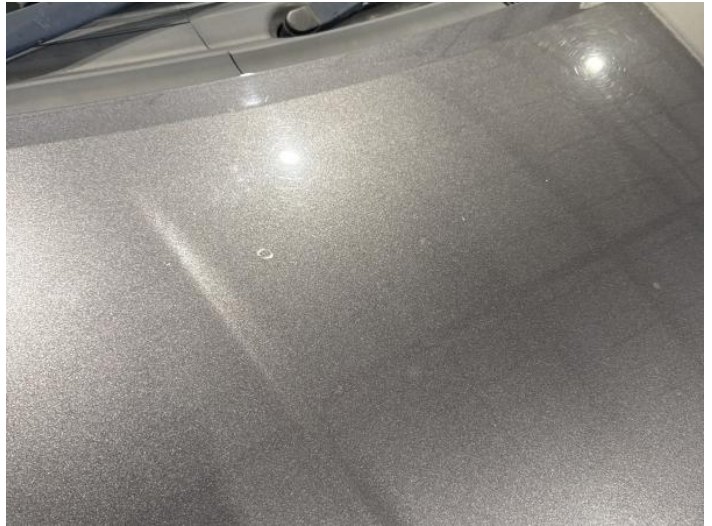
4: Bonnet  
Scratched  
UpTo 25mm Thru Paint

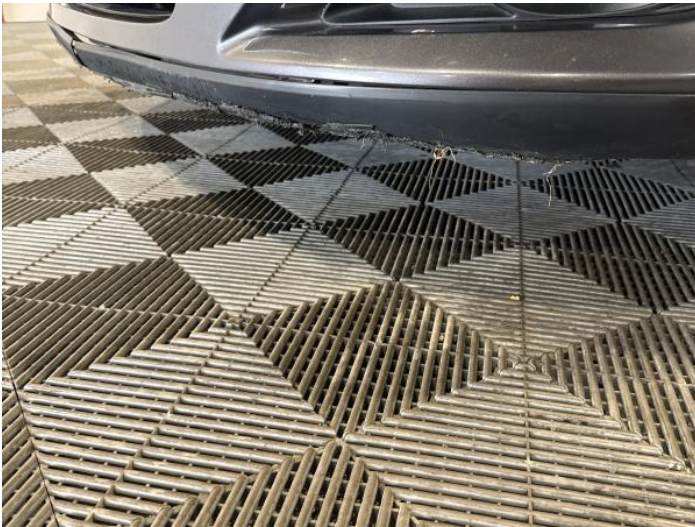
5: Bumper Front Moulding  
Broken  
Replace

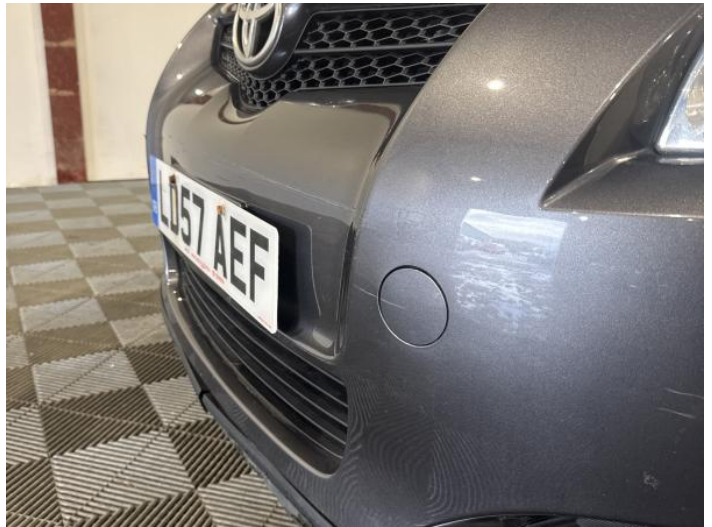
6: Bumper Front  
Scratched  
Over 100mm Thru Paint

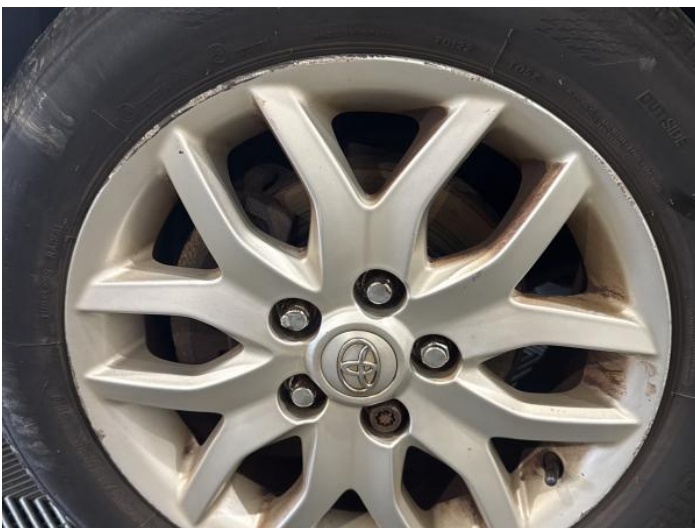
7: Wheel nsf  
Scratched  
Over 50mm

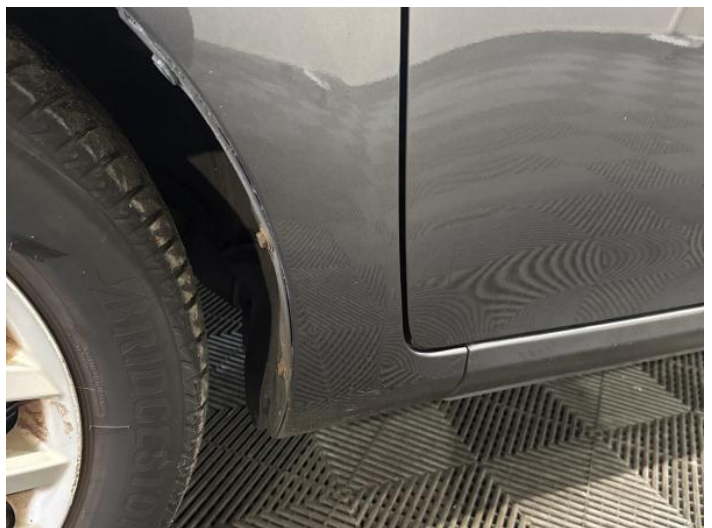
8: Wing nsf  
Scratched  
UpTo 25mm Thru Paint

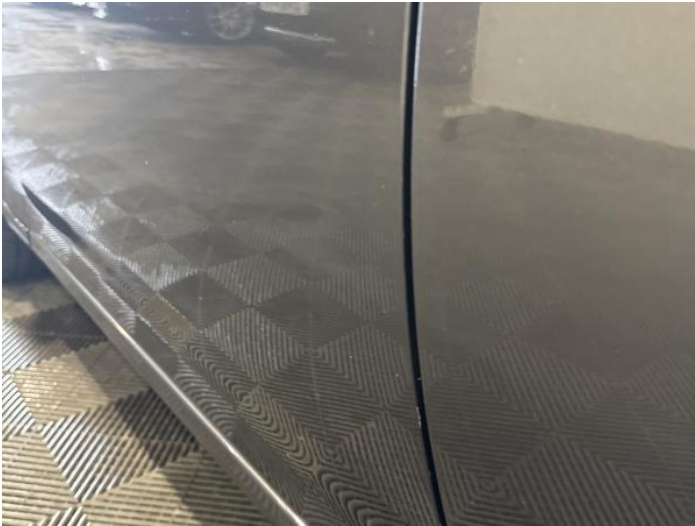
9: Door nsf  
Chipped  
Edge Chip

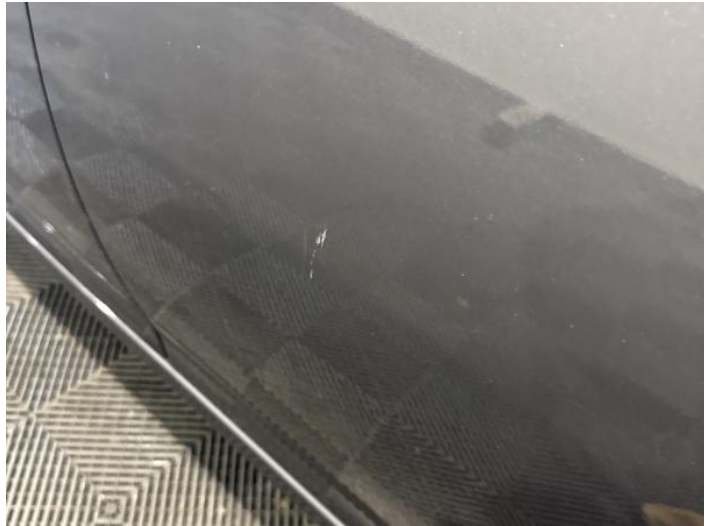
10: Door nsr  
Scratched  
Over 25mm Thru Paint

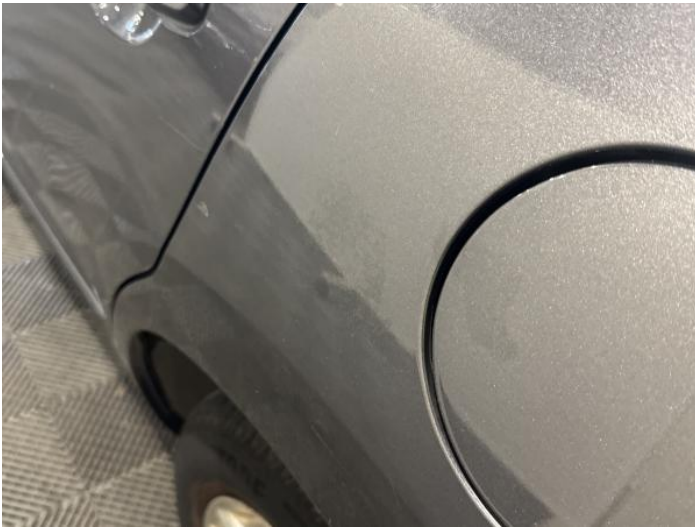
11: Qtr Panel nsr  
Dented  
With Paint Damage

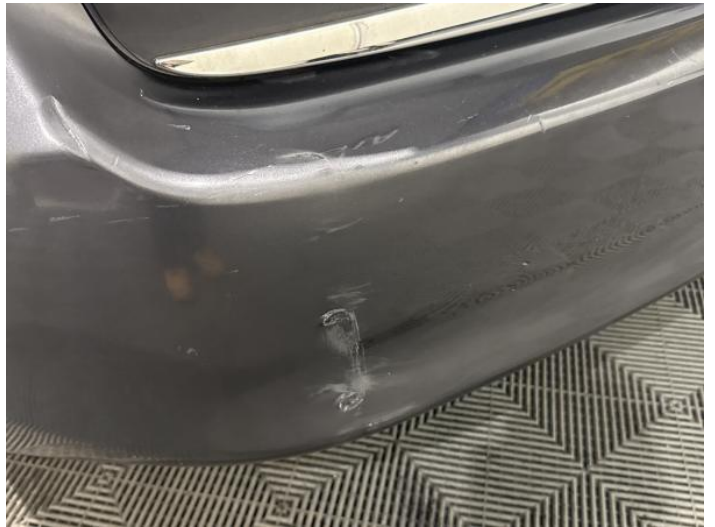
12: Bumper Rear  
Dented  
With Paint Damage

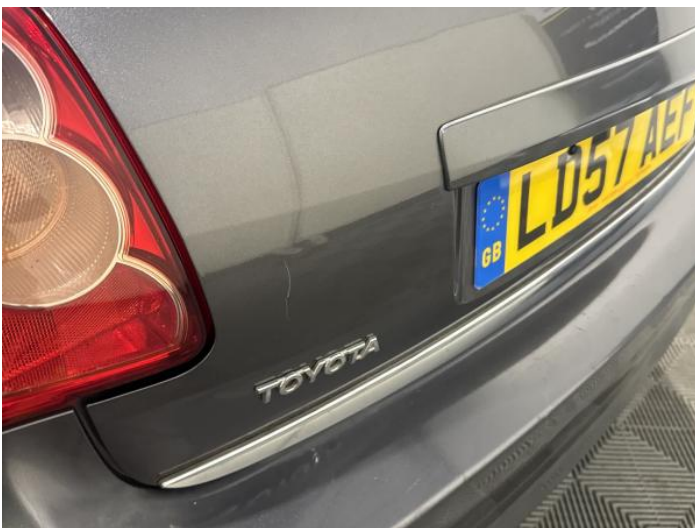
13: Tailgate  
Scratched  
Over 25mm Thru Paint

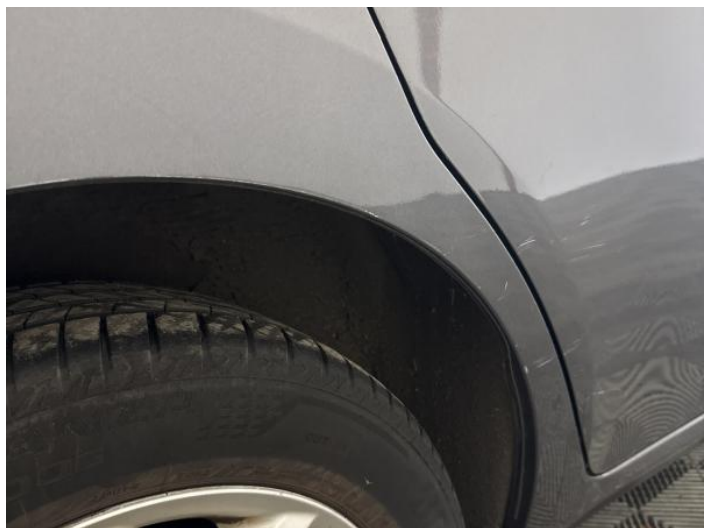
14: Qtr Panel osr  
Scratched  
Over 25mm Thru Paint

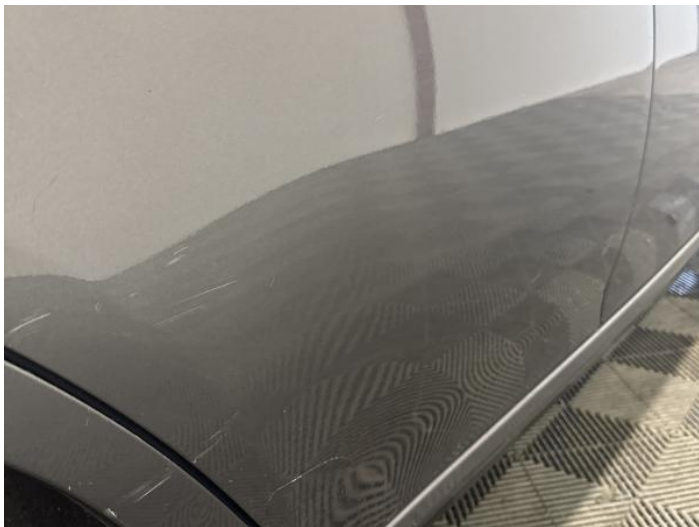
15: Door osr  
Scratched  
Over 25mm Thru Paint

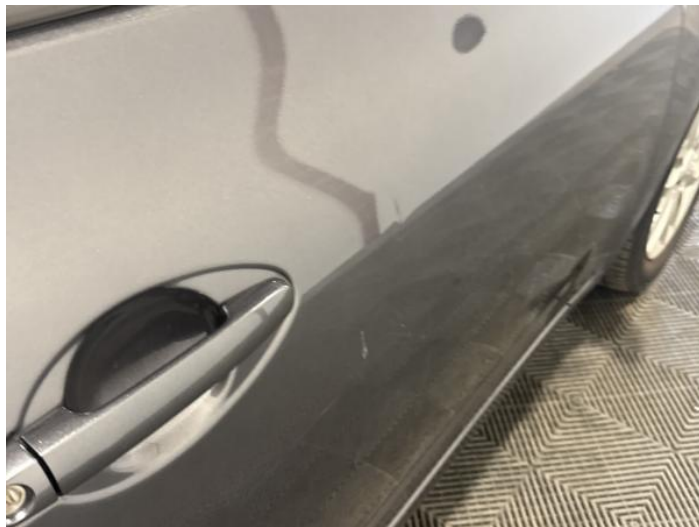
16: Door osf  
Dented  
Over 30mm

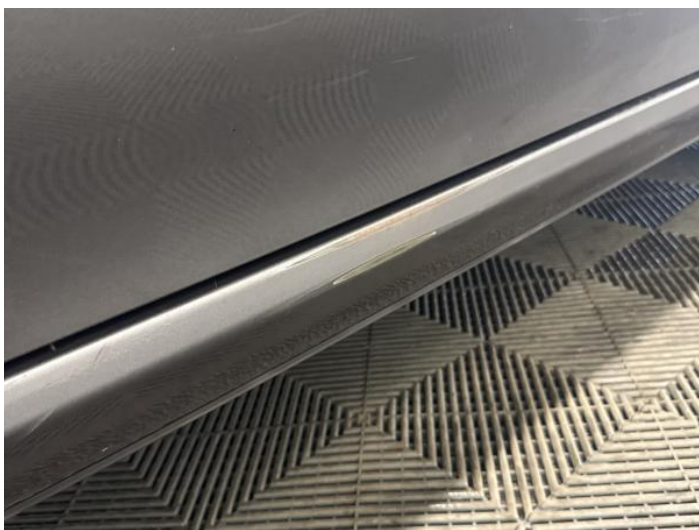
17: Sill os  
Scratched  
Rusted

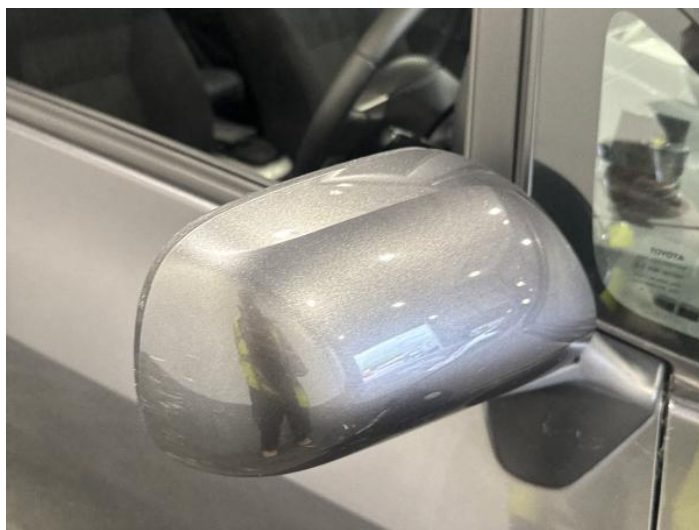
18: Door Mirror Assy osf  
Scratched (Painted)  
UpTo 25mm Thru Paint

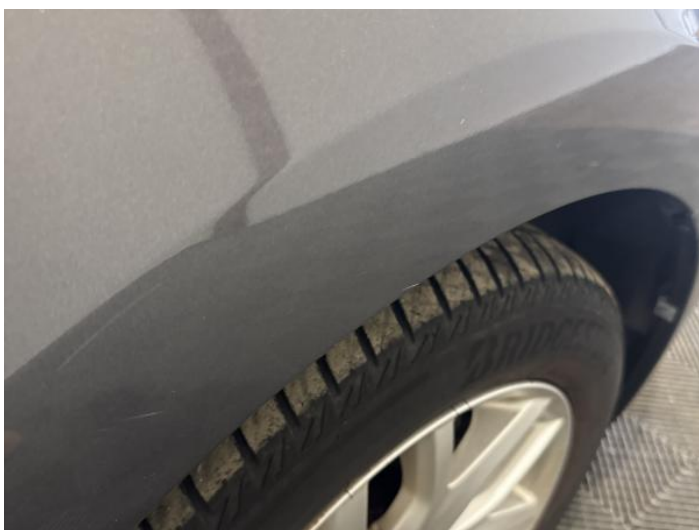
19: Wing osf  
Scratched  
UpTo 25mm Thru Paint

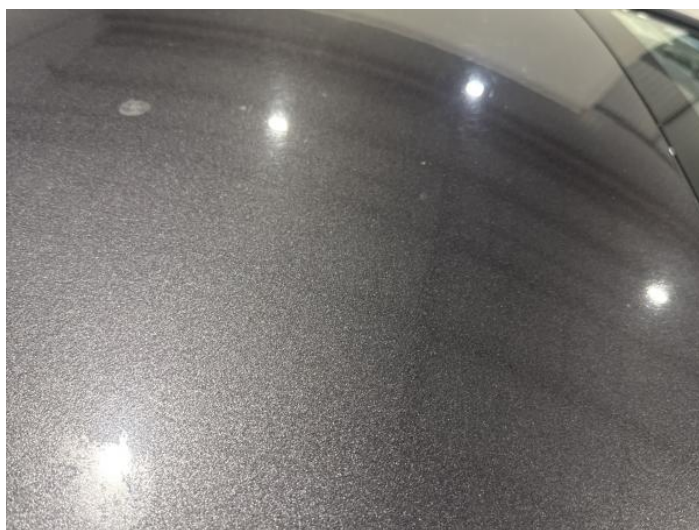
20: Roof  
Chipped  
1 To 5

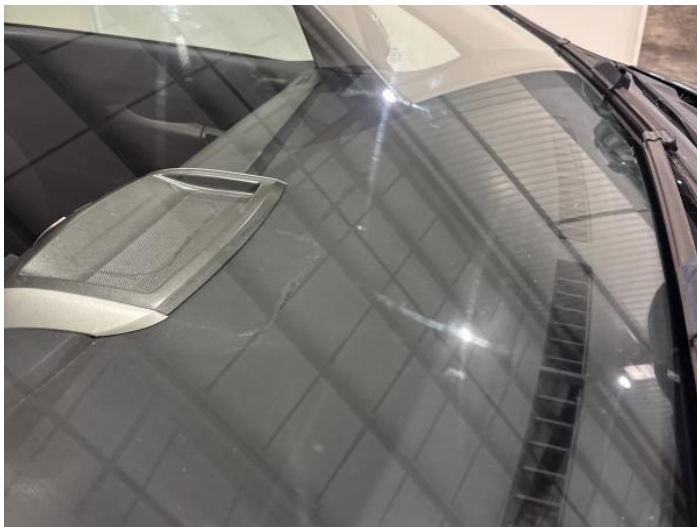
21: Screen Front  
Chipped  
UpTo 10mm

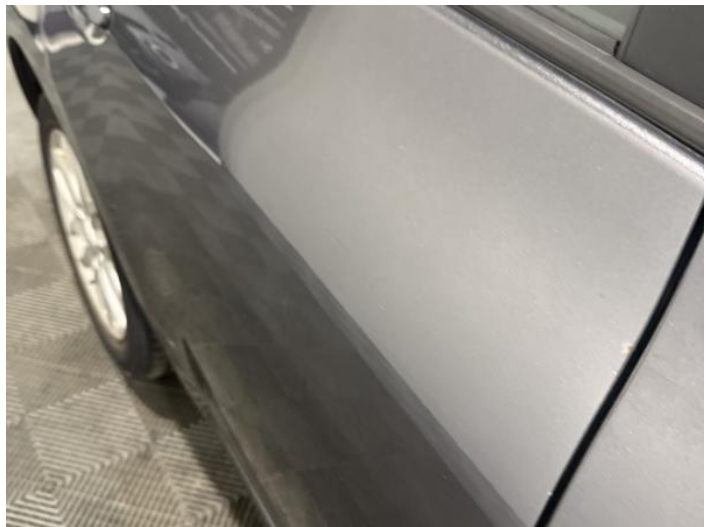
22: Door osr  
Dented  
Between 10mm + 30mm
