# VEHICLE INSPECTION REPORT

**CY65KPG**

## Volkswagen Golf 2.0 TDI 184 GTD 5dr

nama  
GRADE  
**3**

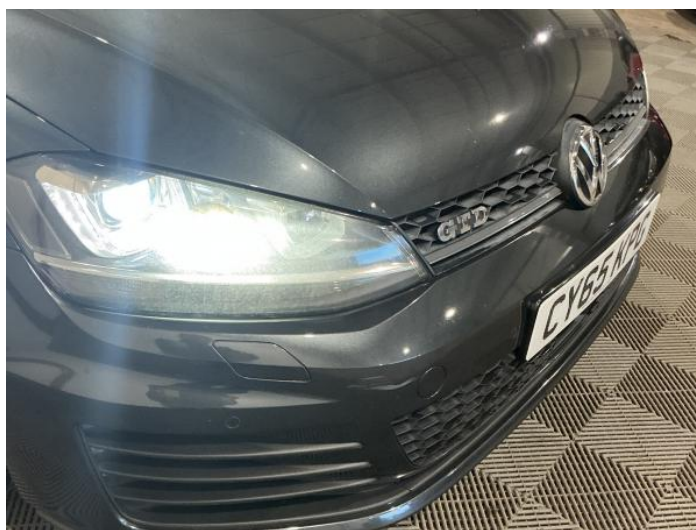
2: Bumper Front  
Scratched  
Over 100mm Thru Paint

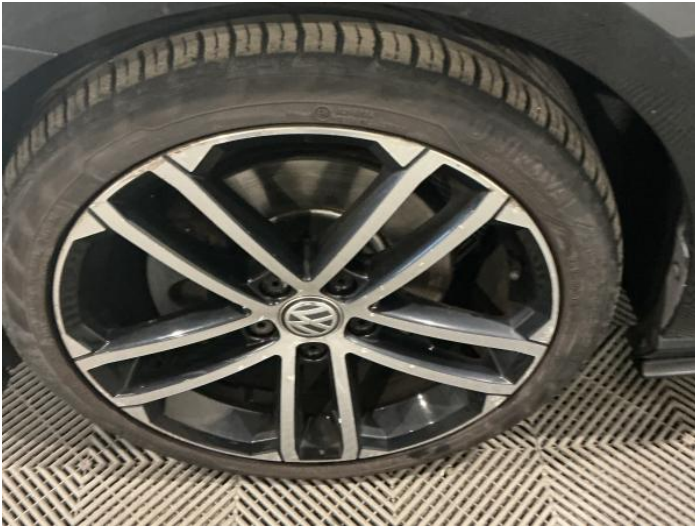
3: Wheel nsf  
Scratched  
Over 50mm

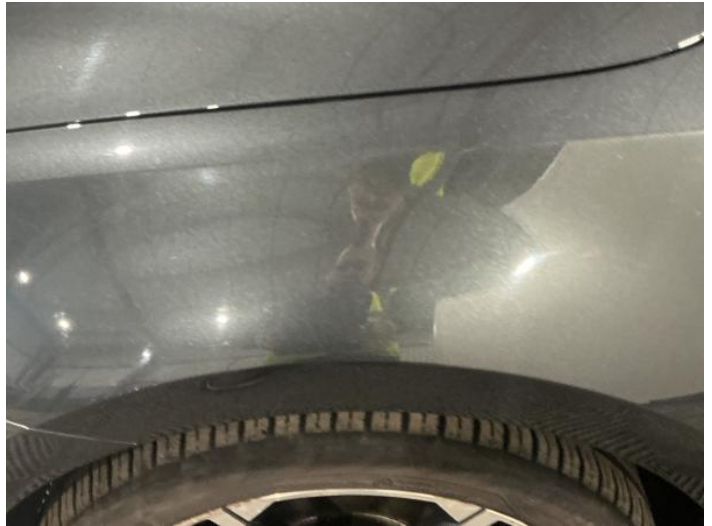
4: Wing nsf  
Dented  
Between 10mm + 30mm

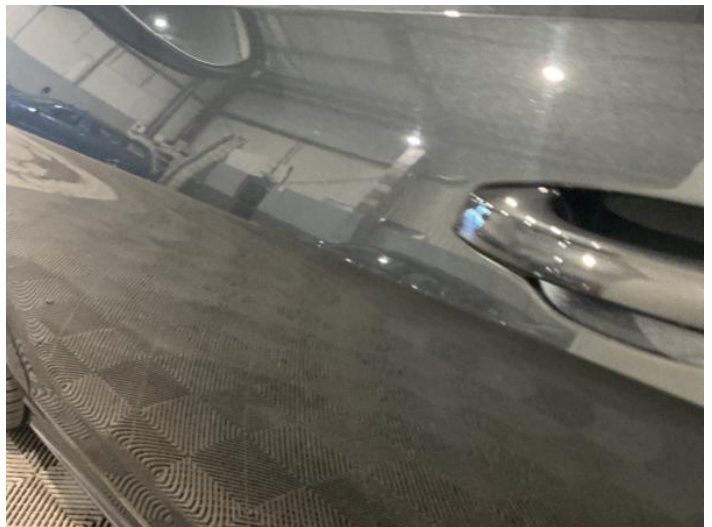
6: Door nsf  
Chipped  
1 To 5

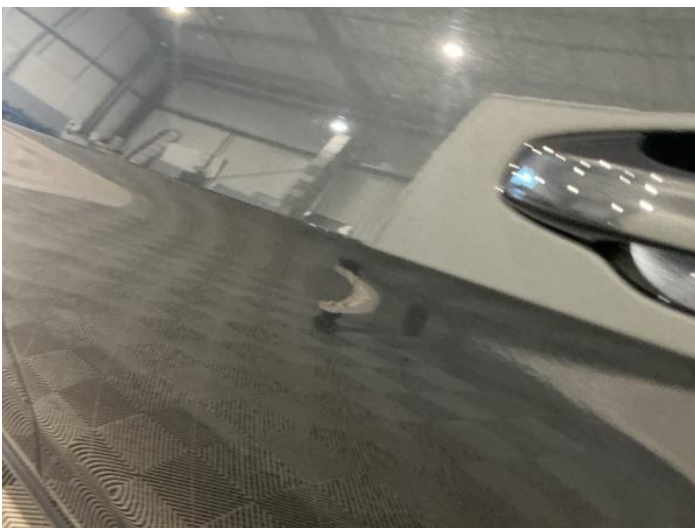
7: Door nsr  
Chipped  
1 To 5

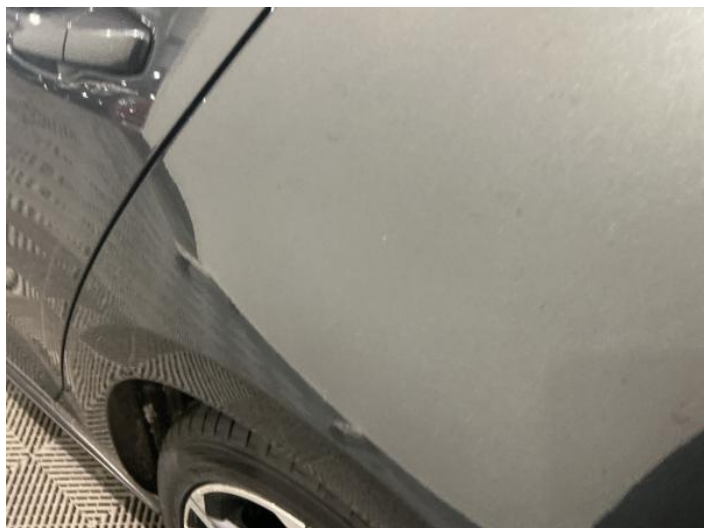
8: Qtr Panel nsr  
Dented  
Over 2 UpTo 10mm

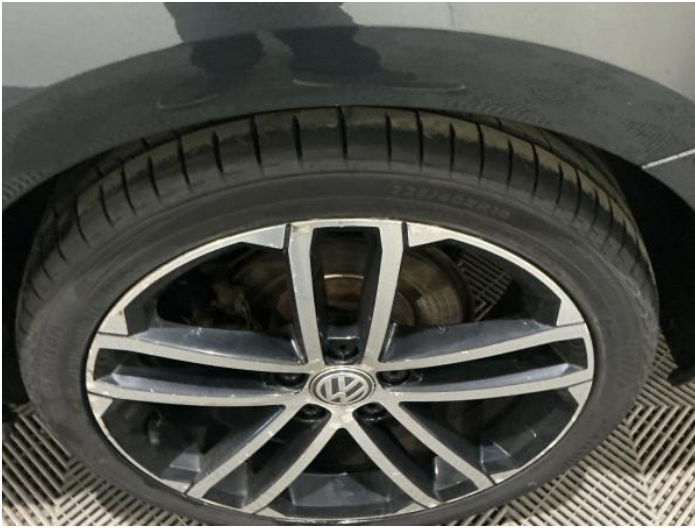
9: Wheel nsr  
Scratched  
Over 50mm

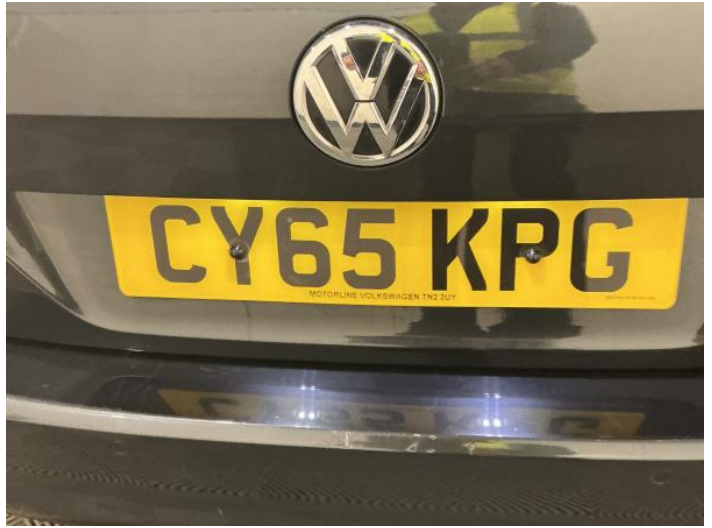
10: Bumper Rear  
Scratched  
Over 100mm Thru Paint

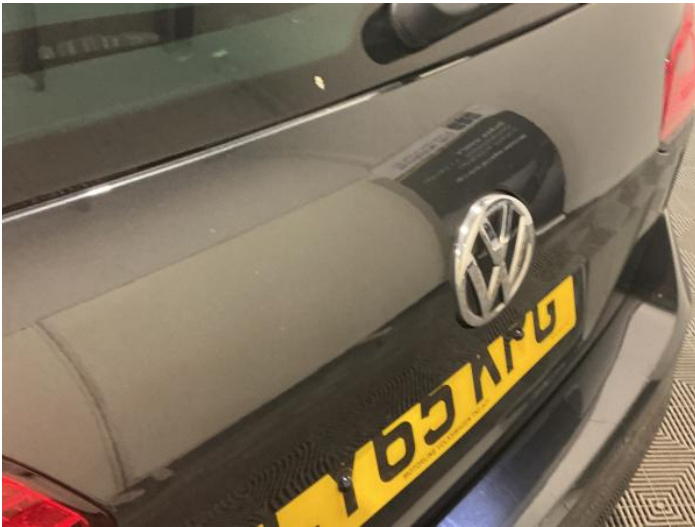
11: Boot Lid  
Chipped  
1 To 5

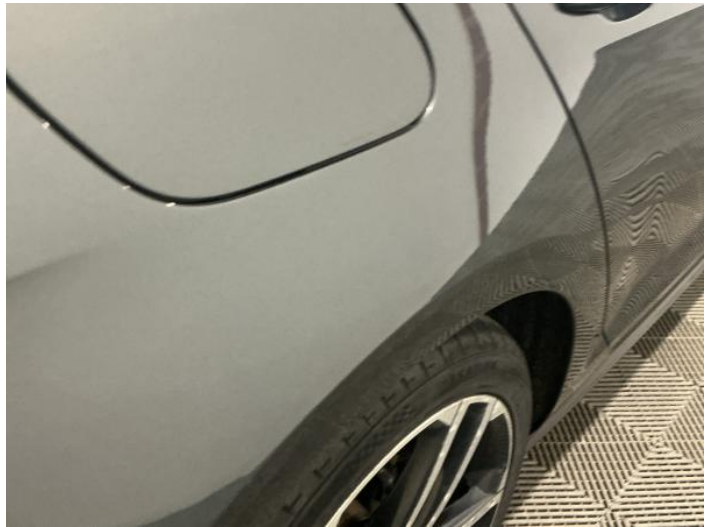
12: Qtr Panel osr  
Chipped  
1 To 5

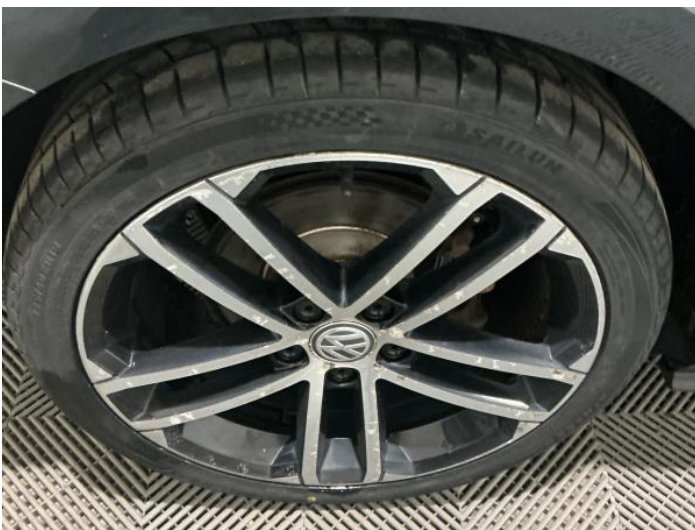
13: Wheel osr  
Scratched  
Over 50mm

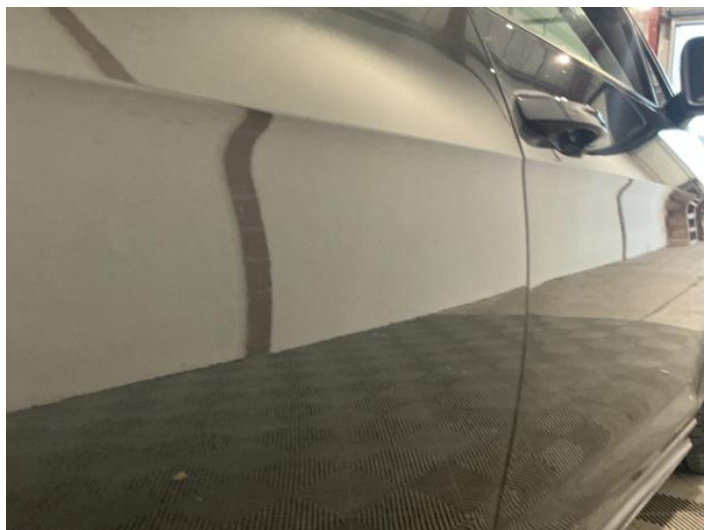
14: Door osr  
Chipped  
1 To 5

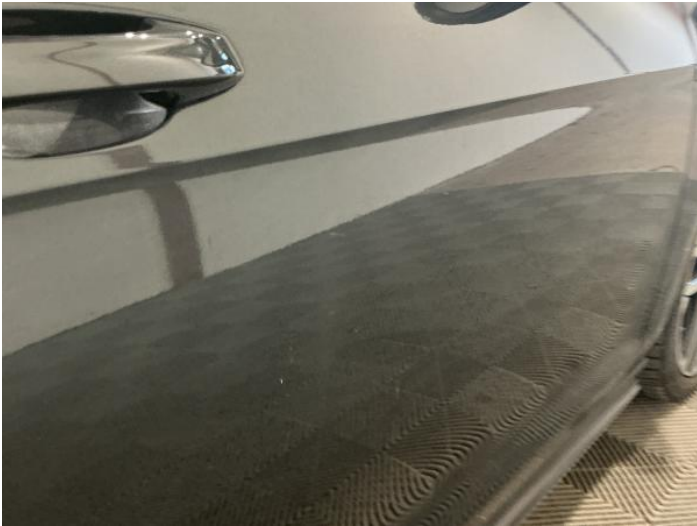
15: Door osf  
Chipped  
1 To 5

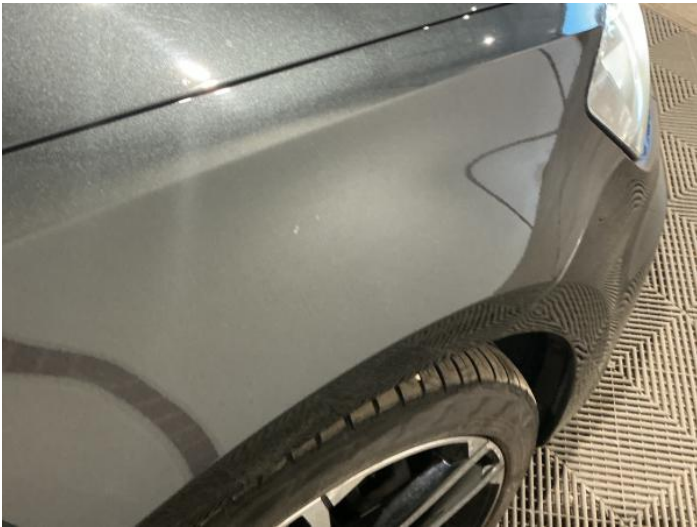
17: Wing osf  
Chipped  
1 To 5

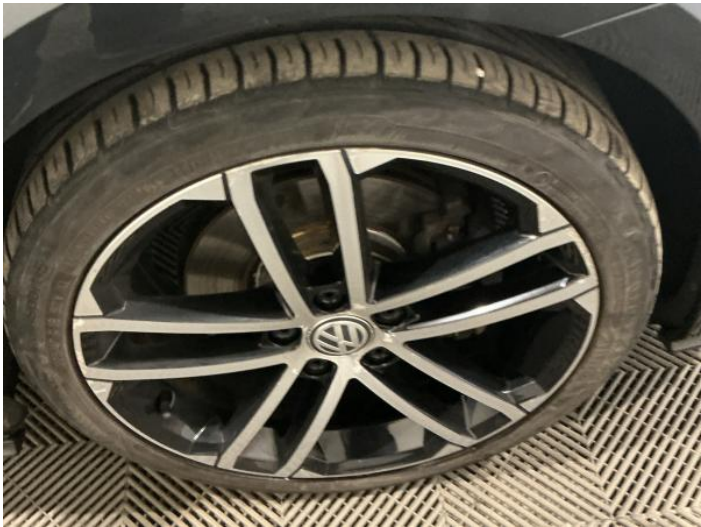
18: Wheel osf  
Scratched  
Over 50mm
