## VEHICLE INSPECTION REPORT

FL16WZS

## **Toyota Avensis 2.0D Business Edition Plus 4dr**

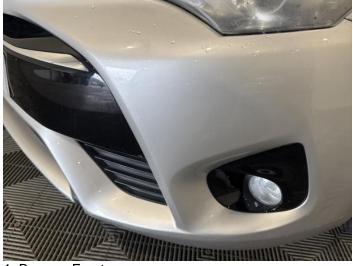
1: Bumper Front Scratched Over 100mm Thru Paint

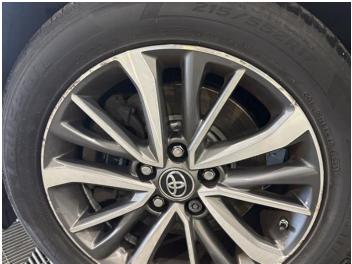
2: Wheel nsf Scratched Over 50mm

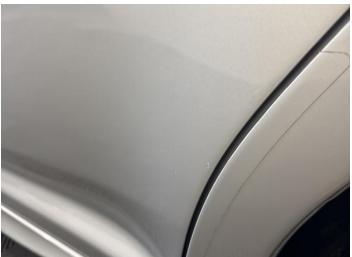
5: Door nsr Chipped 1 To 5

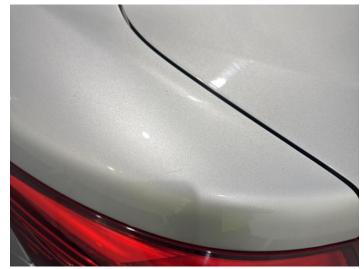
7: Qtr Panel nsr Scratched UpTo 25mm Thru Paint

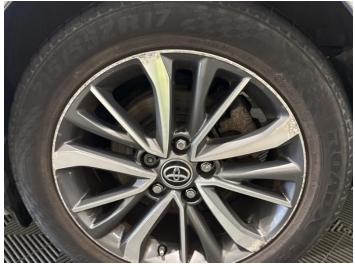
6: Wheel nsr Scratched Over 50mm

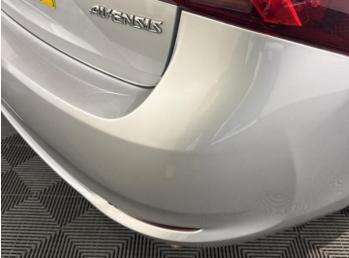
8: Bumper Rear Scratched 25 to 100mm Thru Paint

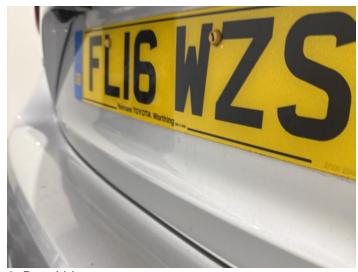
9: Boot Lid Scratched UpTo 25mm Thru Paint

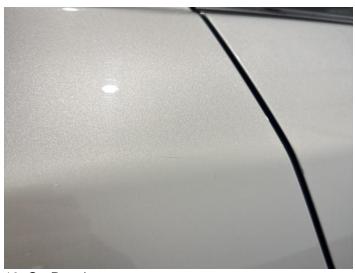
10: Qtr Panel osr Scratched UpTo 25mm Thru Paint

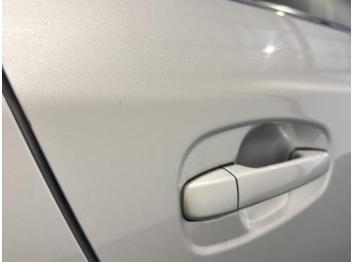
11: Door osr Scratched UpTo 25mm Thru Paint

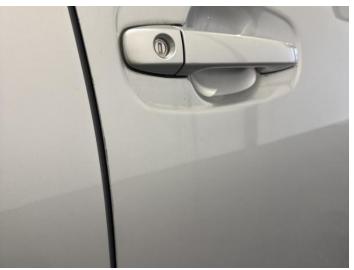
12: Door osf Chipped Edge Chip

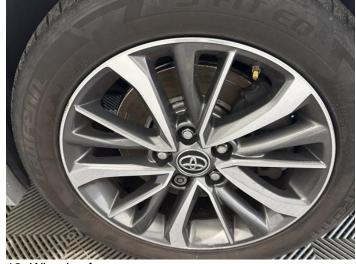
13: Wheel osf Scratched Over 50mm

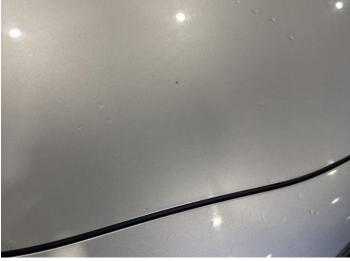
14: Bonnet Chipped 1 To 5
