## VEHICLE INSPECTION REPORT

**NV11HVX**

### Mazda 6 2.2d [163] TS2 5dr

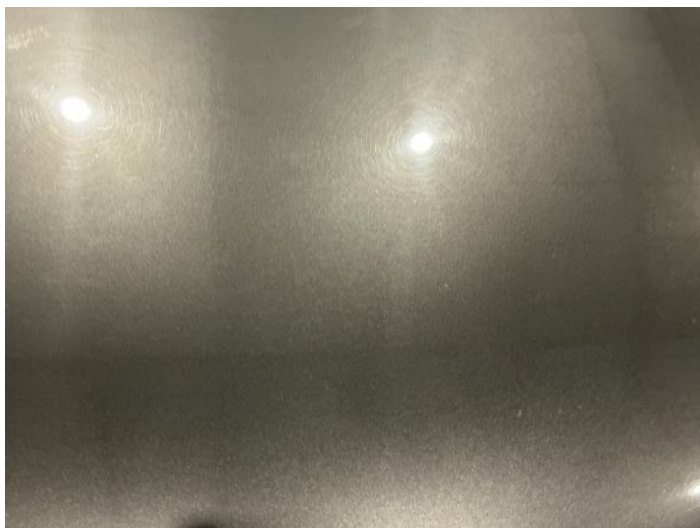
1: Bonnet  
Chipped  
1 To 5

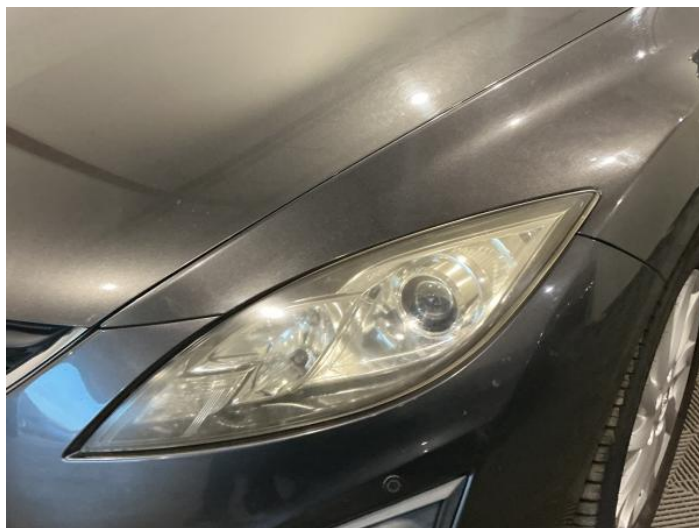
2: Bumper Front  
Scratched  
Over 100mm Thru Paint

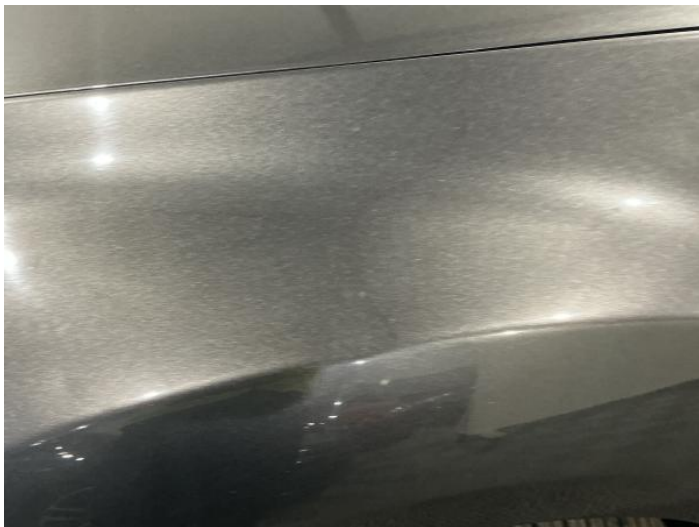
3: Wing nsf  
Dented  
Over 30mm

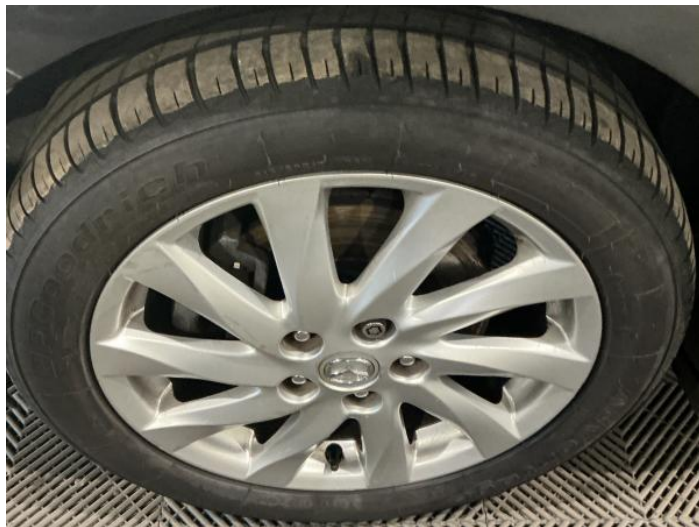
4: Wheel nsf  
Scratched  
Over 50mm

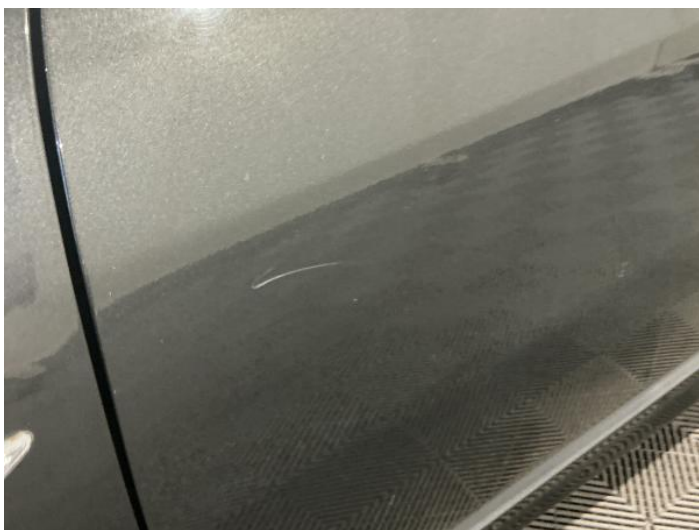
5: Door nsf  
Scratched  
Over 25mm Thru Paint

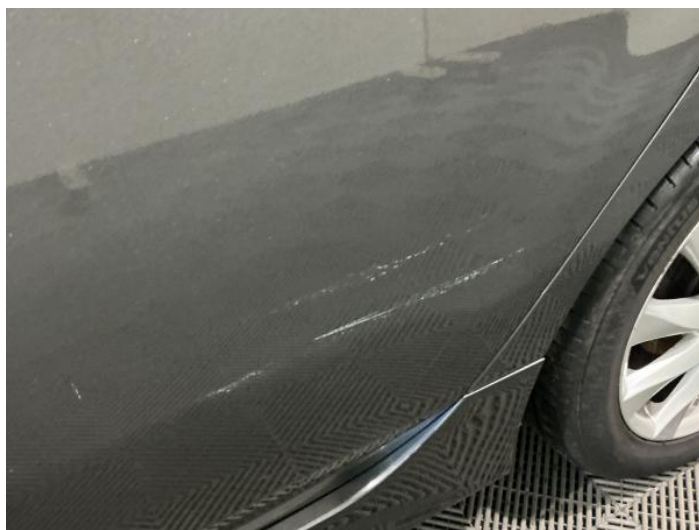
6: Door nsr  
Scratched  
Over 25mm Thru Paint

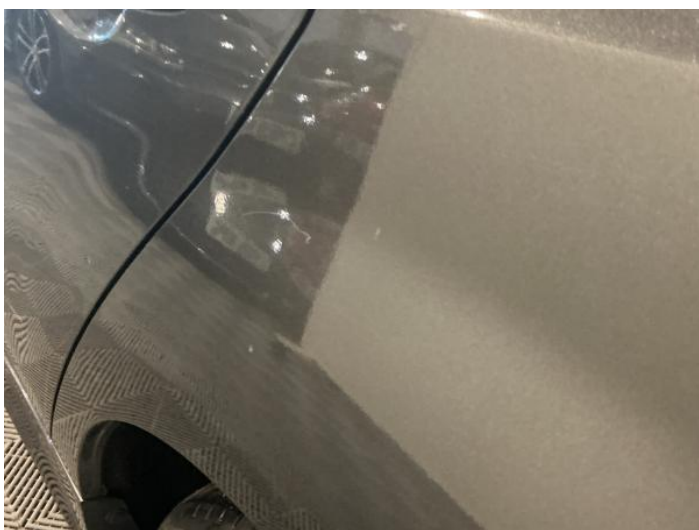
7: Qtr Panel nsr  
Scratched  
UpTo 25mm Thru Paint

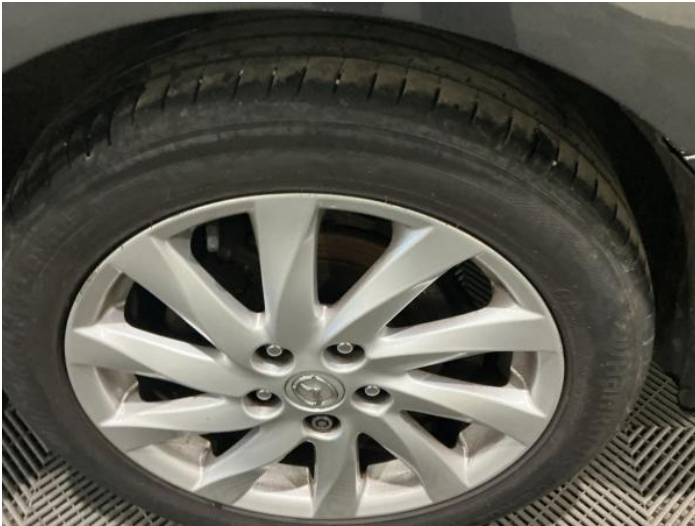
9: Wheel nsr  
Scratched  
Over 50mm

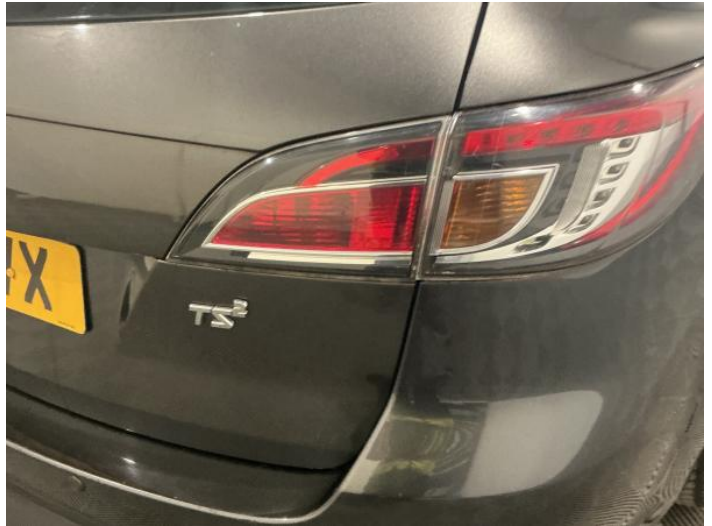
10: Bumper Rear  
Scratched  
Over 100mm Thru Paint

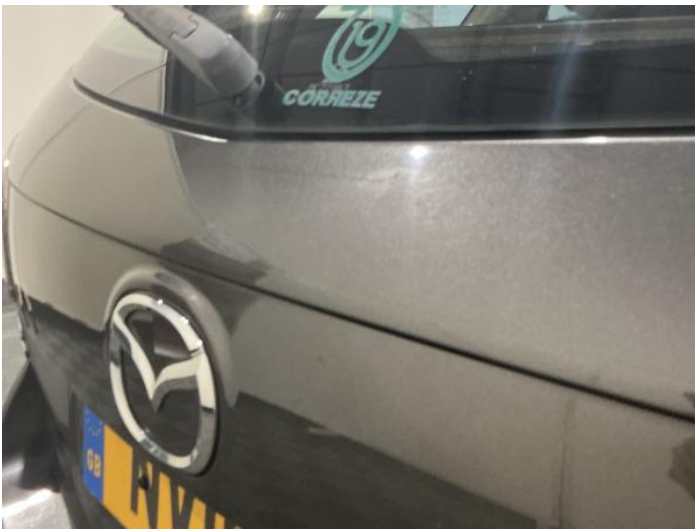
11: Boot Lid  
Dented  
Over 2 UpTo 10mm

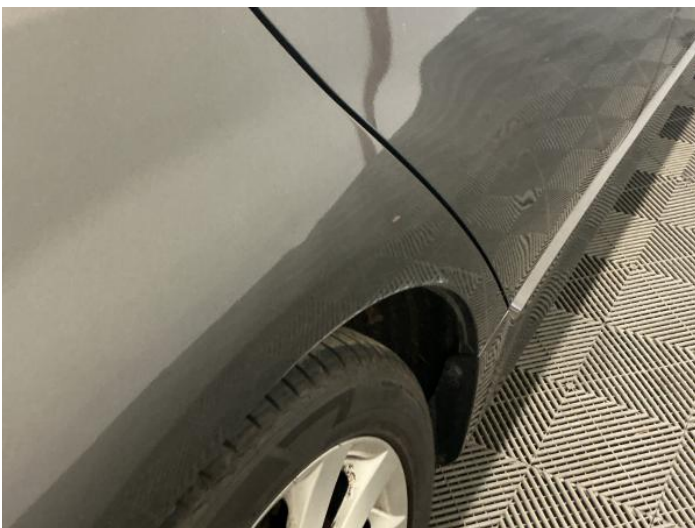
13: Qtr Panel osr  
Scratched  
Over 25mm Thru Paint

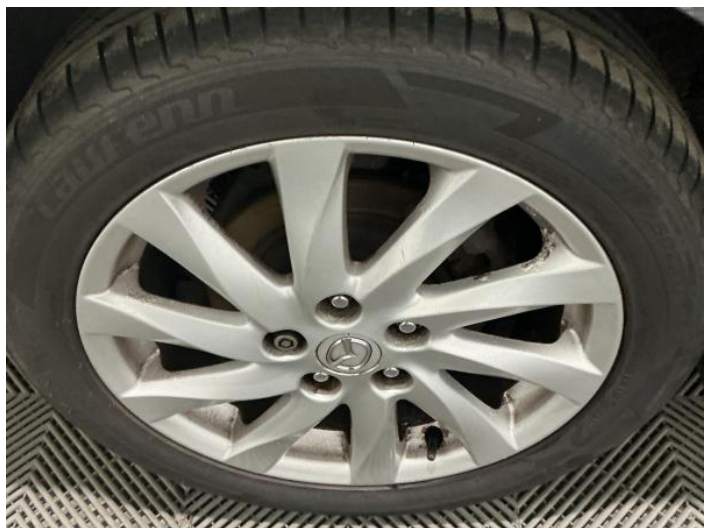
14: Wheel osr  
Scratched  
Over 50mm

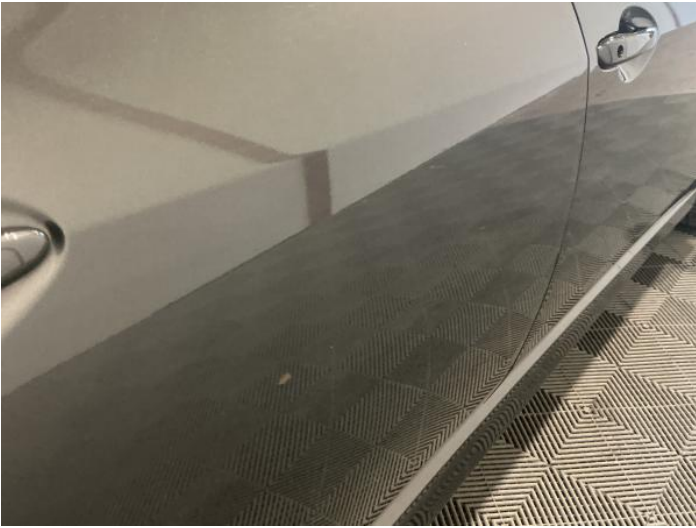
15: Door osr  
Chipped  
1 To 5

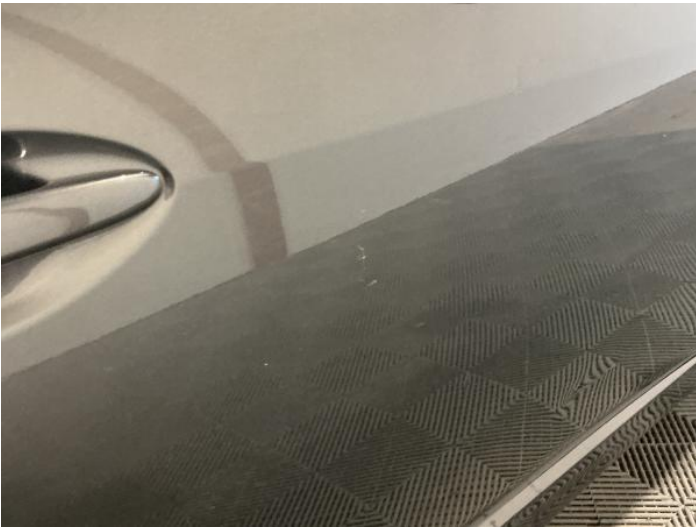
17: Door osf  
Chipped  
Multiple Chips

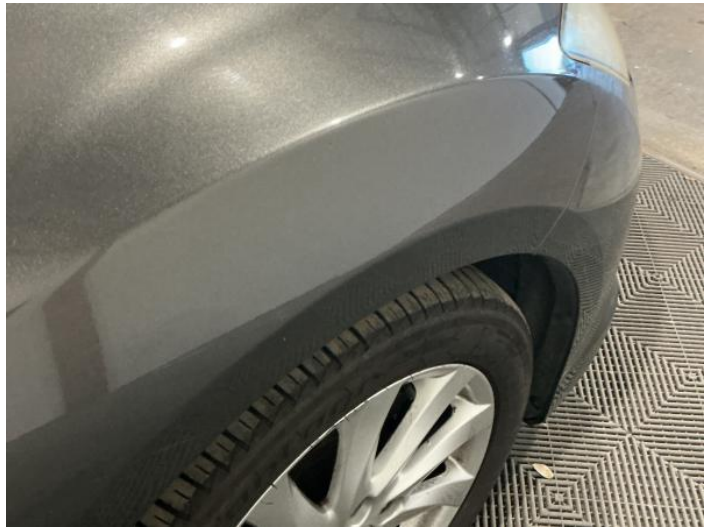
18: Wing osf  
Chipped  
1 To 5

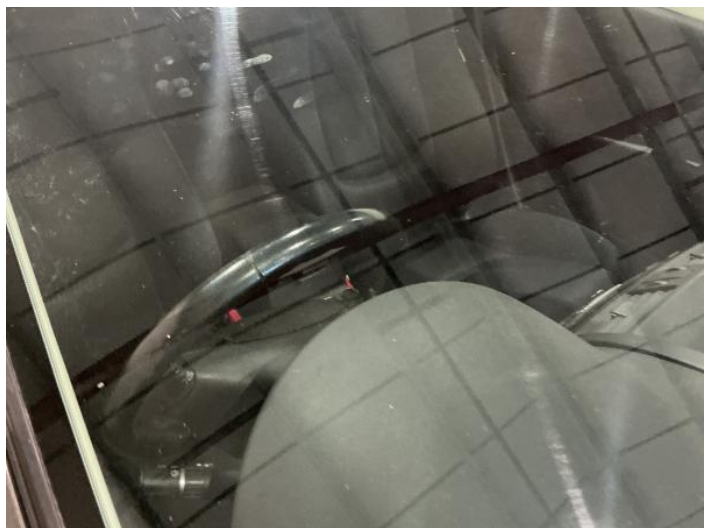
20: Screen Front  
Chipped  
UpTo 10mm

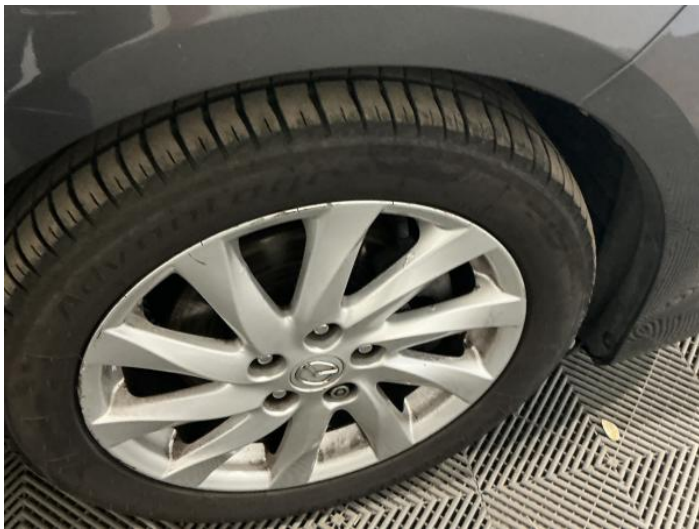
21: Wheel of  
Scratched  
Over 50mm
