# VEHICLE INSPECTION REPORT

MT21DSZ

## Vauxhall Movano 2.3 Turbo D 135ps H2 Van

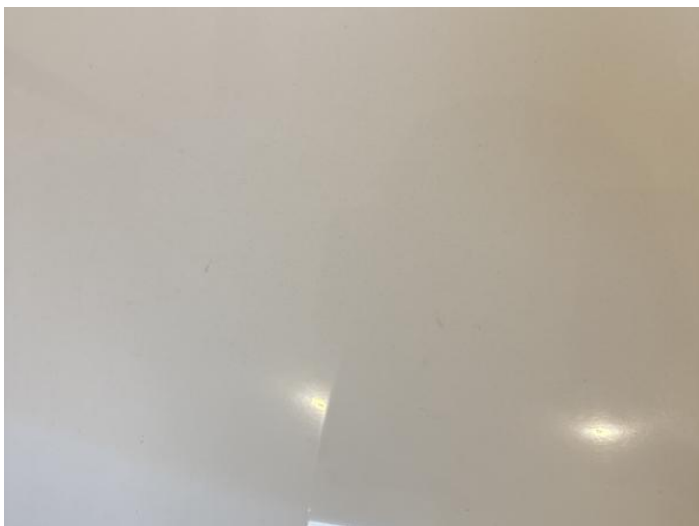
3: Bonnet  
Chipped  
Multiple Chips

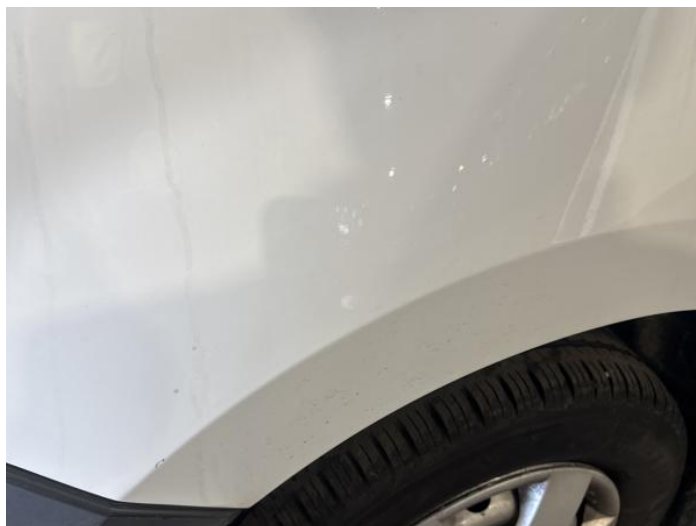
4: Wing nsf  
Chipped  
Multiple Chips

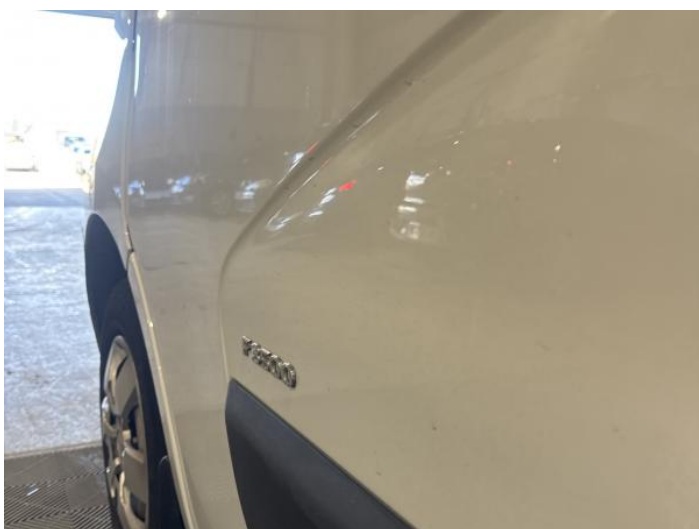
5: Door nsf  
Chipped  
1 To 5

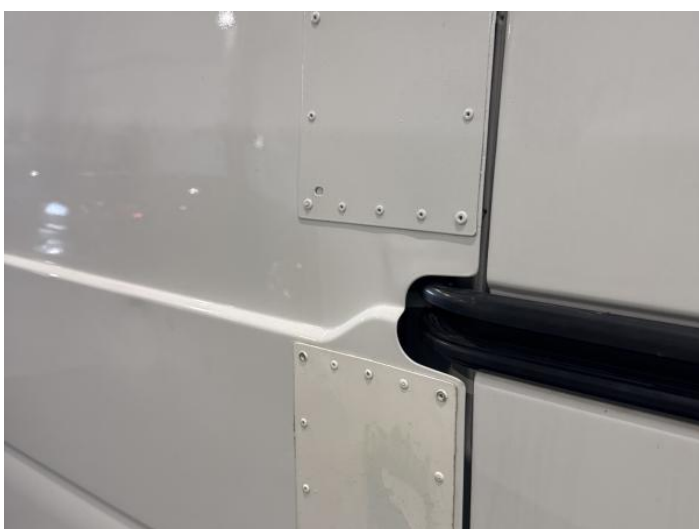
7: Door nsr  
Hole  
Over 10mm

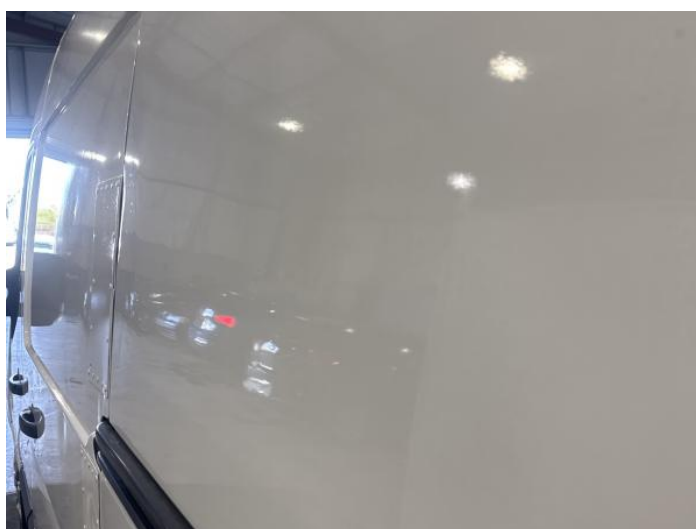
8: Qtr Panel nsr  
Dented  
Over 30mm

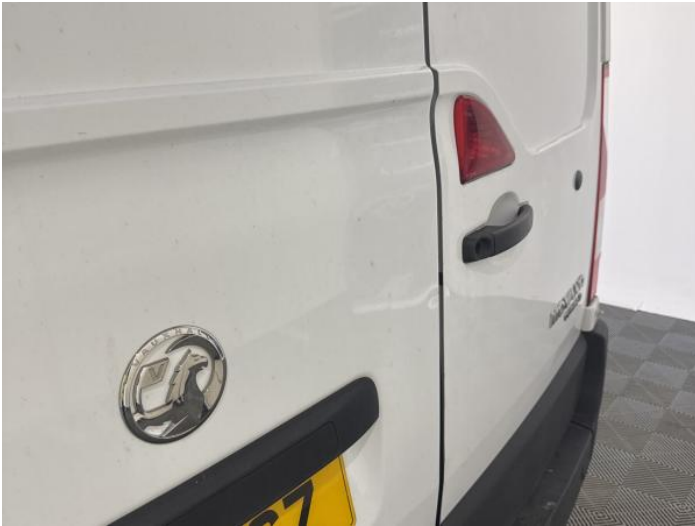
9: Boot Lid  
Dented  
Over 30mm

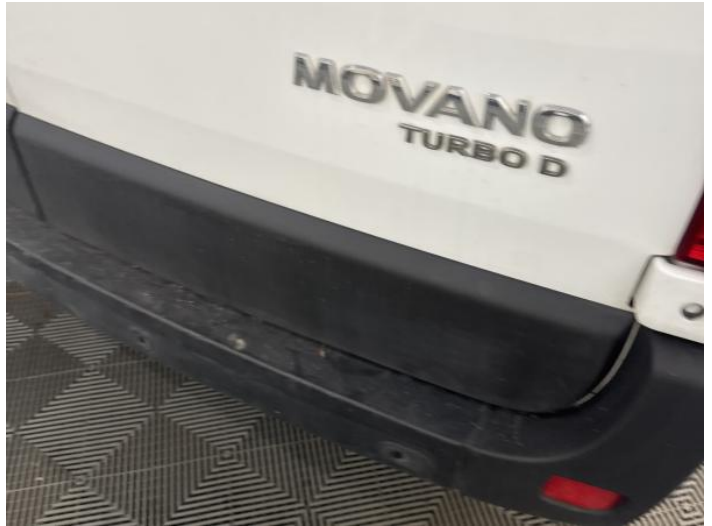
10: Bumper Rear Moulding  
Scratched (Painted)  
Over 25mm Thru Paint

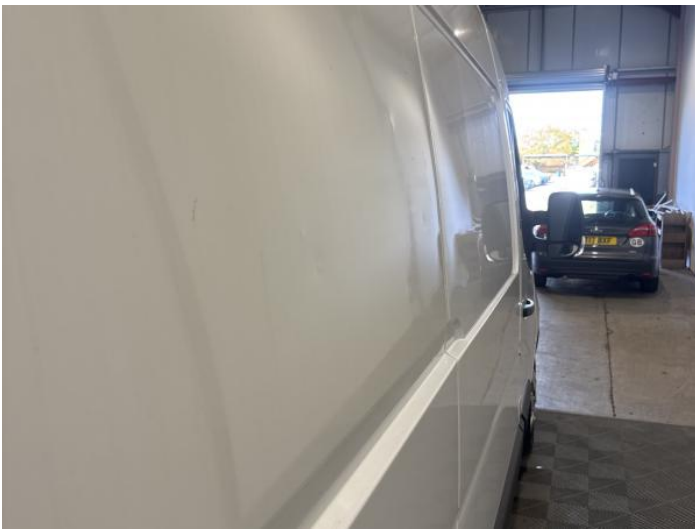
11: Qtr Panel osr  
Dented  
Over 30mm

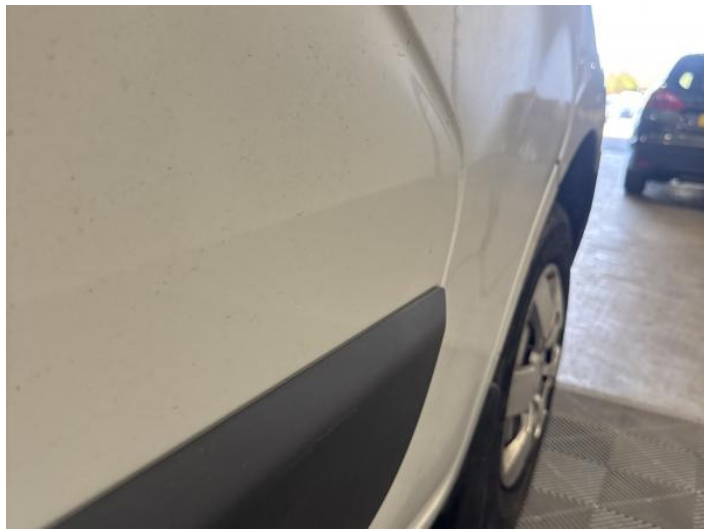
12: Door osf  
Chipped  
1 To 5

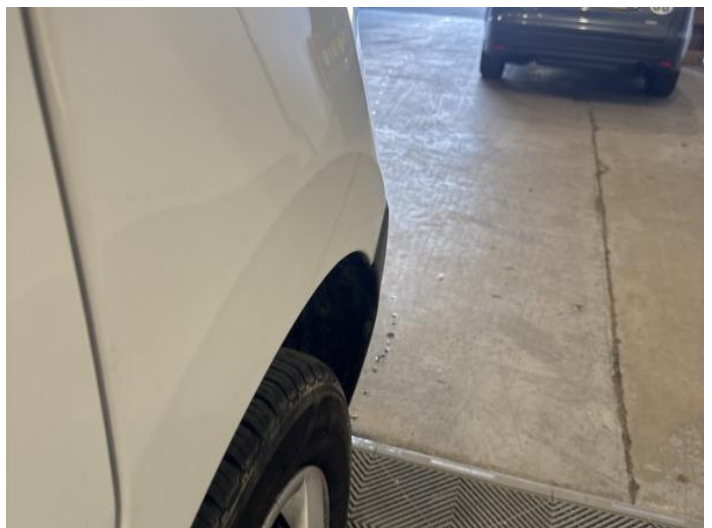
14: Wing osf  
Dented  
Over 30mm

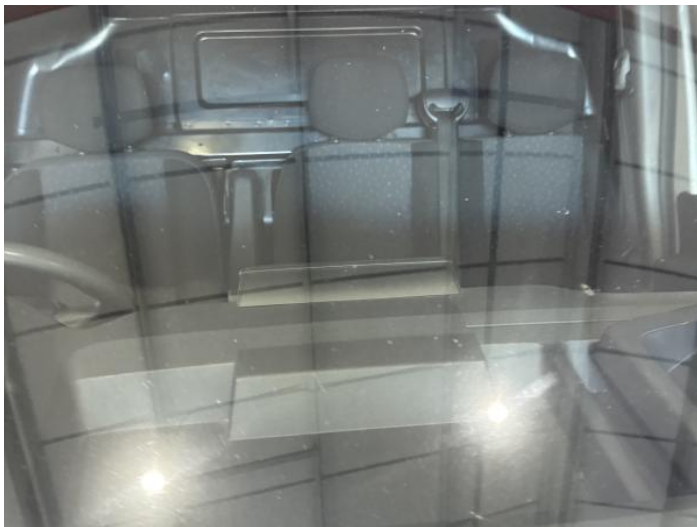
15: Screen Front  
Chipped  
UpTo 10mm

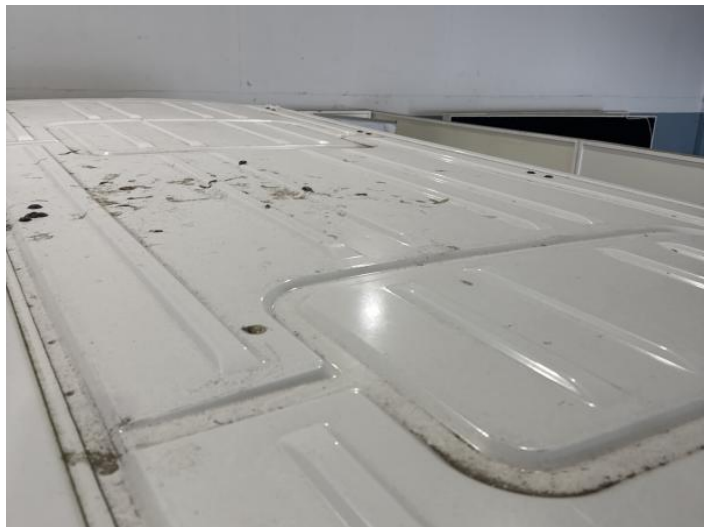
16: Roof  
Dented  
Over 30mm
