VEHICLE INSPECTION REPORT

GK22EHS

Nissan Qashqai 1.3 DiG-T MH 158 Tekna+ 5dr

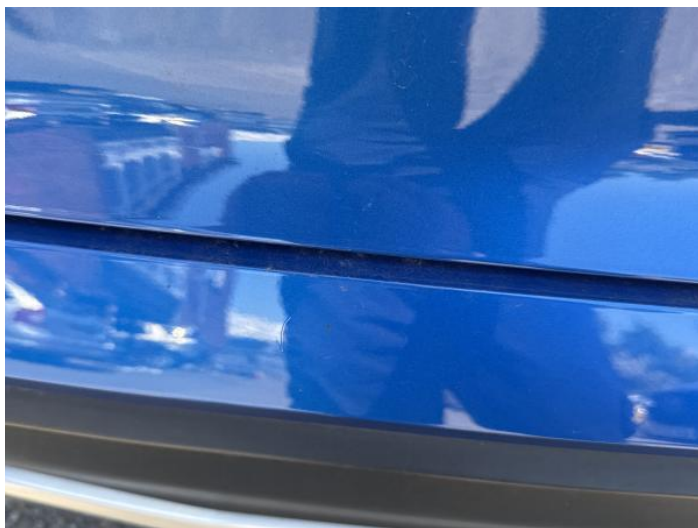
1: Bumper Rear
Scratched
25 to 100mm Thru Paint

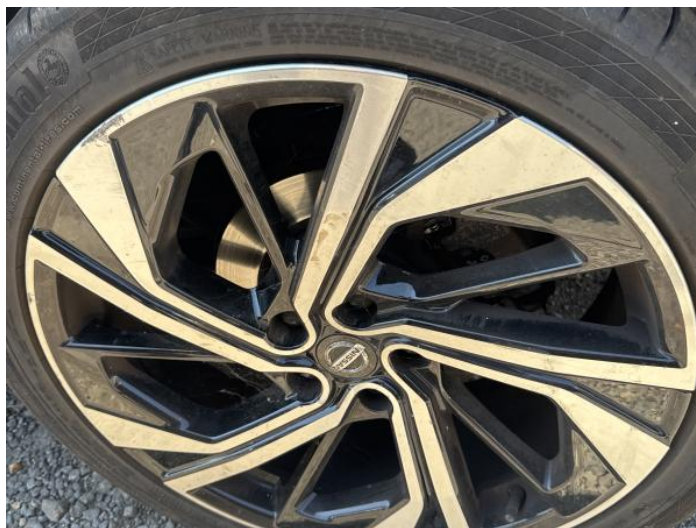
2: Wheel nsr
Scratched
Over 50mm

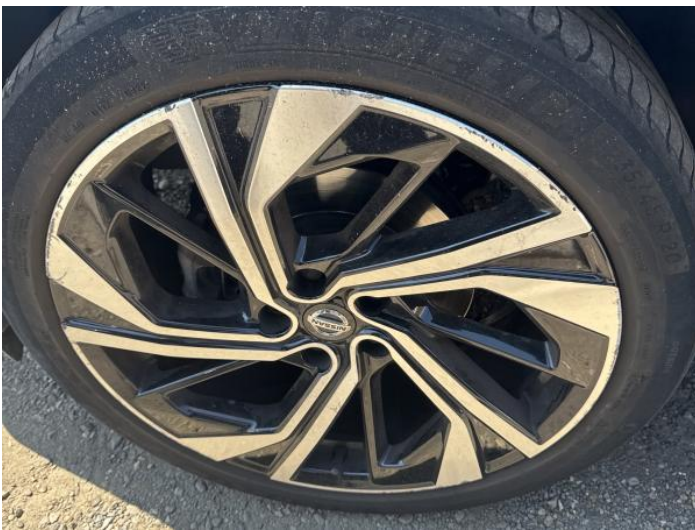
5: Wheel nsf
Scratched
Over 50mm

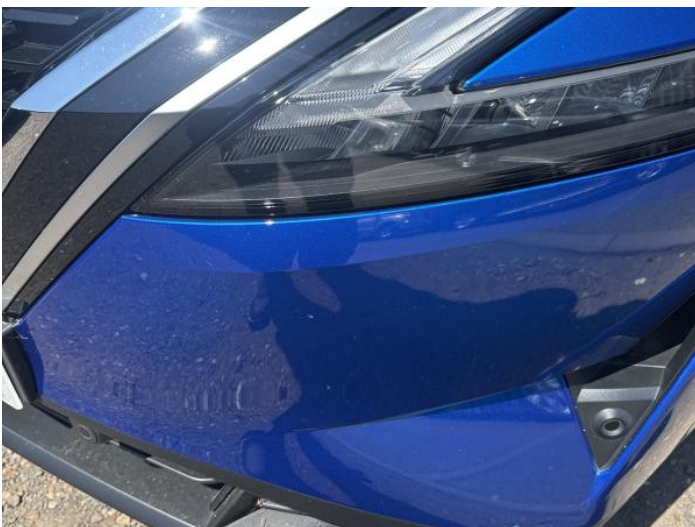
7: Bumper Front
Chipped
Multiple Chips

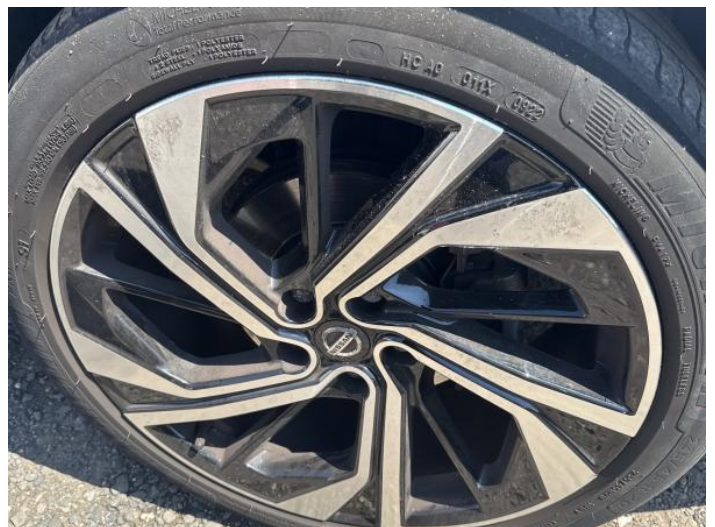
8: Wheel osf
Scratched
Up To 50mm

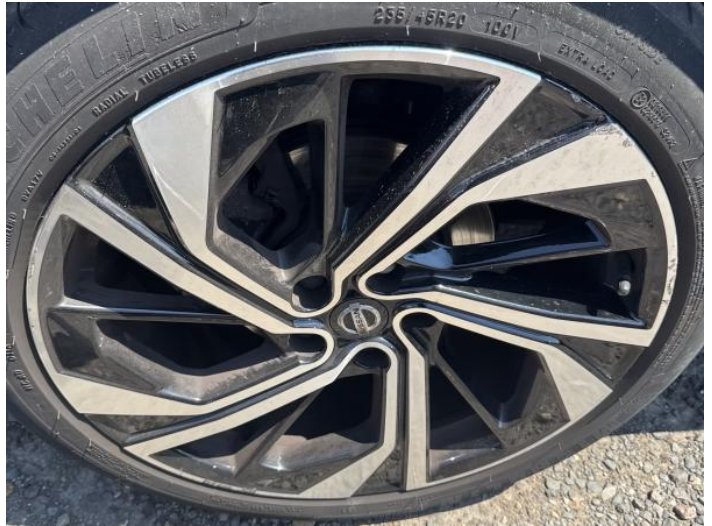
10: Wheel osr
Scratched
Over 50mm

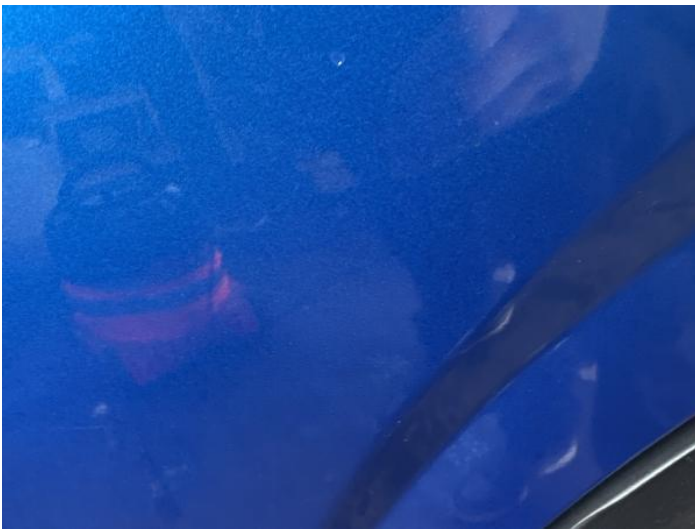
11: Door nsr
Scratched
Over 25mm Thru Paint
