## VEHICLE INSPECTION REPORT

**PK15OSZ**

### Volkswagen Tiguan 2.0 TDi BlueMotion Tech Match 177 5dr DSG

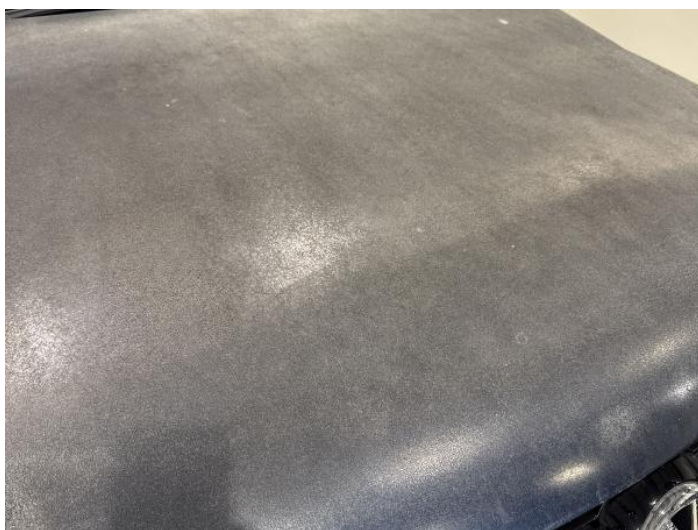
1: Bonnet  
Poor Previous Repair  
Poor Paint

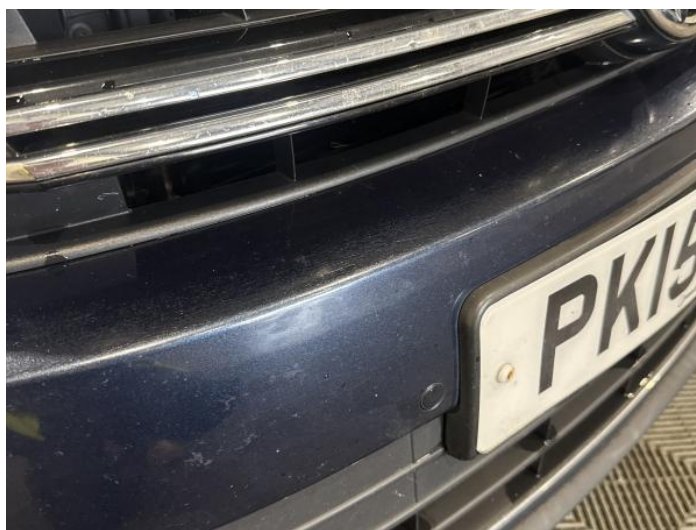
2: Bumper Front  
Poor Previous Repair  
Poor Paint

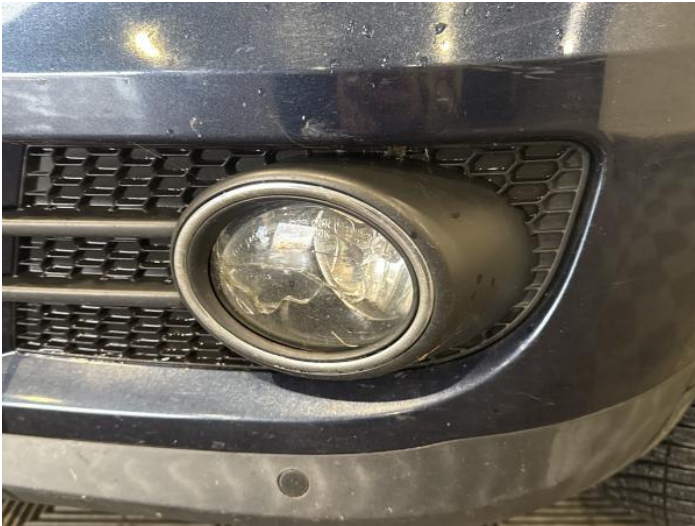
3: Fogdriving Lamp nsf  
Broken  
Replace

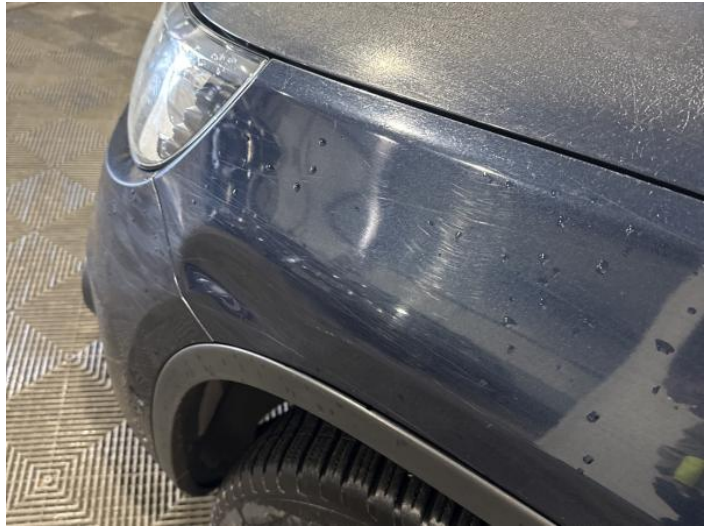
4: Wing nsf  
Dented  
With Paint Damage

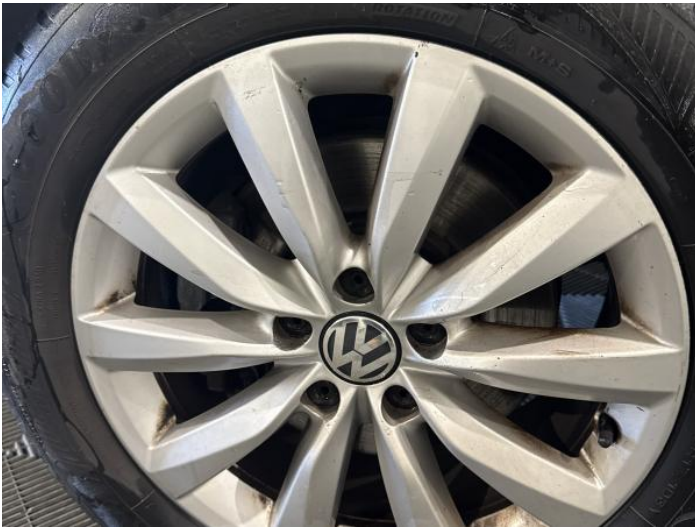
5: Wheel nsf  
Scratched  
Up To 50mm

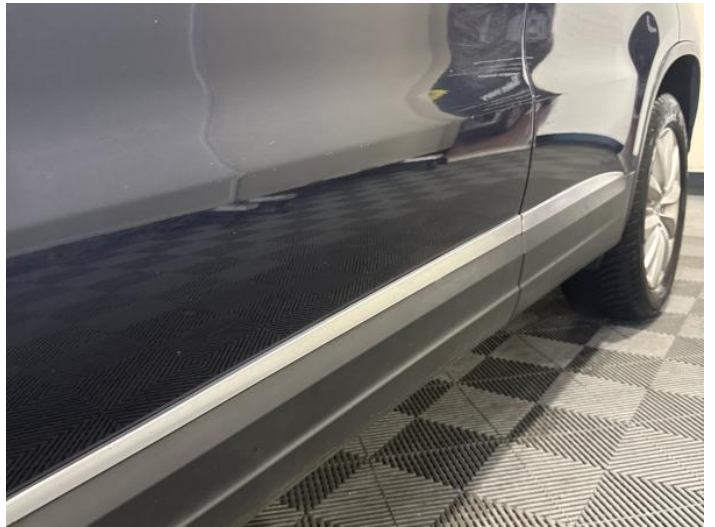
6: Door nsf  
Dented  
Between 10mm + 30mm

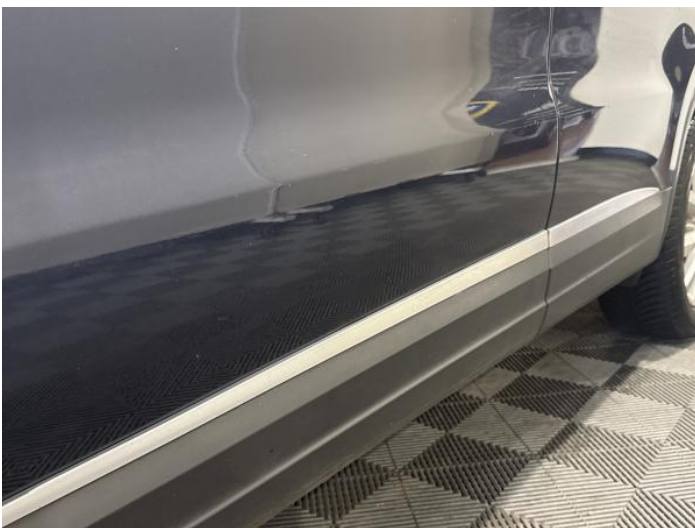
7: Door nsf  
Chipped  
Multiple Chips

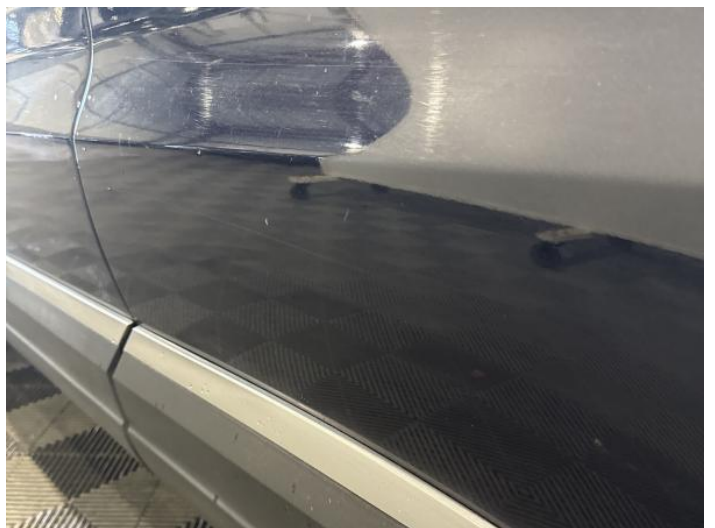
8: Door nsr  
Scratched  
Over 25mm Thru Paint

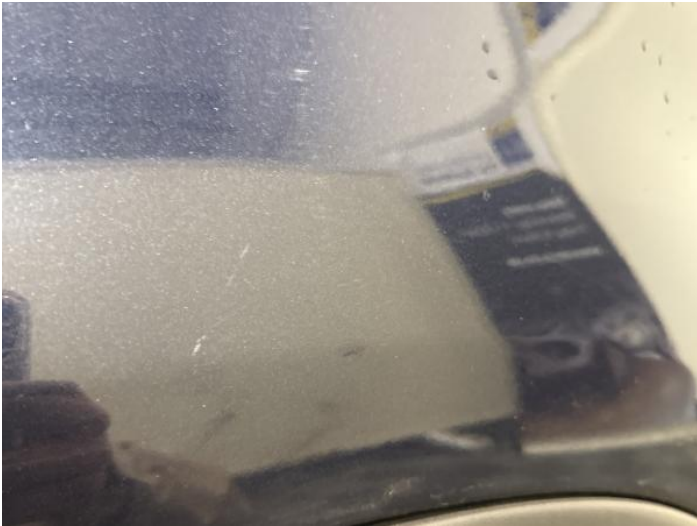
9: Qtr Panel nsr  
Scratched  
UpTo 25mm Thru Paint

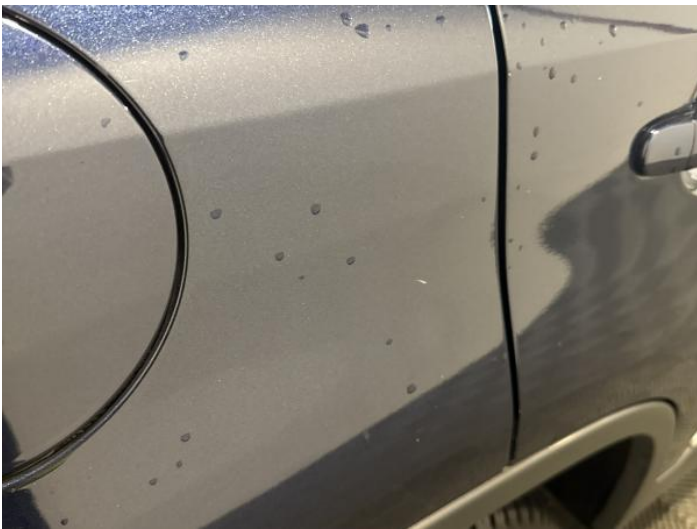
11: Qtr Panel osr  
Scratched  
UpTo 25mm Thru Paint

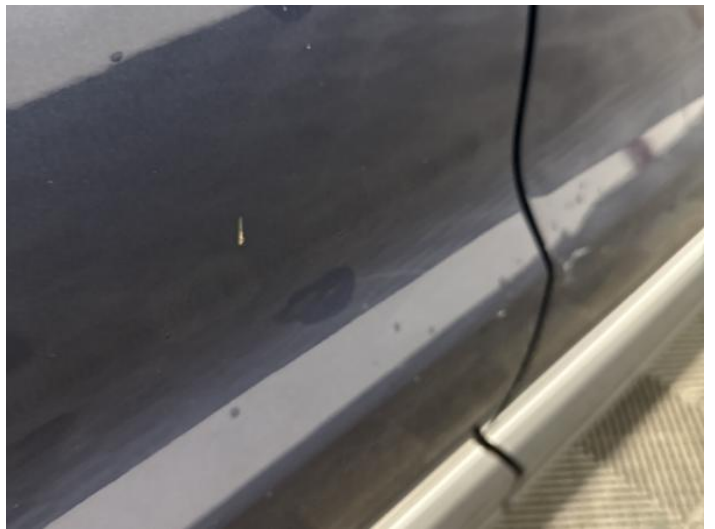
12: Door osr  
Scratched  
Over 25mm Thru Paint

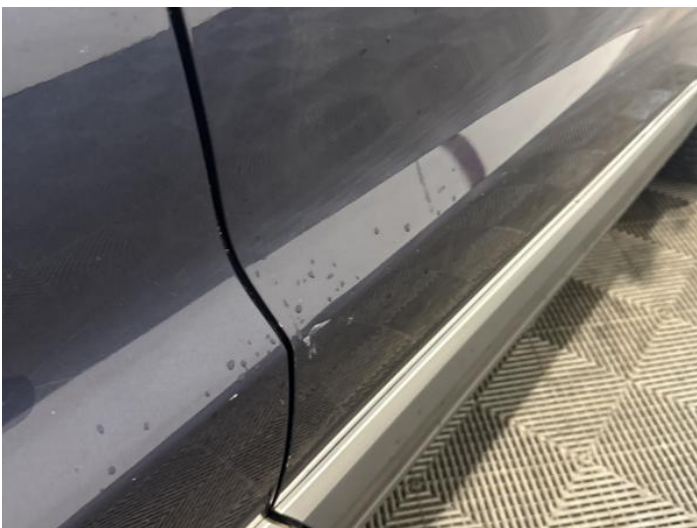
13: Door osf  
Dented  
With Paint Damage

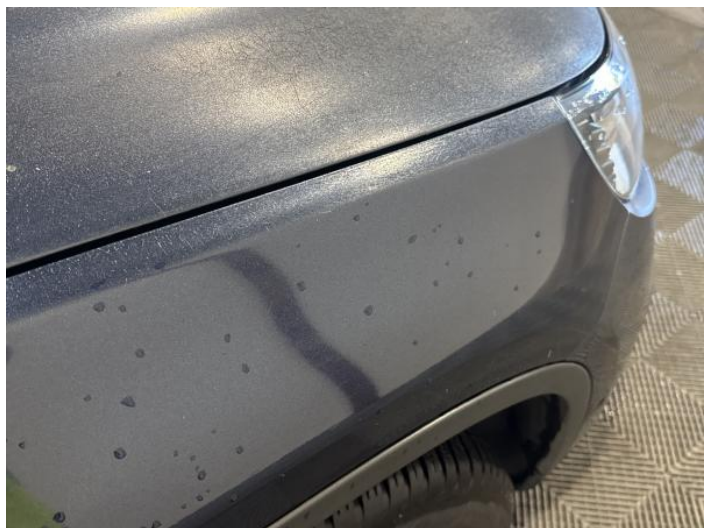
14: Wing osf  
Poor Previous Repair  
Poor Paint

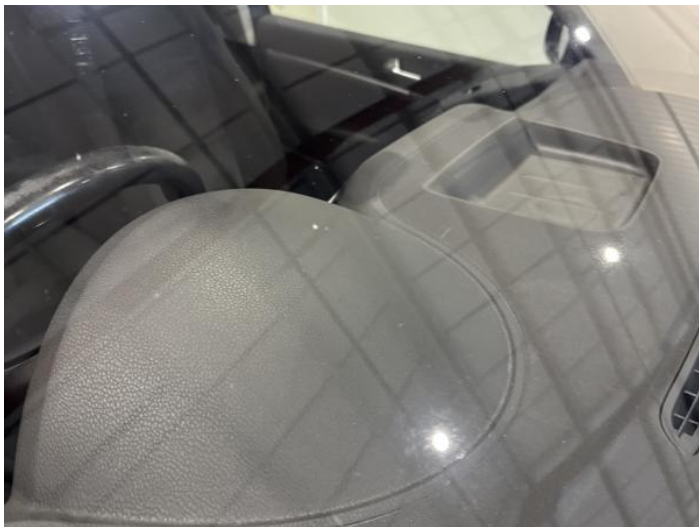
15: Screen Front  
Chipped  
UpTo 10mm
