VEHICLE INSPECTION REPORT

GX21YZK

Seat Ibiza 1.0 TSI 110 FR [EZ] 5dr

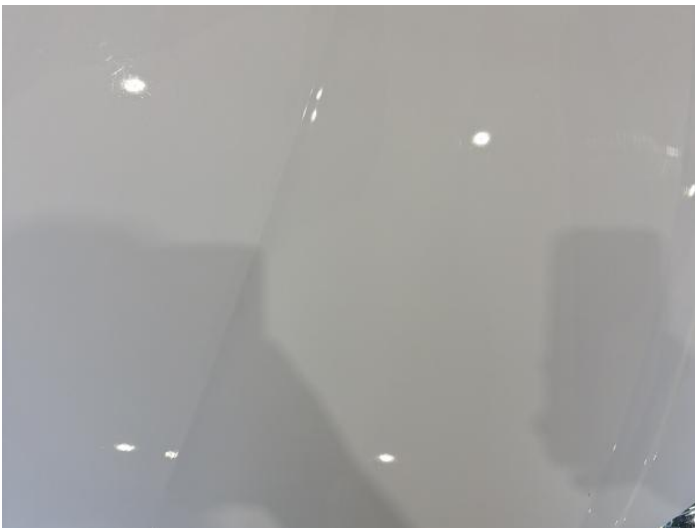
1: Bonnet
Chipped
Multiple Chips

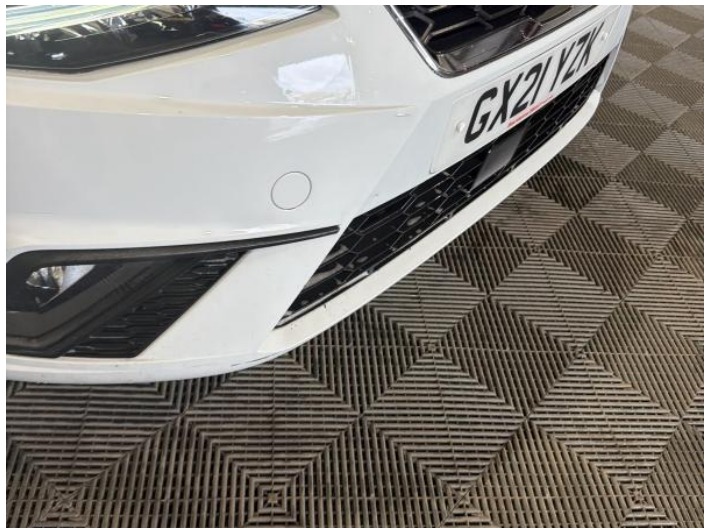
2: Bumper Front
Scratched
Over 100mm Thru Paint

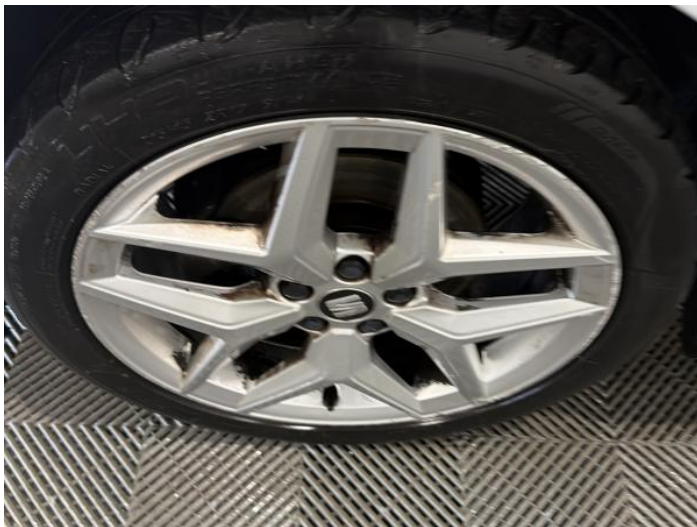
3: Wheel nsf
Scratched
Over 50mm

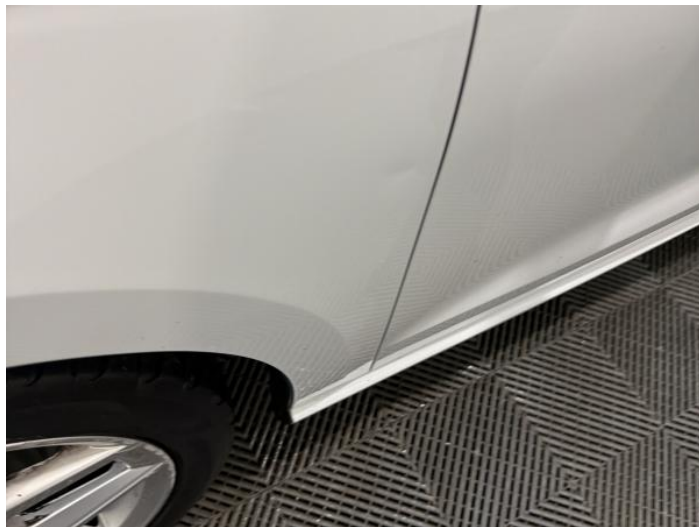
4: Wing nsf
Dented
Between 10mm + 30mm

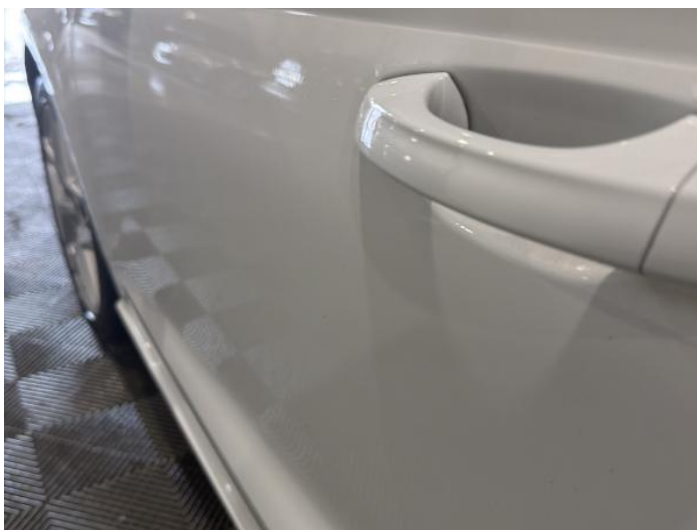
5: Door nsf
Dented
Over 2 UpTo 10mm

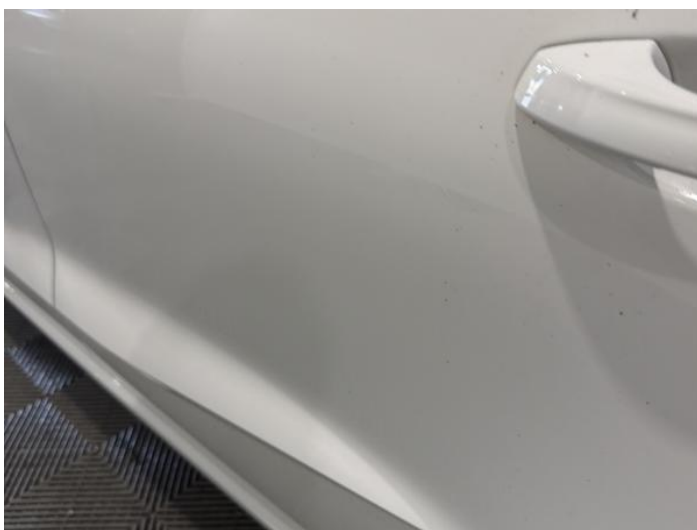
7: Door nsr
Chipped
1 To 5

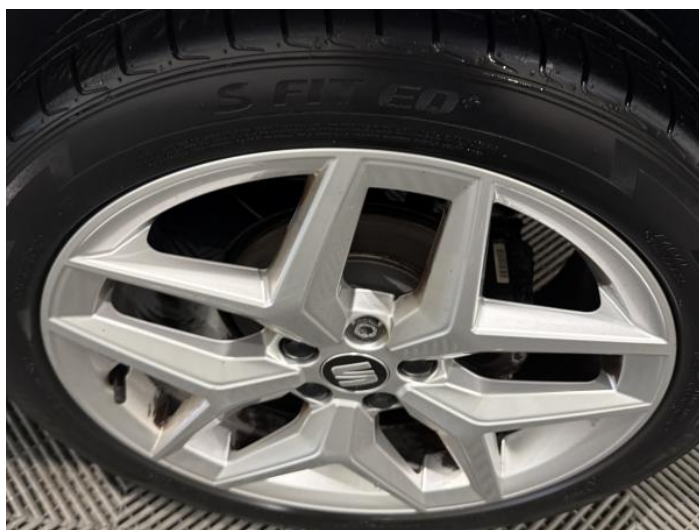
8: Wheel nsr
Scratched
Up To 50mm

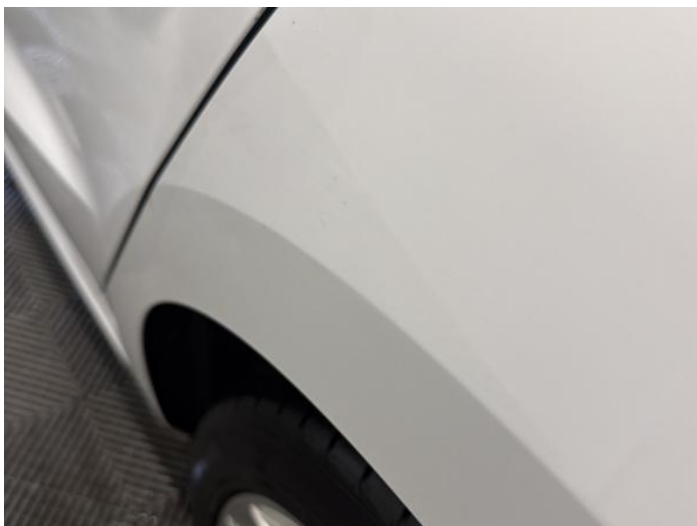
9: Qtr Panel nsr
Dented
Between 10mm + 30mm

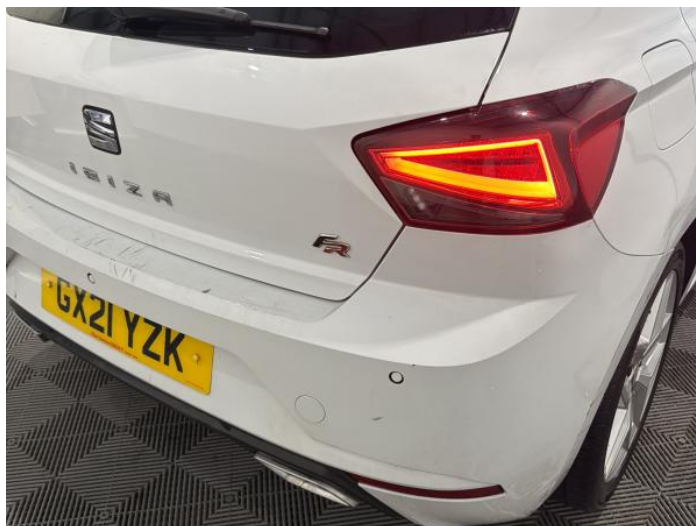
10: Bumper Rear
Scratched
Over 100mm Thru Paint

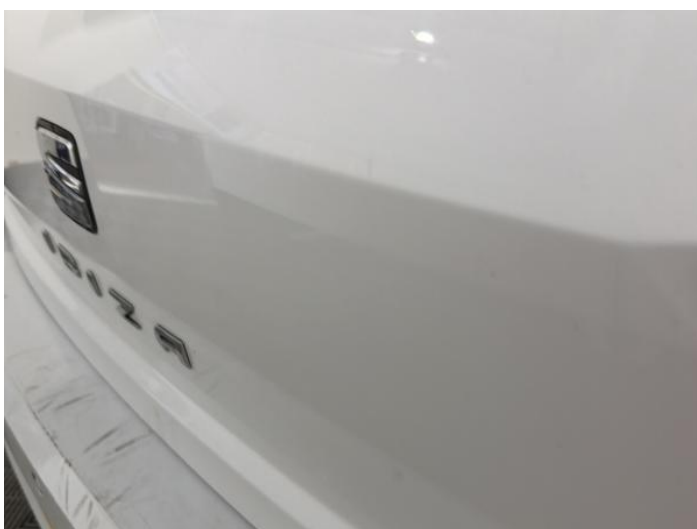
11: Boot Lid
Dented
Over 2 UpTo 10mm

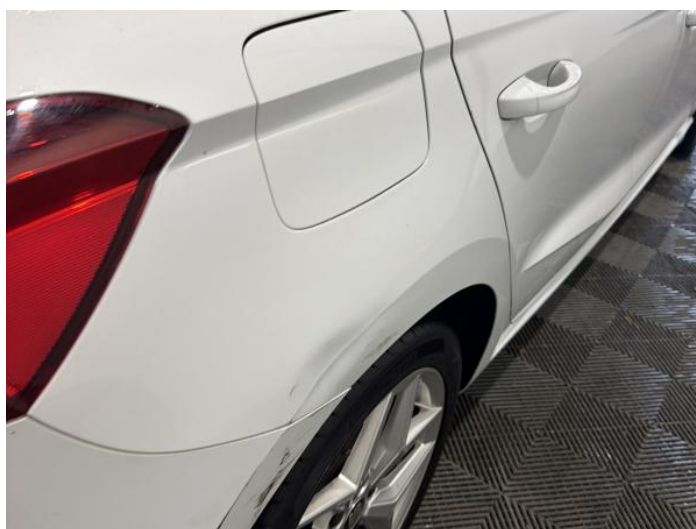
12: Qtr Panel osr
Dented
With Paint Damage

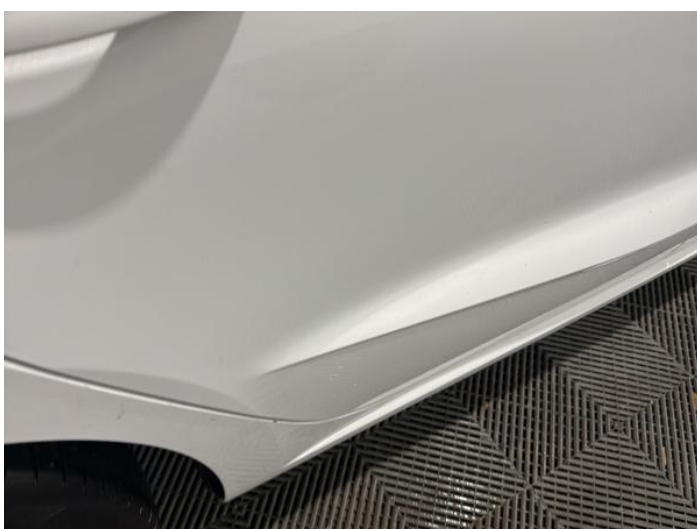
13: Qtr Panel osr
Dented
With Paint Damage

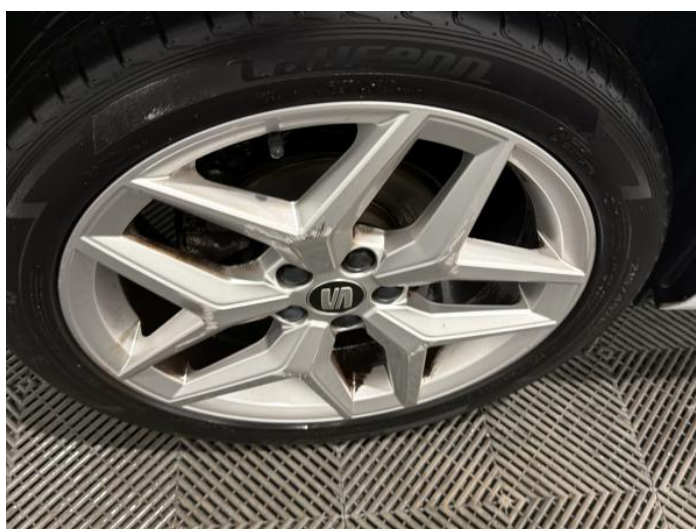
14: Wheel osr
Scratched
Over 50mm

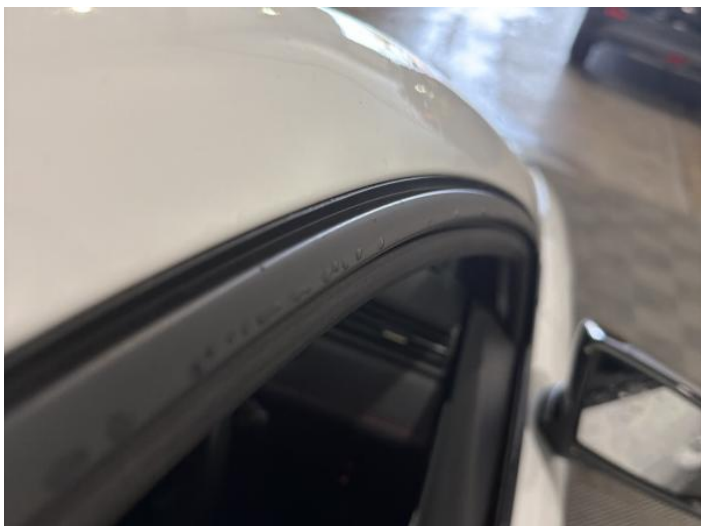
15: A Post os
Dented
Over 30mm

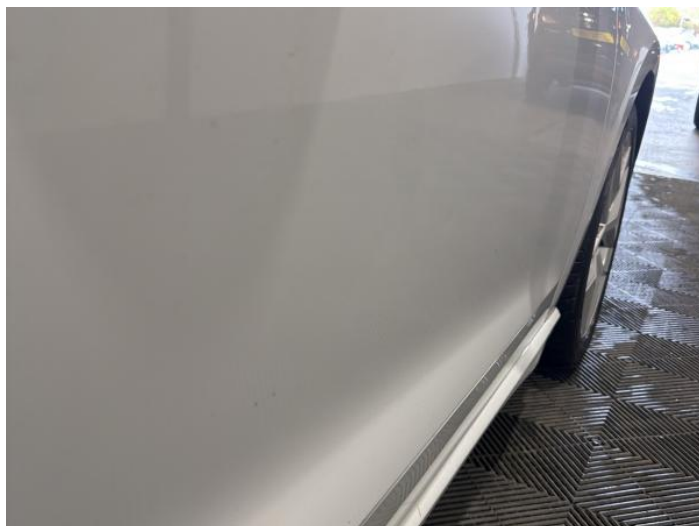
16: Door osf
Dented
Over 2 UpTo 10mm

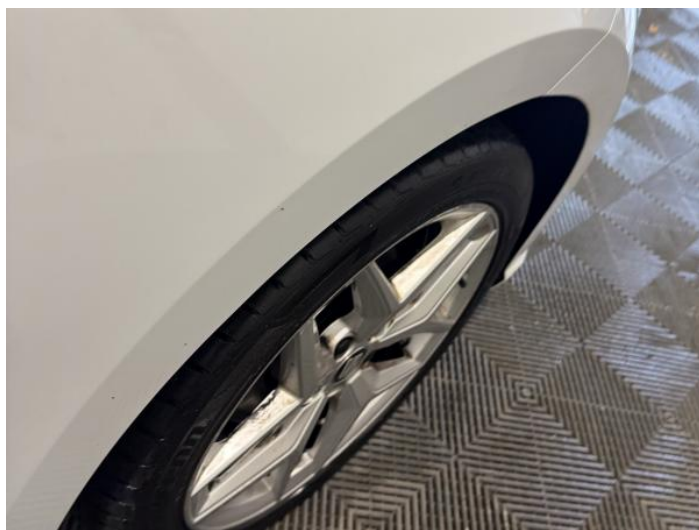
18: Wing osf
Chipped
1 To 5

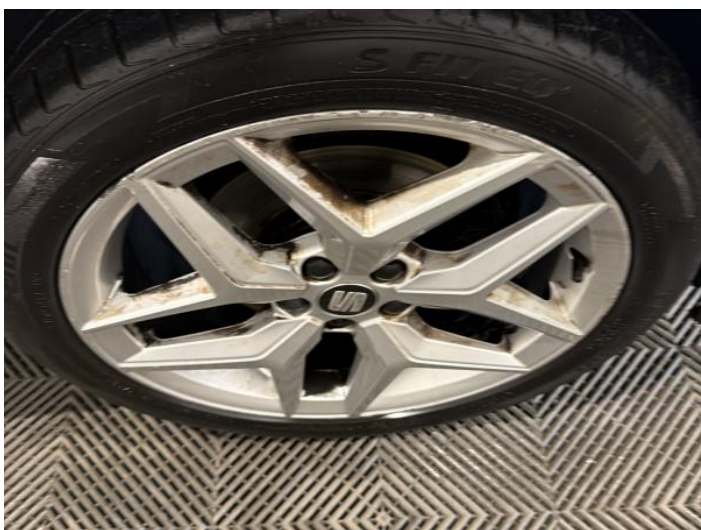
19: Wheel osf
Scratched
Over 50mm

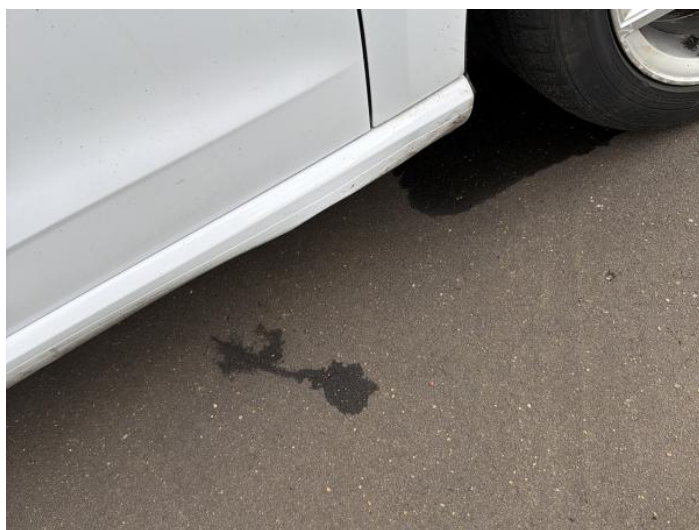
20: Sill os
Dented
Over 30mm
