# VEHICLE INSPECTION REPORT

**GX63PYT**

## Mercedes-Benz A Class A200 CDI BlueEFFICIENCY AMG Sport 5dr Auto

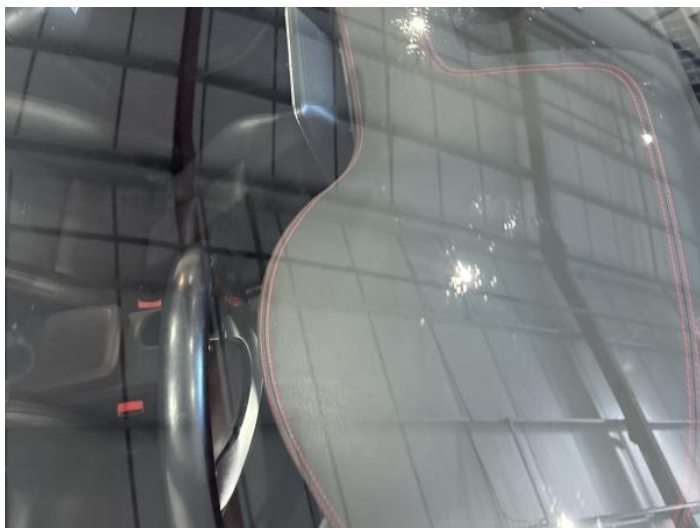
1: Screen Front  
Chipped  
UpTo 10mm

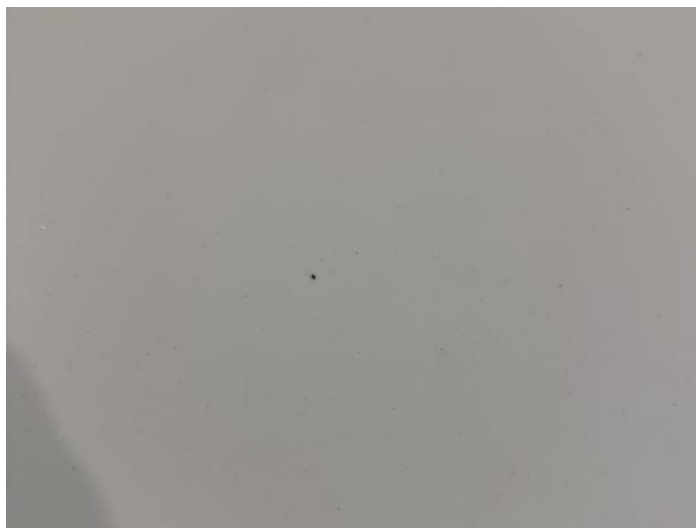
2: Bonnet  
Chipped  
1 To 5

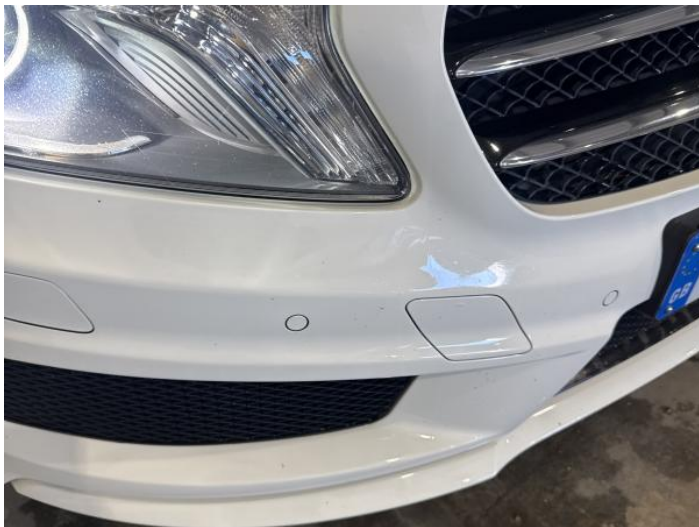
3: Bumper Front  
Chipped  
Multiple Chips

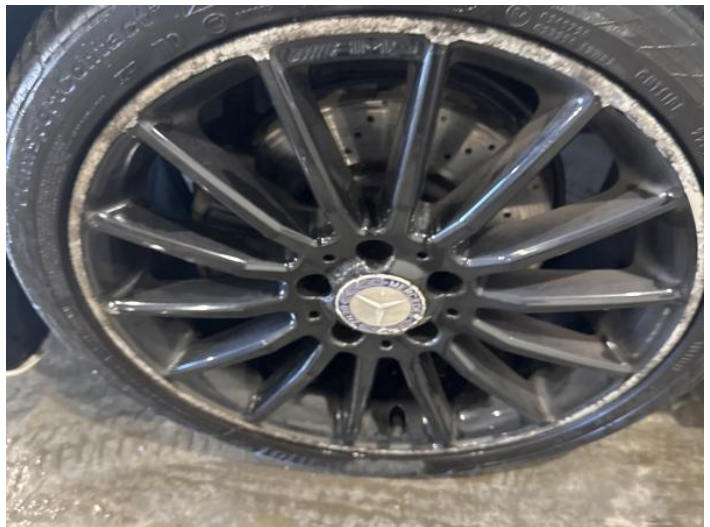
4: Wheel nsf  
Scratched  
Over 50mm

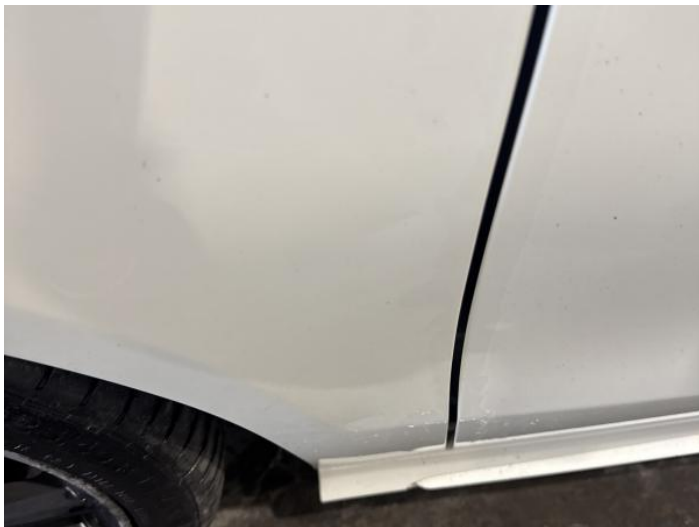
5: Wing nsf  
Dented  
Over 30mm

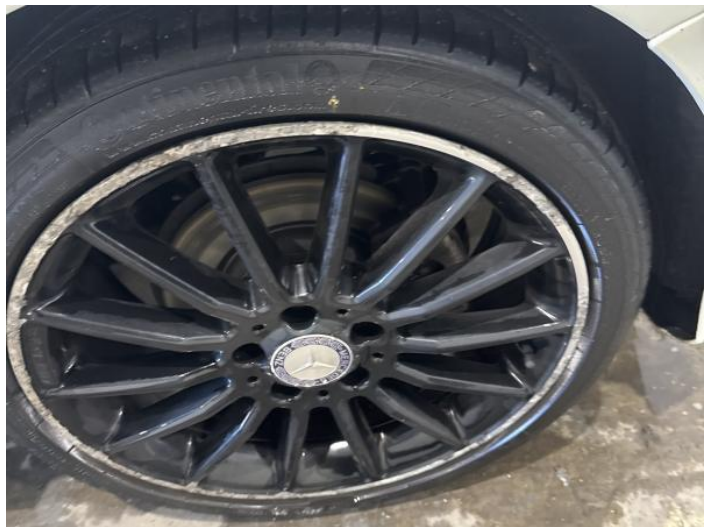
6: Wheel nsr  
Scratched  
Over 50mm

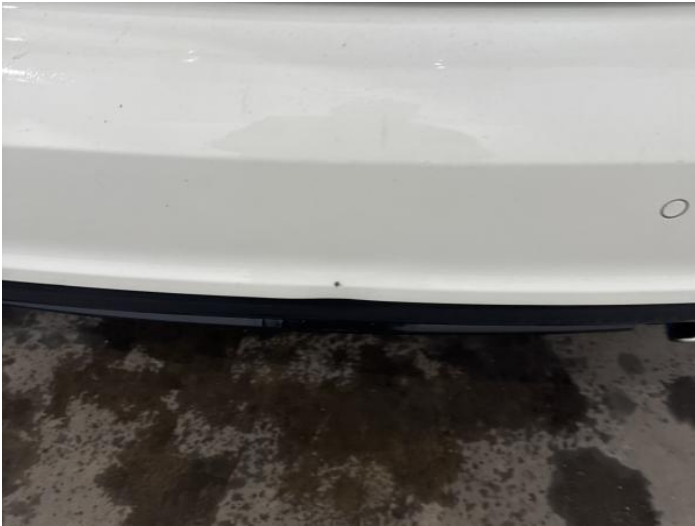
9: Bumper Rear  
Dented  
Over 30mm

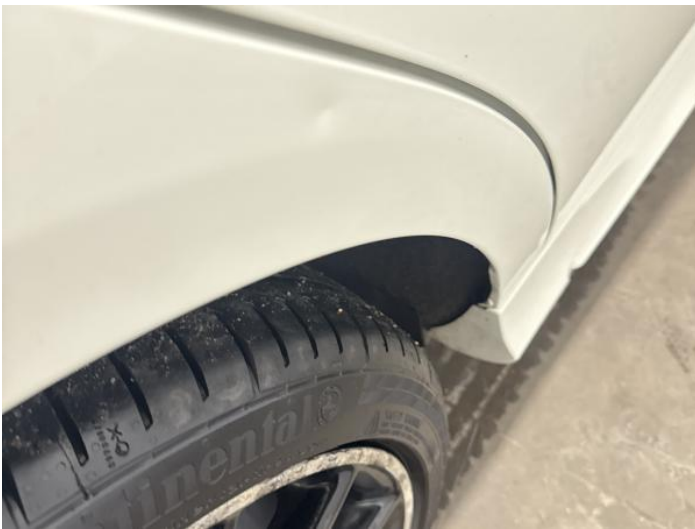
11: Qtr Panel osr  
Dented  
2 Or Less UpTo 10mm

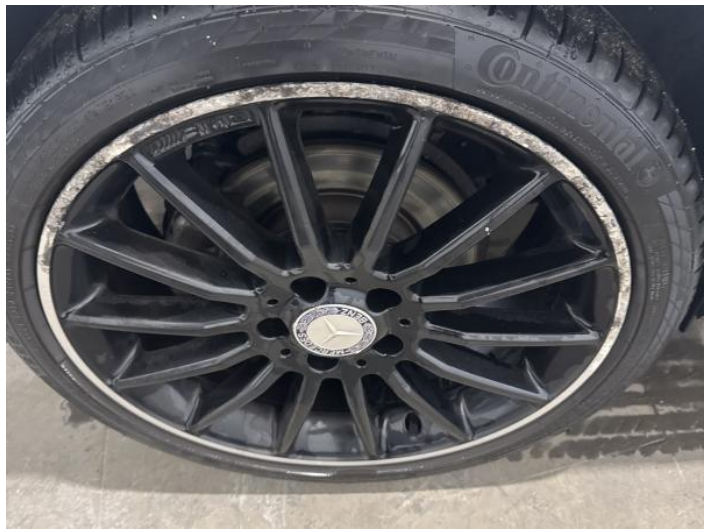
12: Wheel osr  
Scratched  
Over 50mm

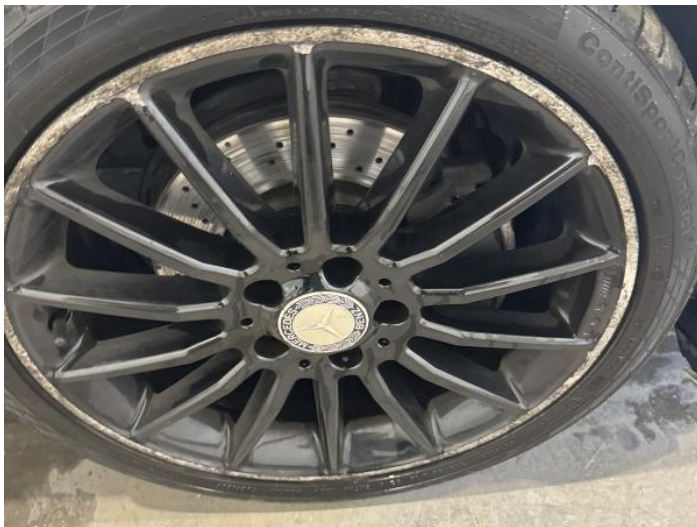
15: Wheel osf  
Scratched  
Over 50mm

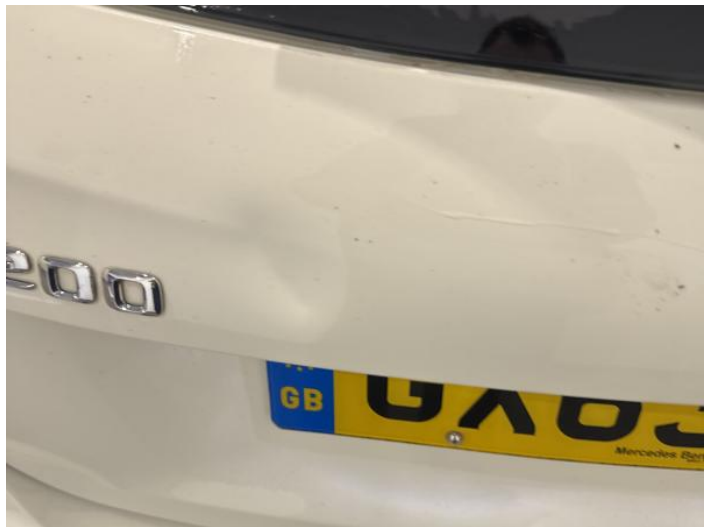
16: Boot Lid  
Dented  
Over 30mm
