# VEHICLE INSPECTION REPORT

**NRZ2153**

## Mercedes-Benz C Class C200d AMG Line 4dr Auto

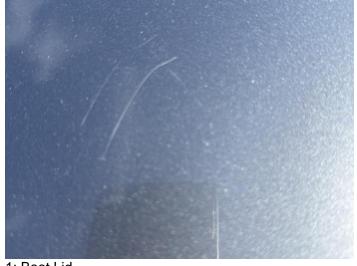
1: Boot Lid Scratched Over 25mm Thru Paint

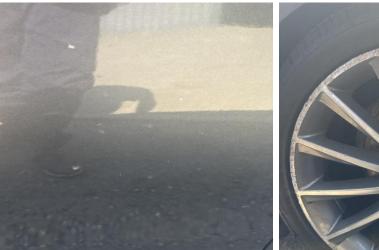
7: Door nsf Chipped 1 To 5

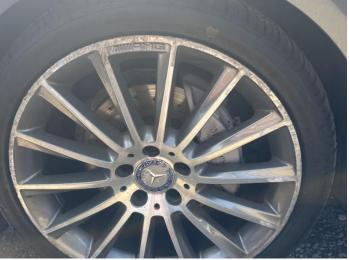
8: Wheel nsf Scratched Over 50mm

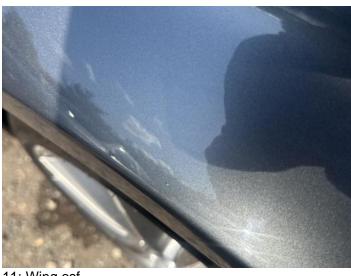
11: Wing osf Chipped 1 To 5

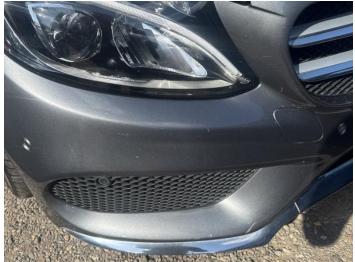
10: Bumper Front Scratched 25 to 100mm Thru Paint

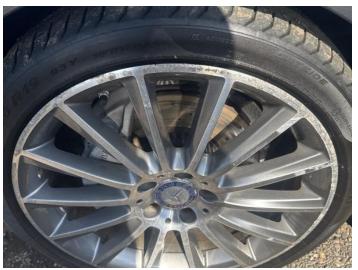
12: Wheel osf Scratched Over 50mm

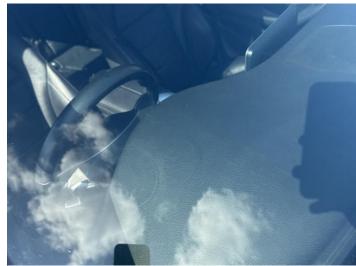
13: Screen Front Chipped UpTo 10mm

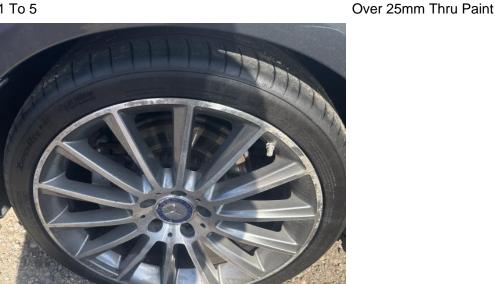
17: Wheel osr Scratched Over 50mm
