VEHICLE INSPECTION REPORT

CN13KJF

Nissan Qashqai 1.6 dCi 360 5dr [Start Stop]

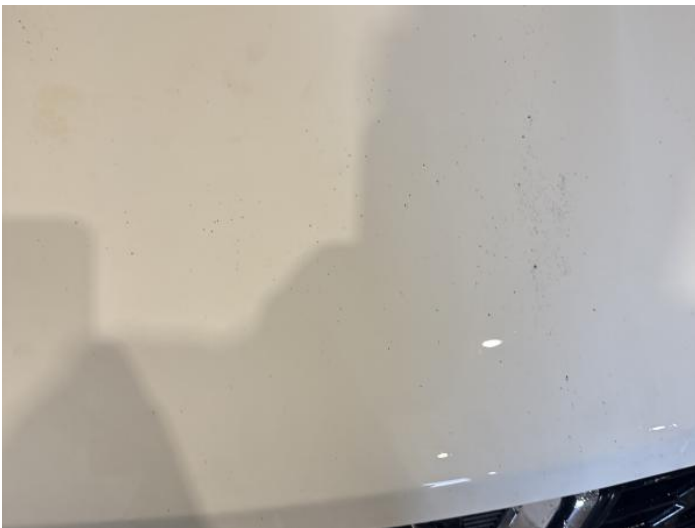
1: Bonnet
Chipped
Multiple Chips

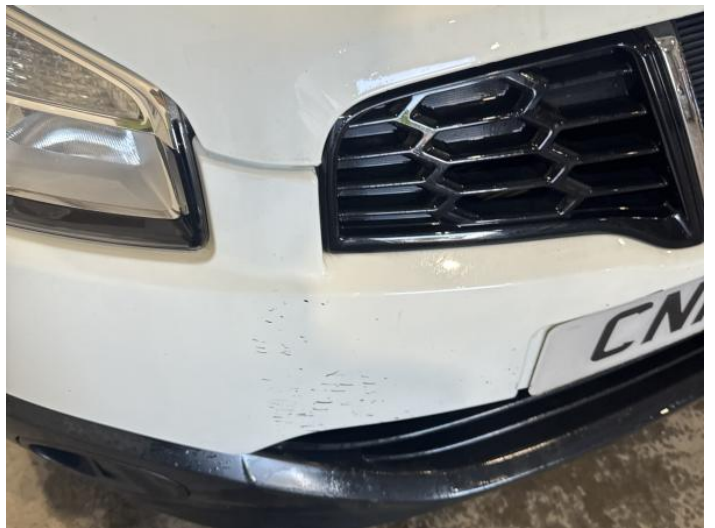
2: Bumper Front
Poor Previous Repair
Poor Paint

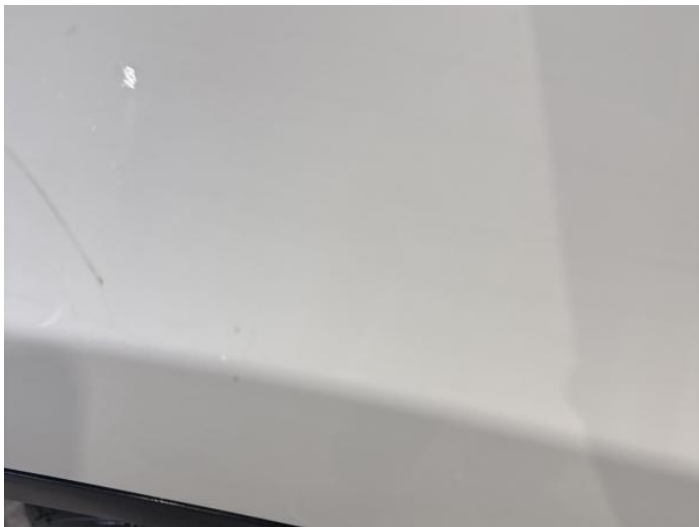
3: Wing nsf
Scratched
Over 25mm Not Thru Paint

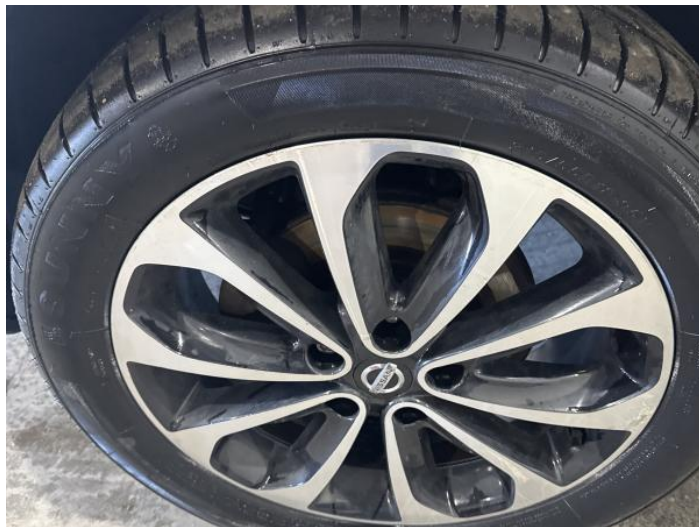
4: Wheel nsf
Scratched
Over 50mm

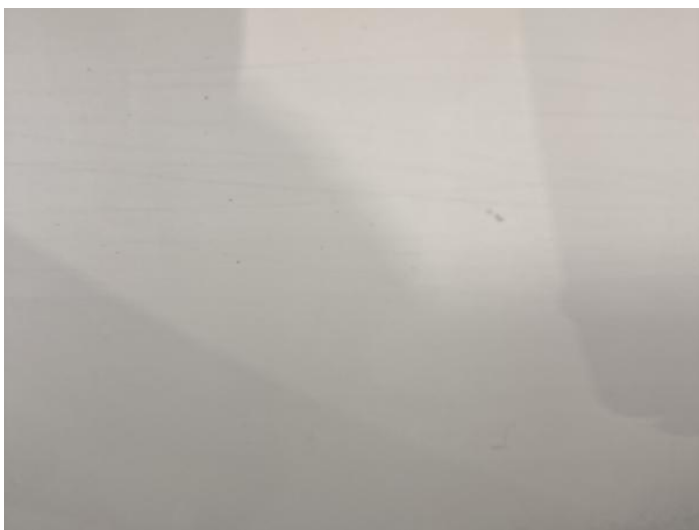
5: Door nsf
Poor Previous Repair
Poor Paint

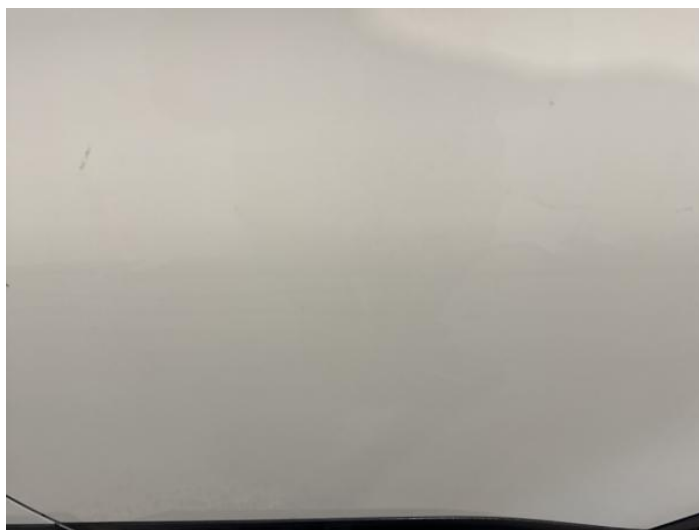
6: Door nsr
Poor Previous Repair
Poor Paint

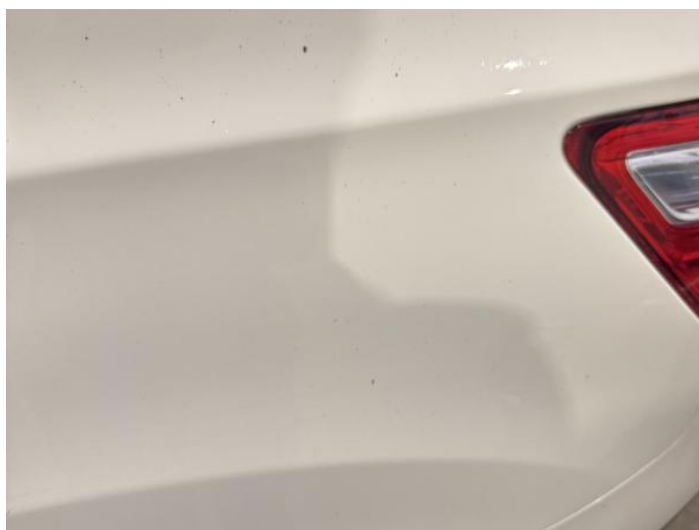
8: Qtr Panel nsr
Poor Previous Repair
Poor Paint

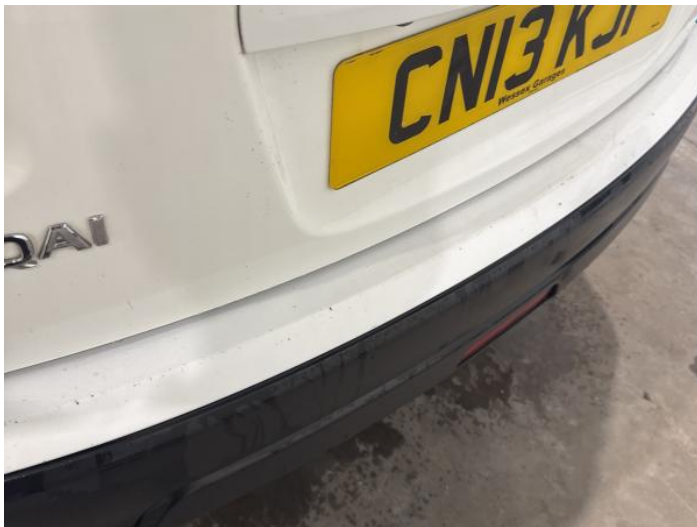
9: Bumper Rear
Poor Previous Repair
Poor Paint

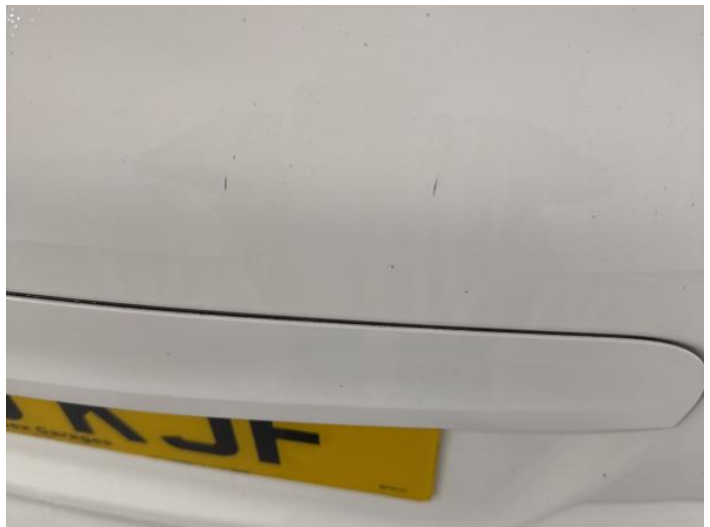
10: Boot Lid
Chipped
Multiple Chips

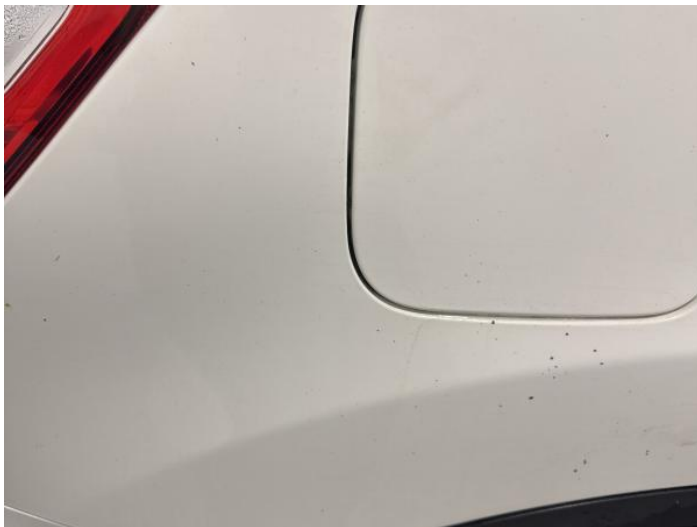
11: Qtr Panel osr
Scratched
Over 25mm Not Thru Paint

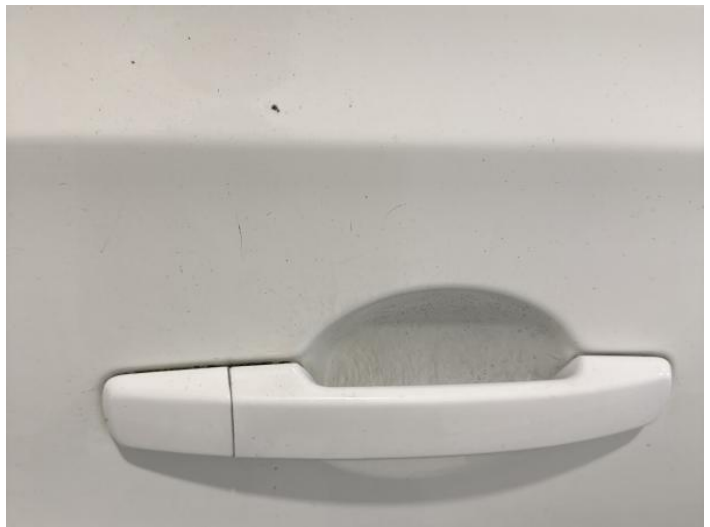
12: Door osr
Chipped
1 To 5

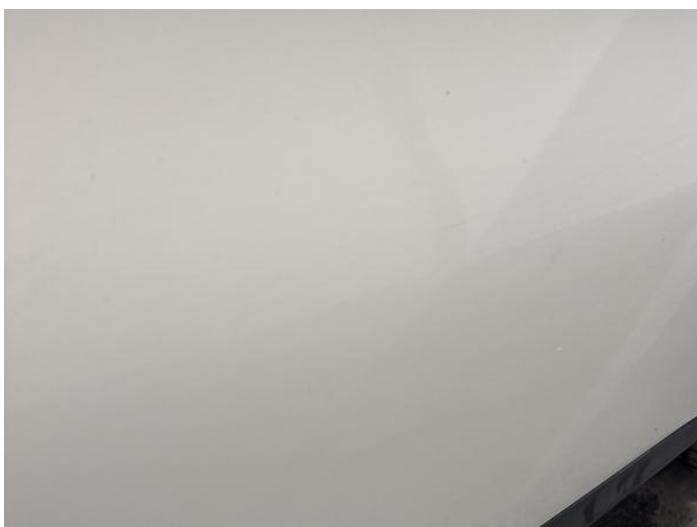
13: Door osf
Poor Previous Repair
Poor Paint

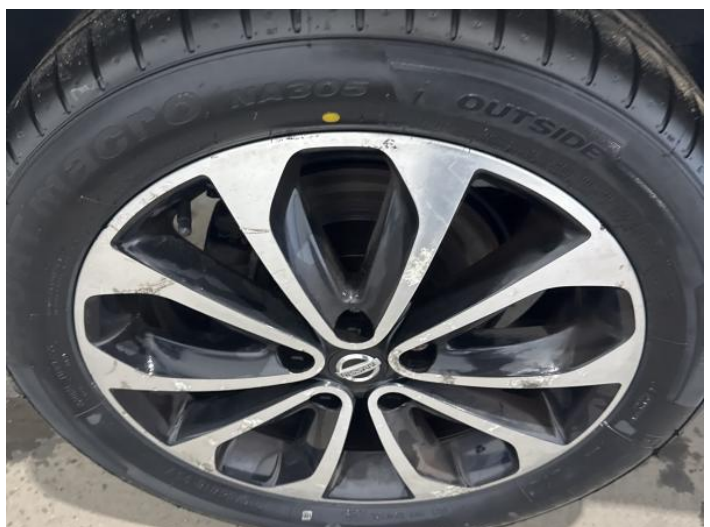
14: Wheel osr
Scratched
Over 50mm

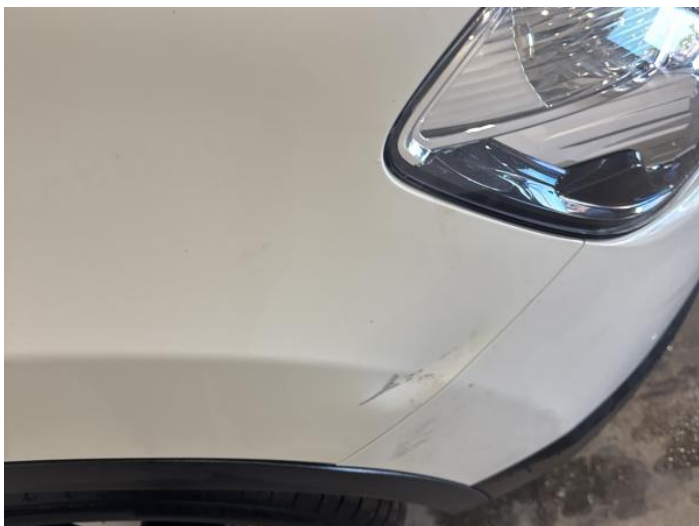
15: Wing of
Dented
With Paint Damage

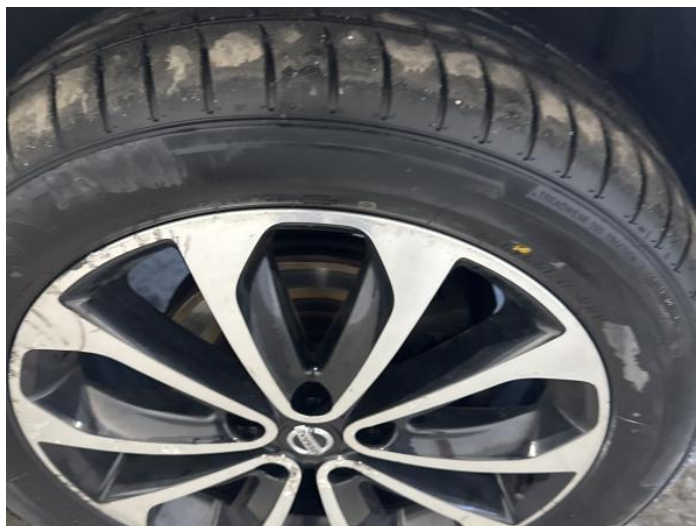
16: Wheel of
Scratched
Over 50mm
