## **VEHICLE INSPECTION REPORT**

## Skoda Octavia 1.6 TDI CR SE 5dr DSG

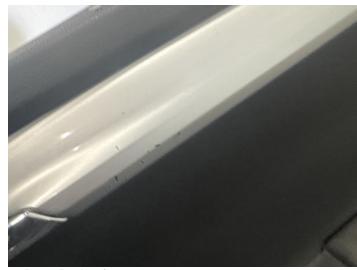
1: Door Pad osf Scuffed UpTo 25mm

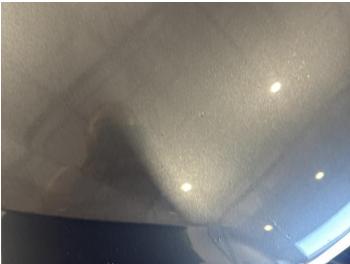
2: Bonnet Chipped 1 To 5

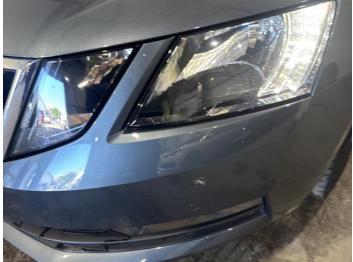
3: Bumper Front Chipped Multiple Chips

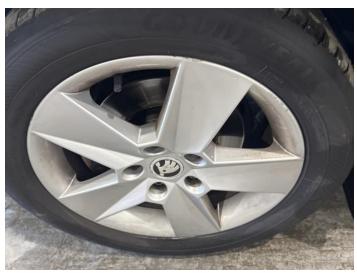
4: Wheel nsf Scratched Over 50mm

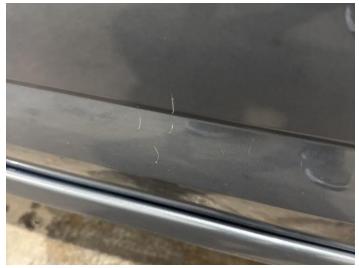
5: Door nsr Scratched Over 25mm Thru Paint

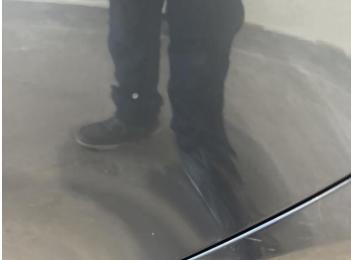
6: Door nsr Chipped 1 To 5

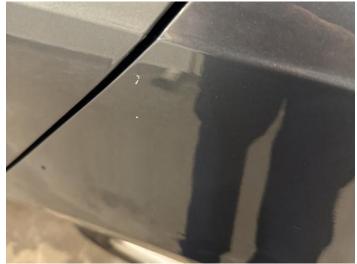
7: Qtr Panel nsr Chipped 1 To 5

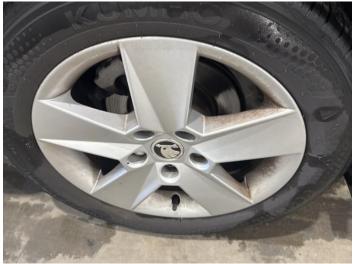
8: Wheel nsr Corroded Light

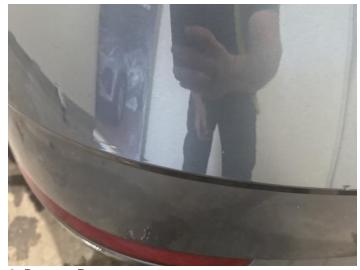
9: Bumper Rear Scratched 25 to 100mm Thru Paint

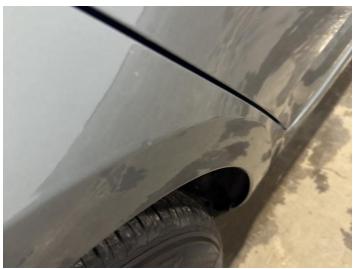
10: Qtr Panel osr Dented Between 10mm + 30mm

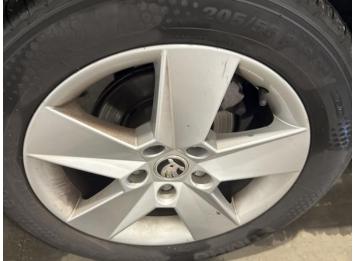
11: Wheel osr Scratched Over 50mm

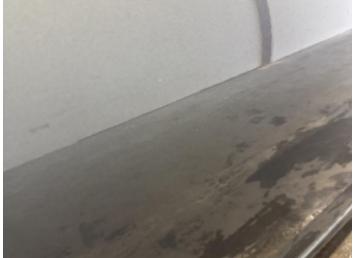
12: Door osr Chipped 1 To 5

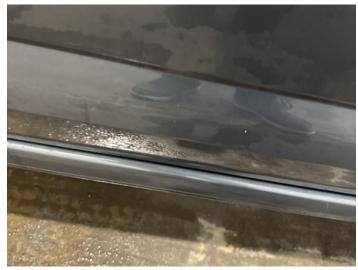
13: Door osf Dented Over 2 UpTo 10mm

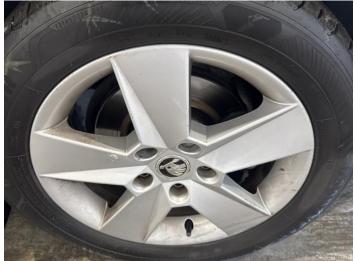
14: Wheel osf Corroded Light

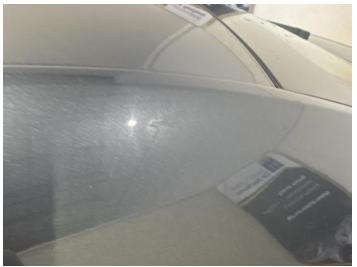
### 15: D Post ns Dented Over 2 UpTo 10mm
