VEHICLE INSPECTION REPORT

GY72VLG

Dacia Duster 1.0 TCe 90 Comfort 5dr

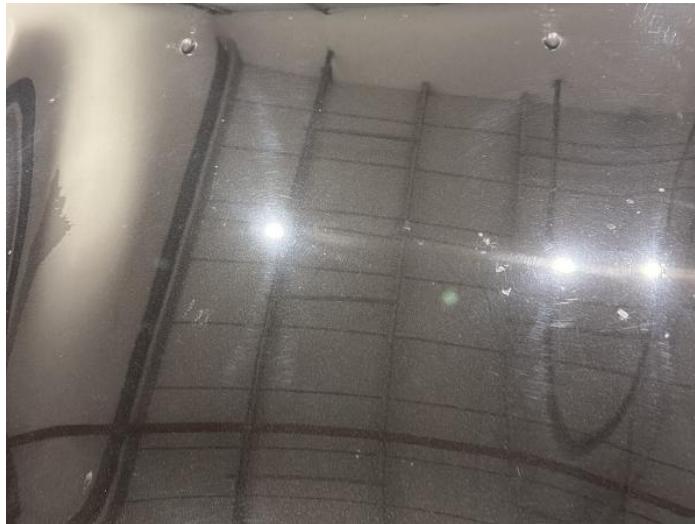
1: Bonnet
Chipped
Multiple Chips

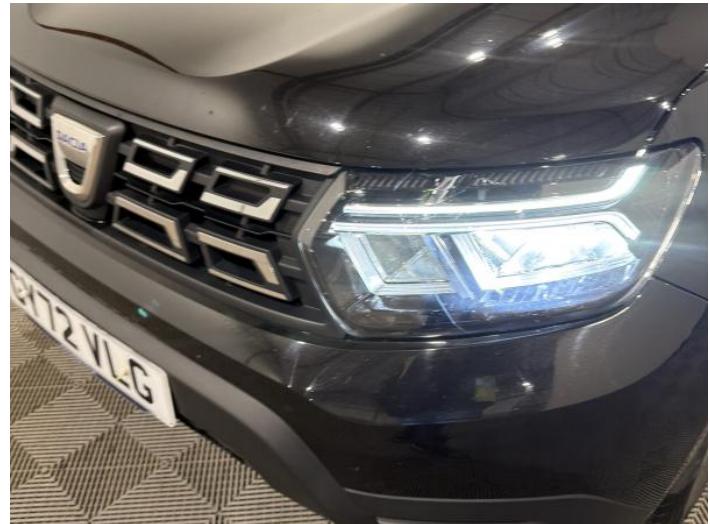
2: Bumper Front
Chipped
Multiple Chips

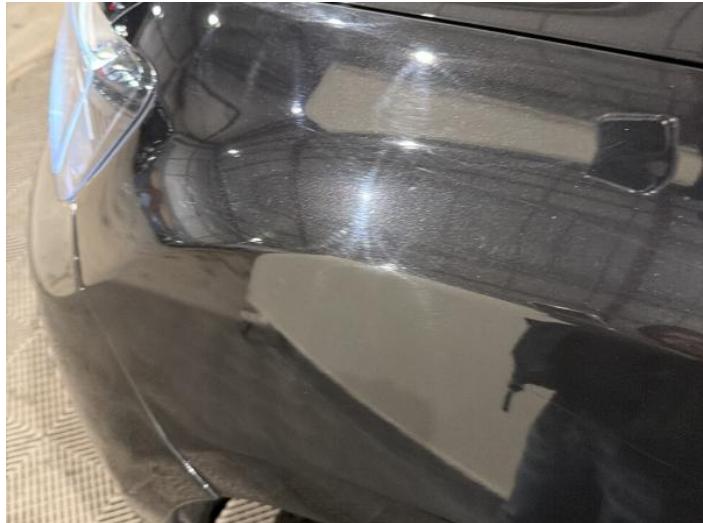
3: Bumper Front
Scratched
Over 25mm Not Thru Paint

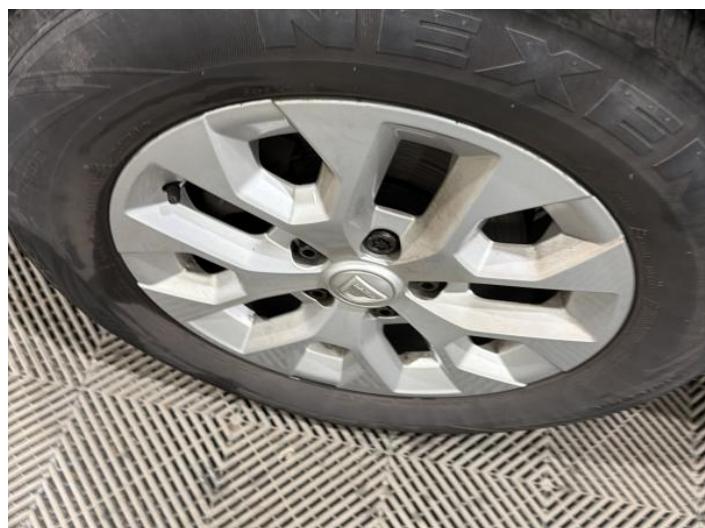
5: Wheel nsf
Scratched
Up To 50mm

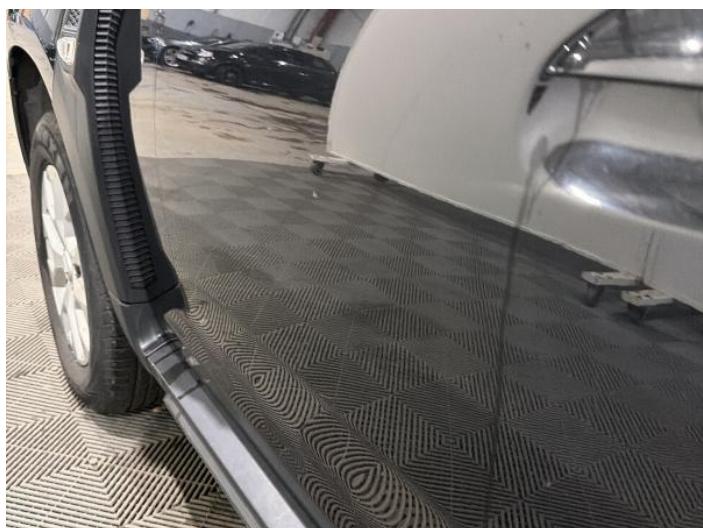
6: Door nsf
Chipped
1 To 5

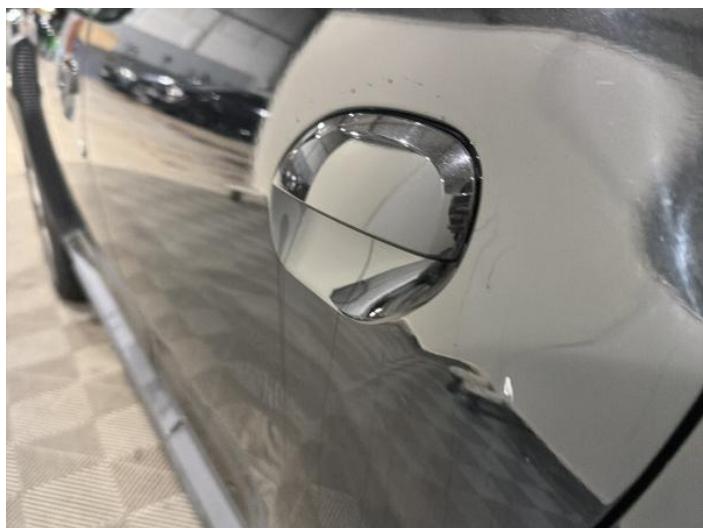
7: Door nsf
Scratched
Over 25mm Not Thru Paint

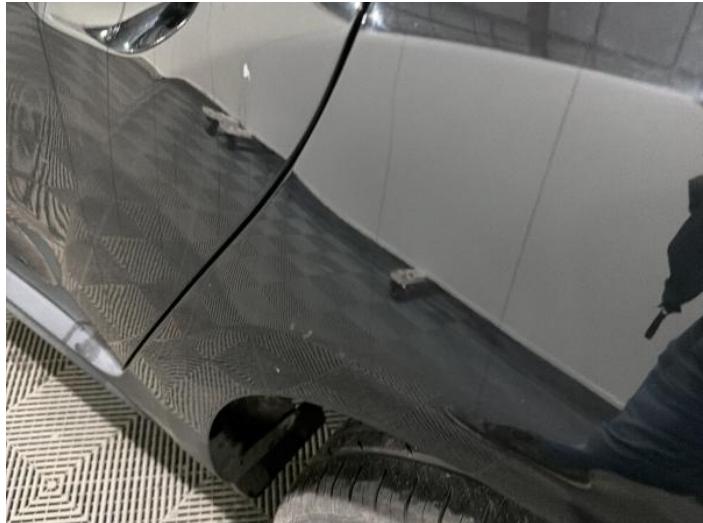
10: Qtr Panel nsr
Dented
With Paint Damage

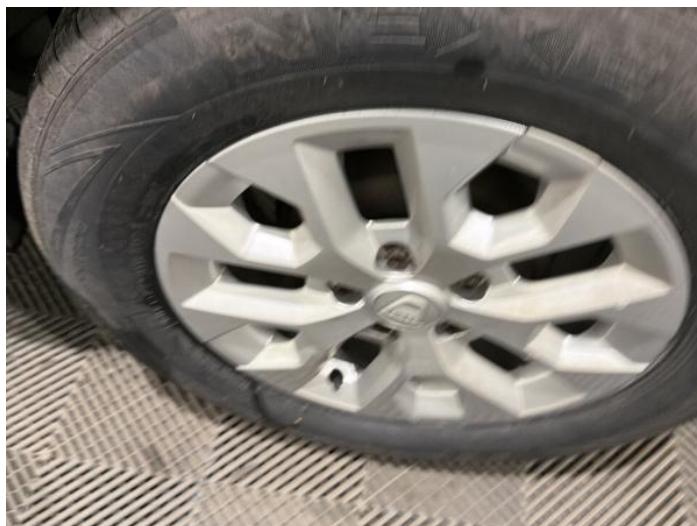
11: Wheel nsr
Scratched
Up To 50mm

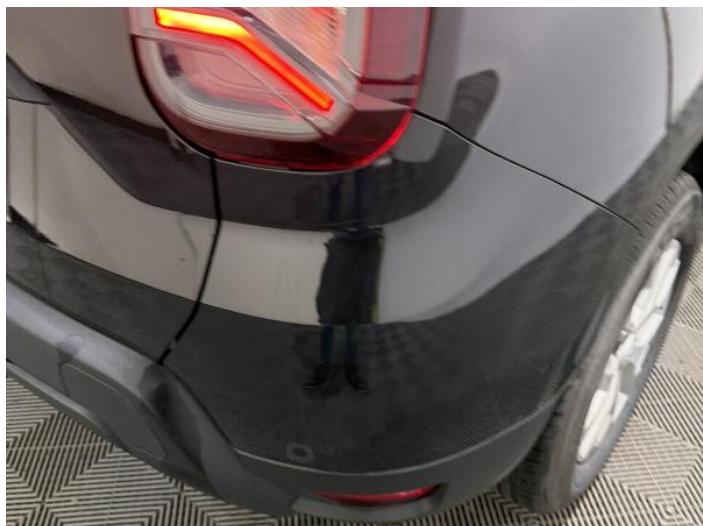
12: Bumper Rear
Chipped
Multiple Chips

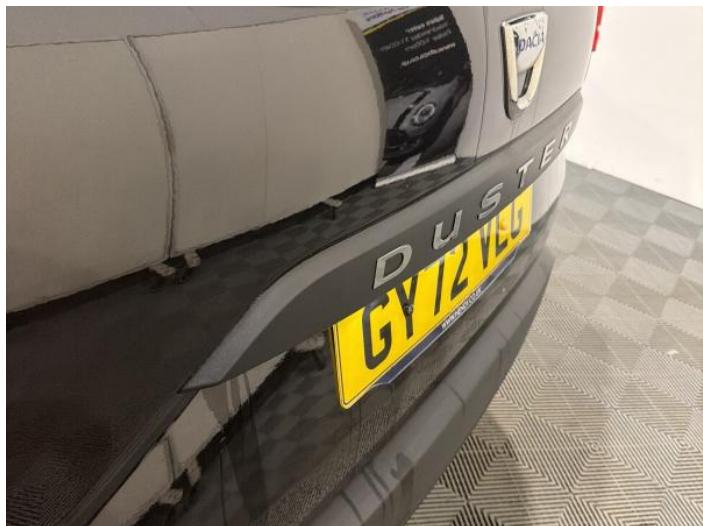
13: Bumper Rear
Scratched
Over 25mm Not Thru Paint

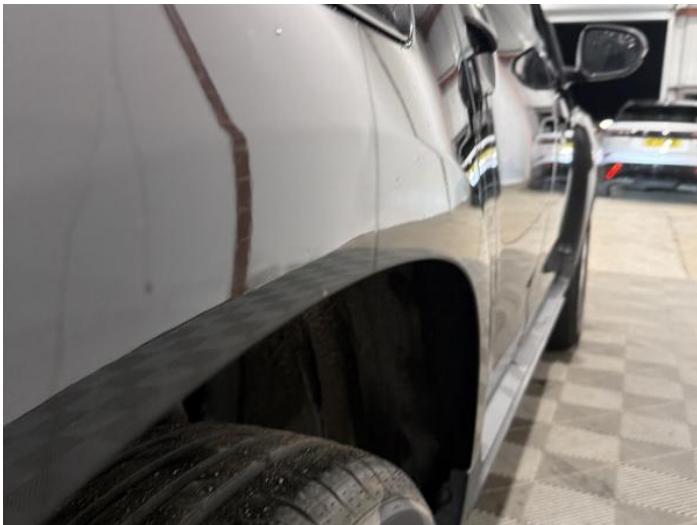
15: Qtr Panel osr
Dented
Between 10mm + 30mm

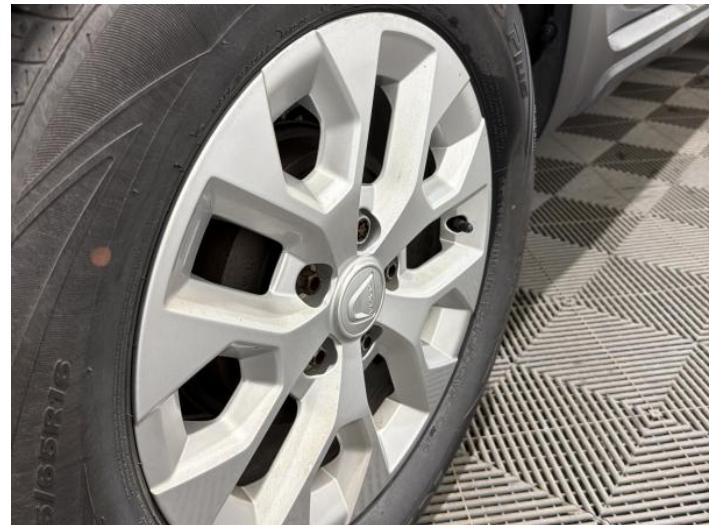
16: Wheel osr
Scratched
Up To 50mm

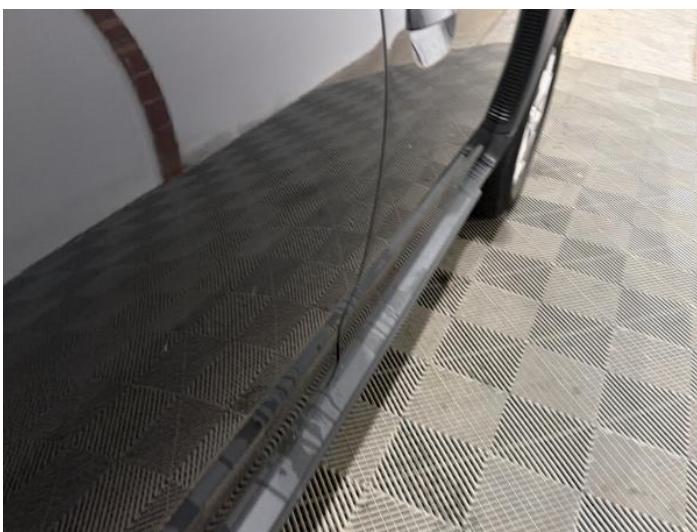
17: Door osr
Dented
Over 2 UpTo 10mm

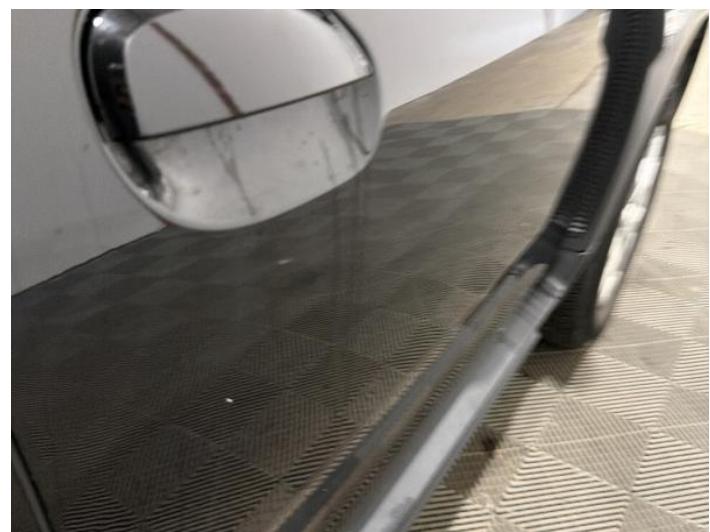
18: Door osf
Dented
Over 30mm

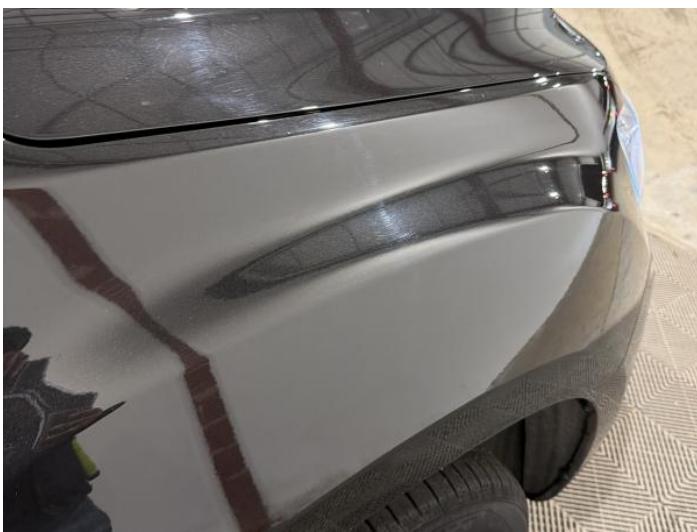
19: Wing osf
Chipped
1 To 5

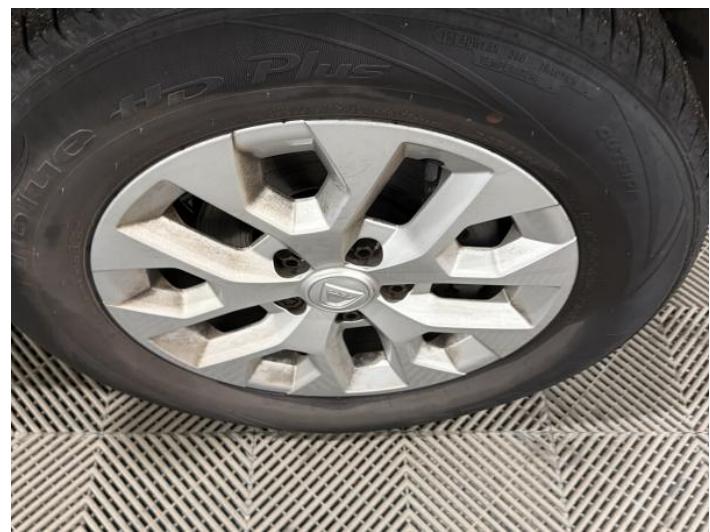
20: Wheel osf
Scratched
Up To 50mm
