VEHICLE INSPECTION REPORT

PX63FHB

Ford C-Max 1.6 Zetec 5dr

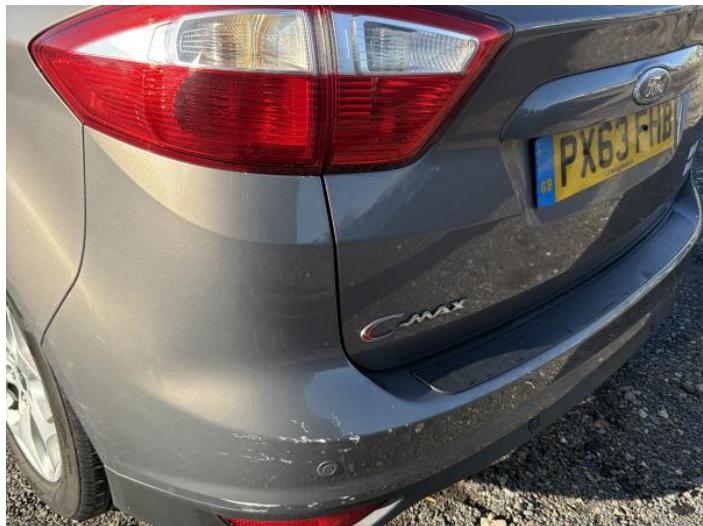
1: Bumper Rear
Dented
With Paint Damage

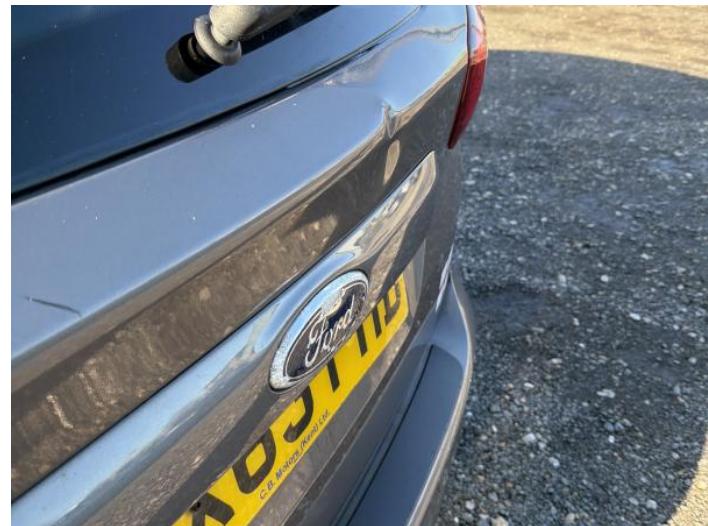
2: Boot Lid
Dented
With Paint Damage

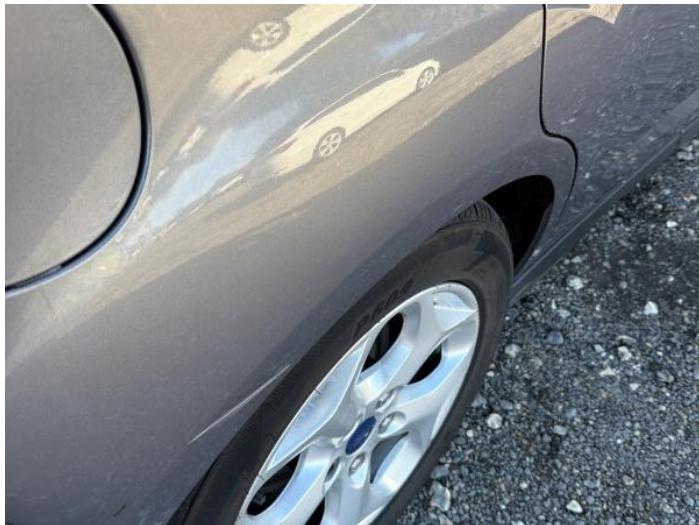
3: Qtr Panel osr
Dented
With Paint Damage

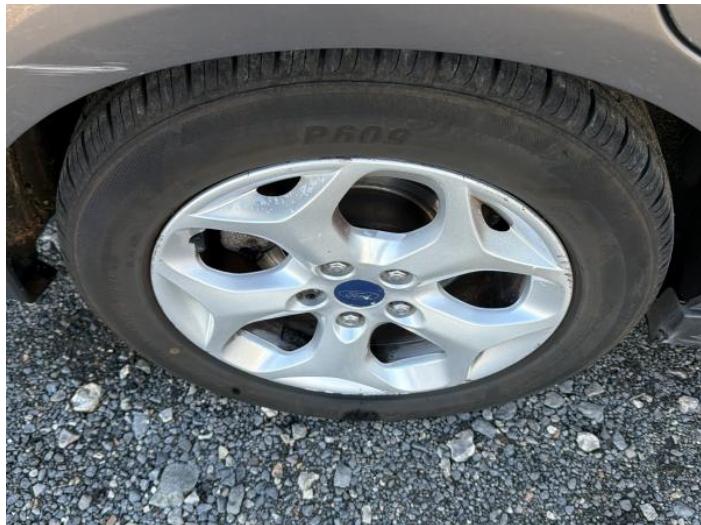
4: Wheel osr
Scratched
Over 50mm

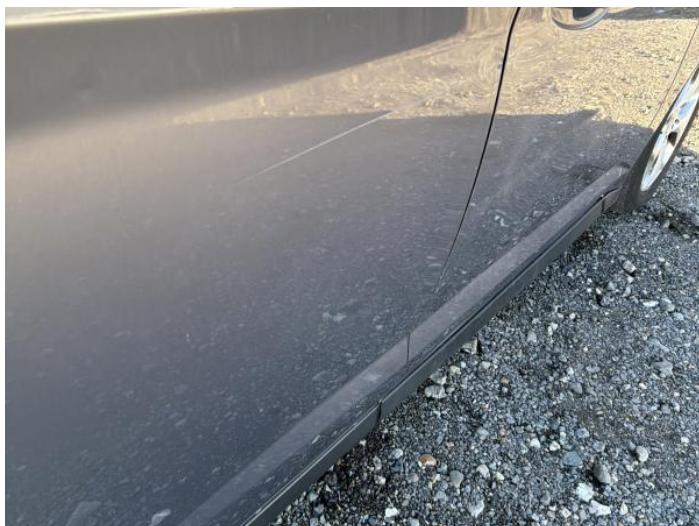
5: Door osr
Dented
With Paint Damage

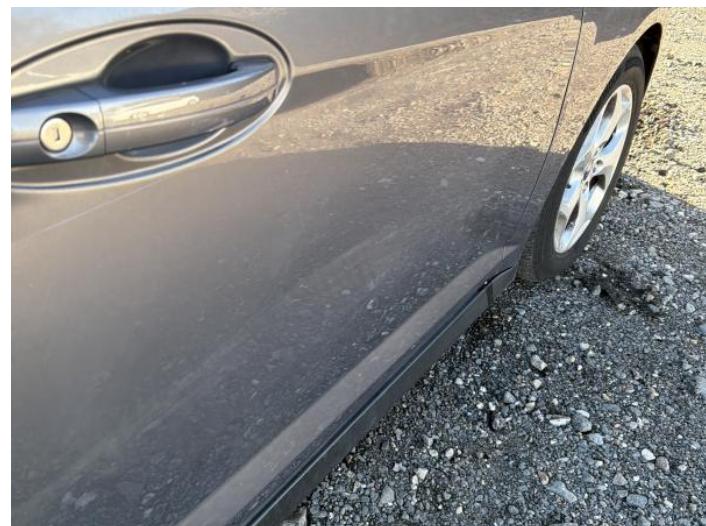
6: Door osf
Dented
With Paint Damage

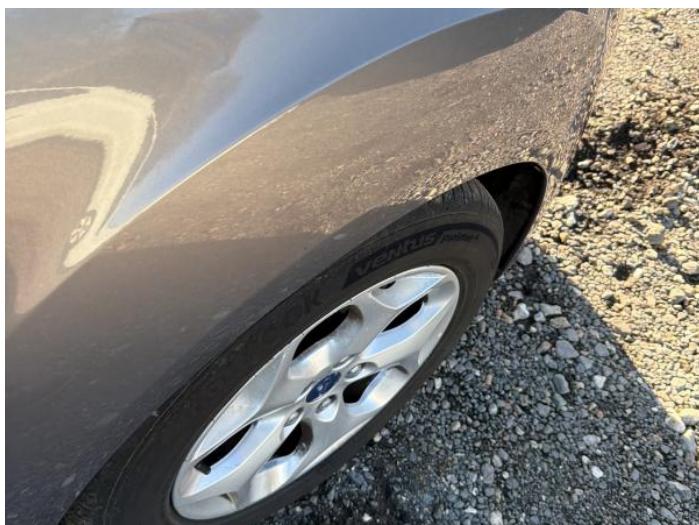
7: Wing osf
Dented
Over 30mm

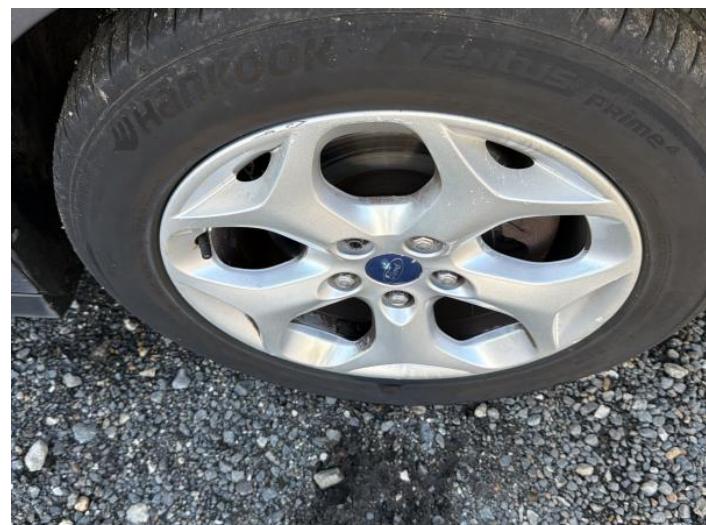
8: Wheel osf
Scratched
Over 50mm

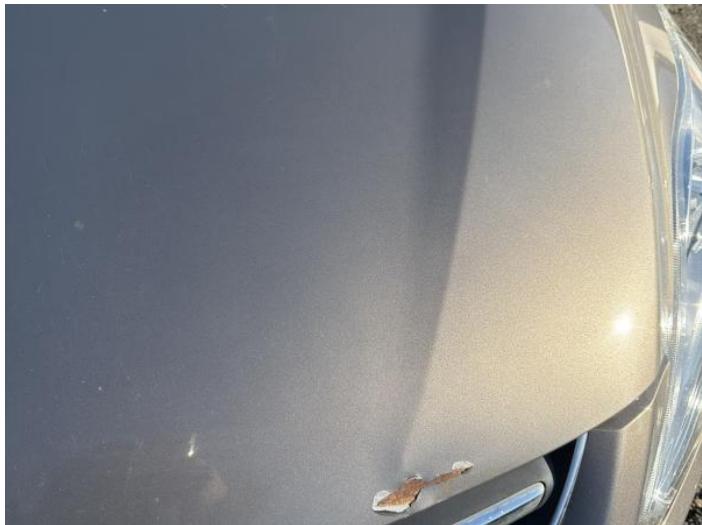
9: Bonnet
Dented
With Paint Damage

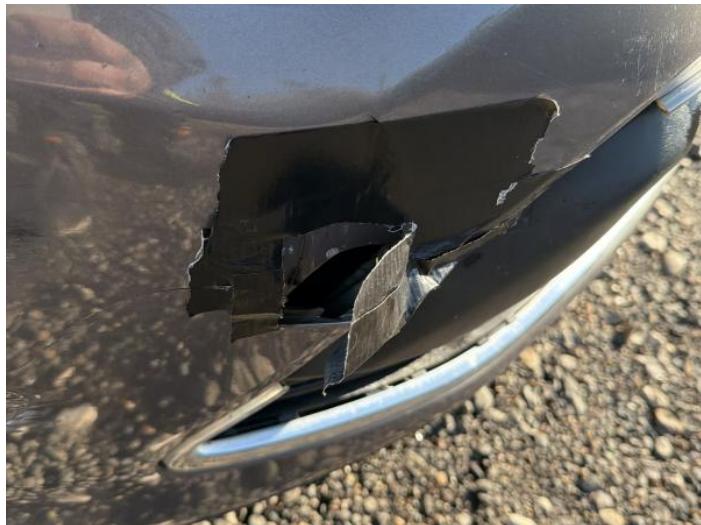
10: Bumper Front
Cracked
Over 25mm

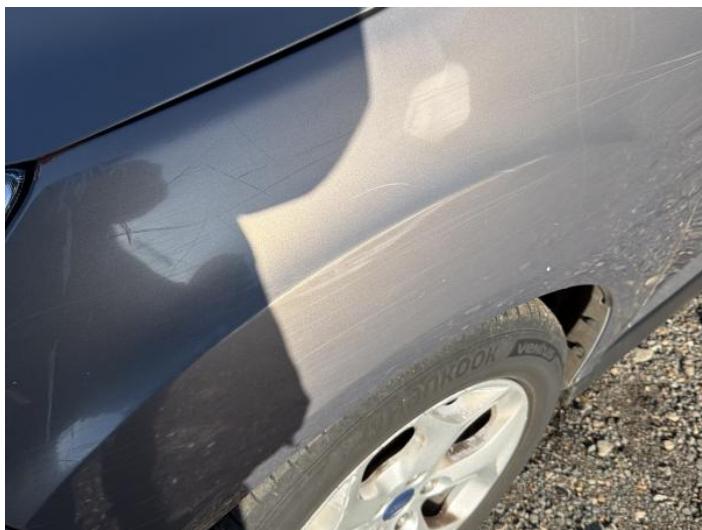
11: Wing nsf
Dented
With Paint Damage

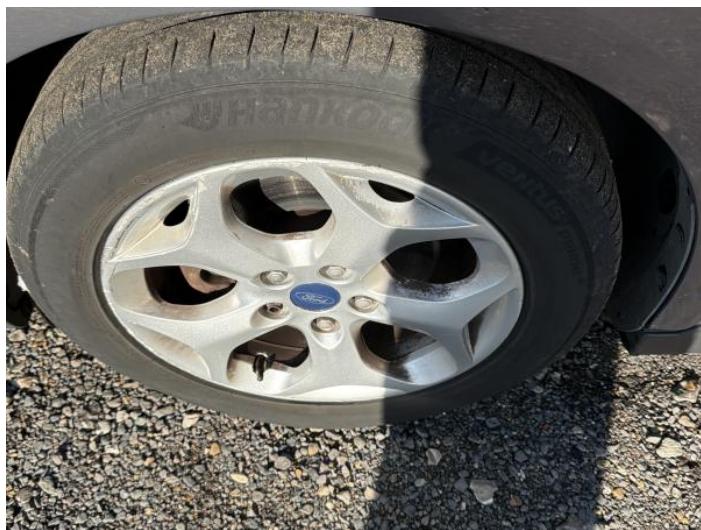
12: Wheel nsf
Scratched
Over 50mm

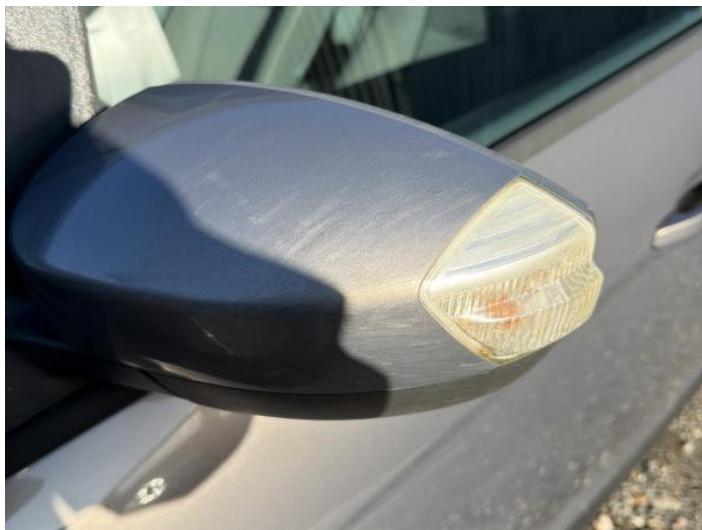
13: Door Mirror Assy nsf
Scratched (Painted)
Over 25mm Thru Paint

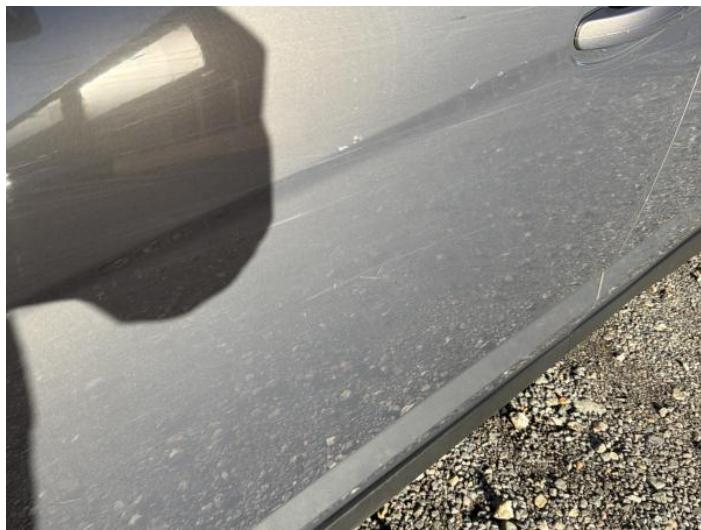
14: Door nsf
Chipped
Multiple Chips

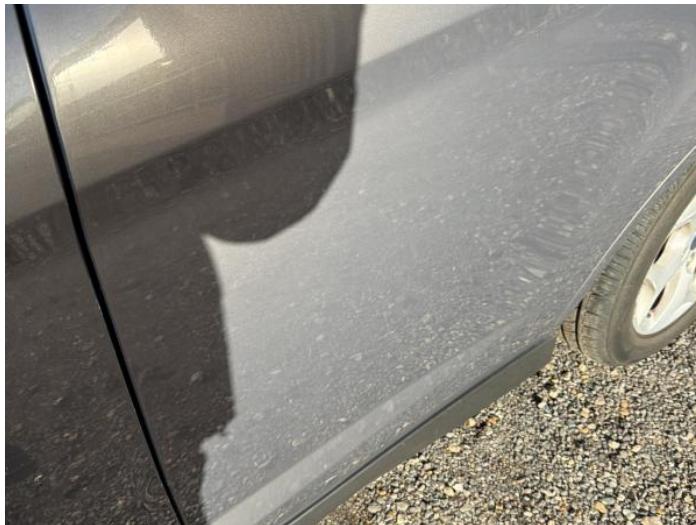
15: Door nsr
Dented
With Paint Damage

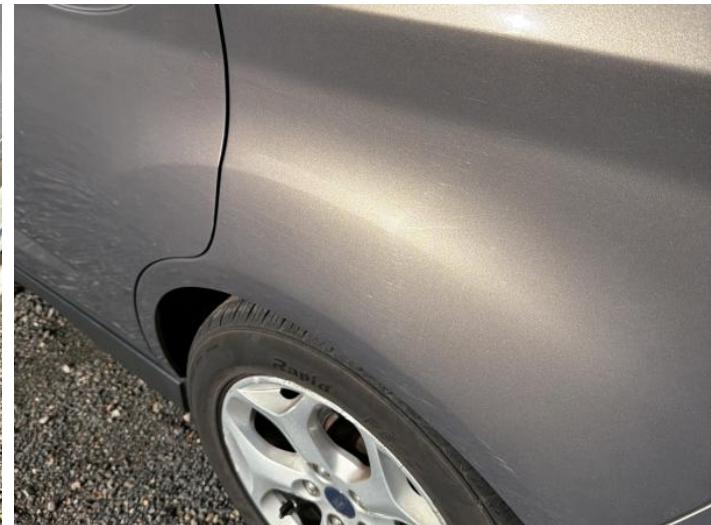
16: Qtr Panel nsr
Dented
With Paint Damage

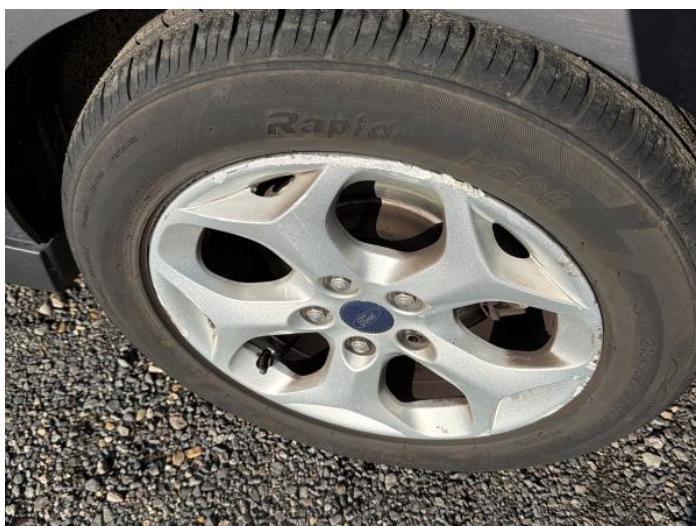
17: Wheel nsr
Scratched
Over 50mm

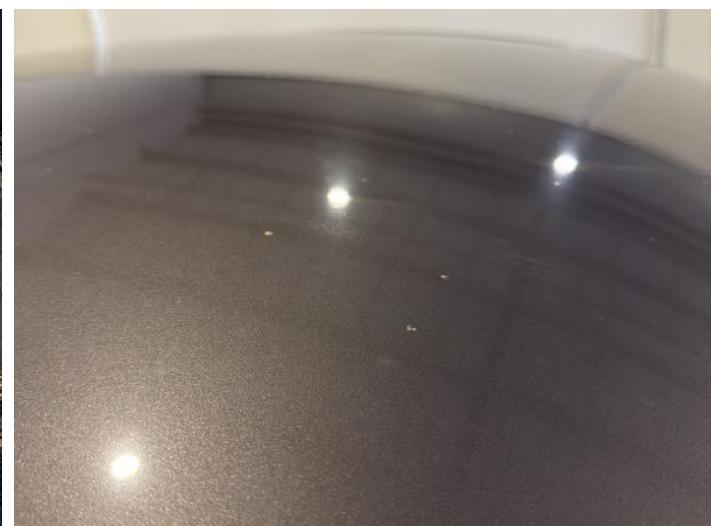
18: Roof
Dented
Between 10mm + 30mm
