VEHICLE INSPECTION REPORT

NC58ZYG

NISSAN X-TRAIL 2.0 dCi Aventura Explorer 5dr Auto

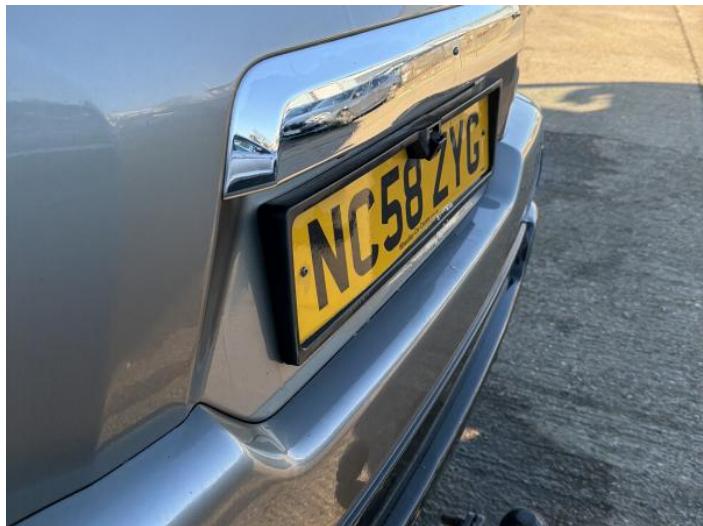
1: Boot Lid
Dented
Over 2 UpTo 10mm

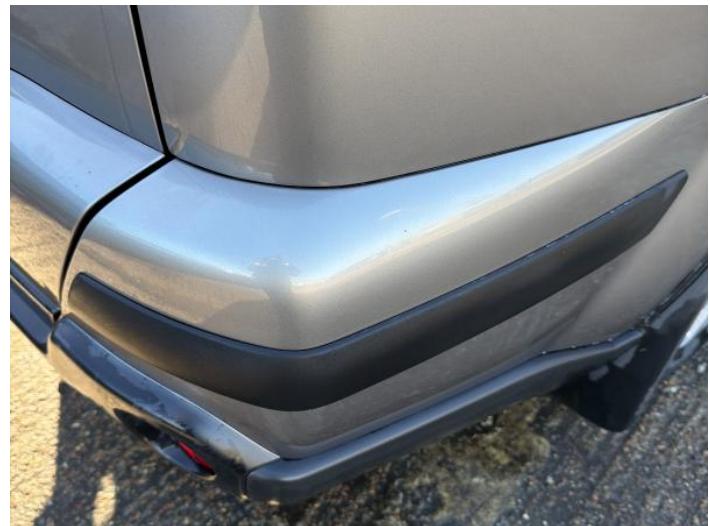
2: Bumper Rear
Chipped
Multiple Chips

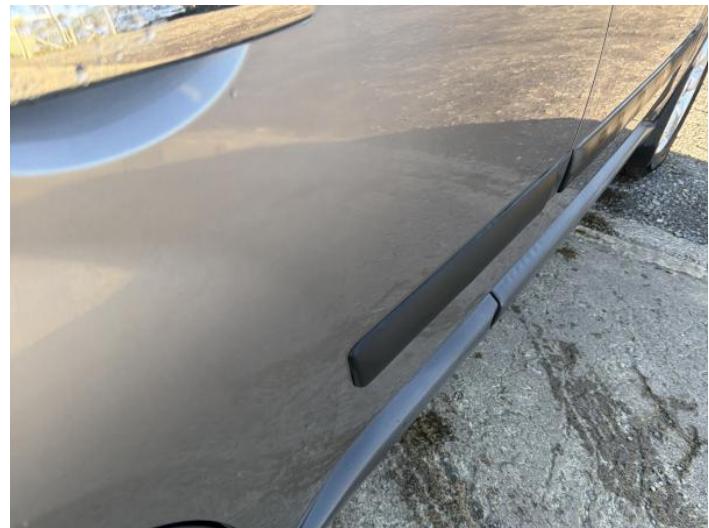
4: Qtr Panel osr
Dented
2 Or Less UpTo 10mm

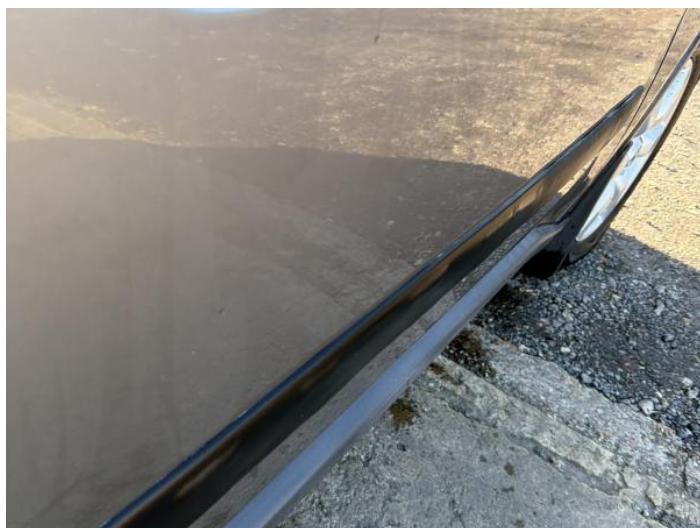
6: Door osr
Chipped
Multiple Chips

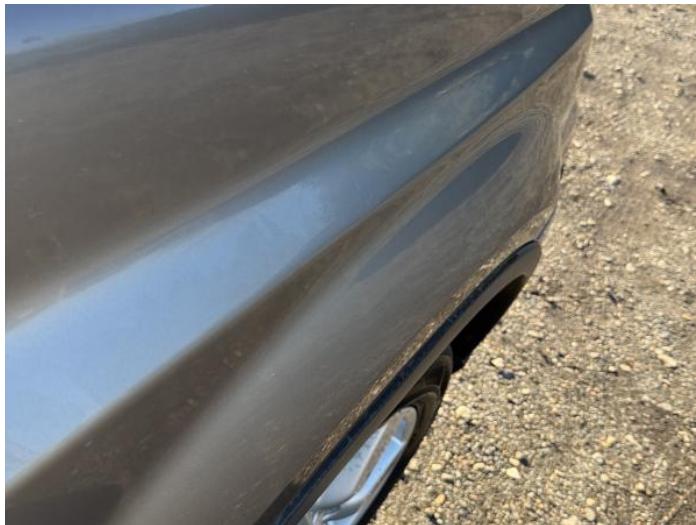
8: Door osf
Scratched
Over 25mm Not Thru Paint

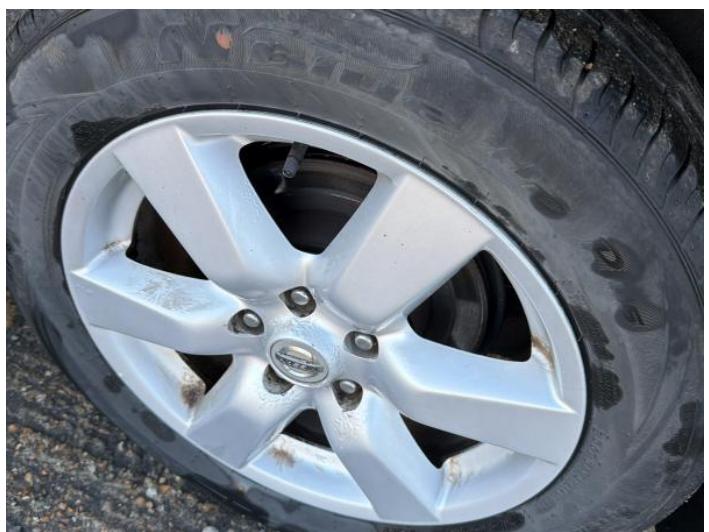
11: Wheel osf
Scratched
Over 50mm

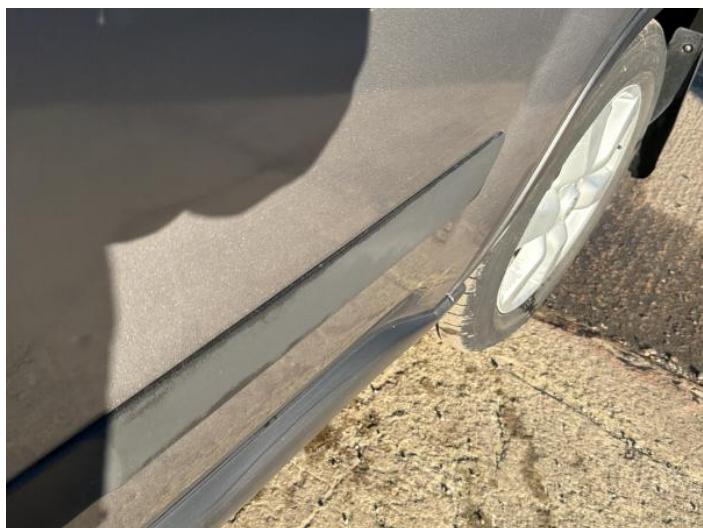
19: Door nsf
Scratched
Over 25mm Not Thru Paint
