VEHICLE INSPECTION REPORT

HN62YDY

Ford Focus 1.6 125 Zetec 5dr Powershift

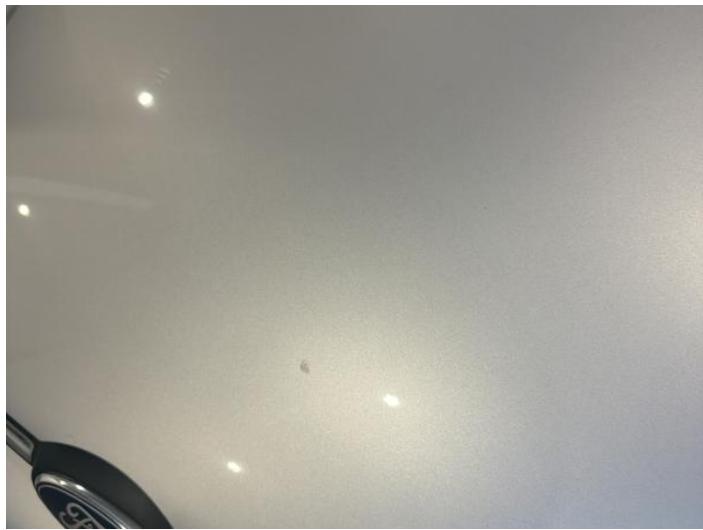
1: Bonnet
Chipped
1 To 5

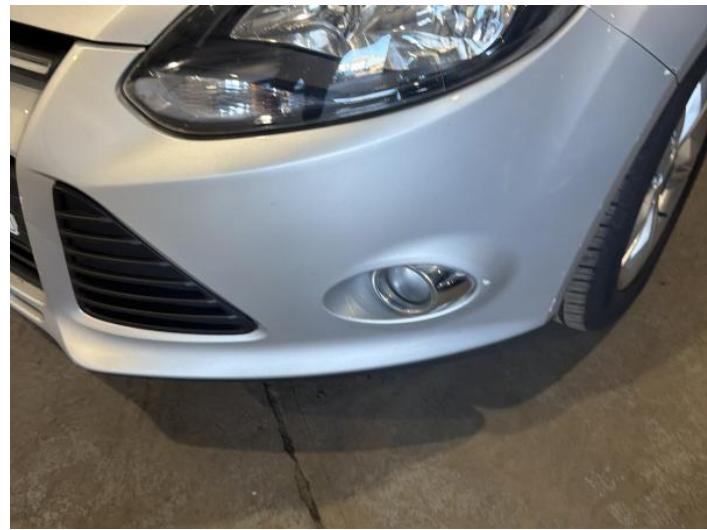
2: Bumper Front
Scratched
Over 100mm Thru Paint

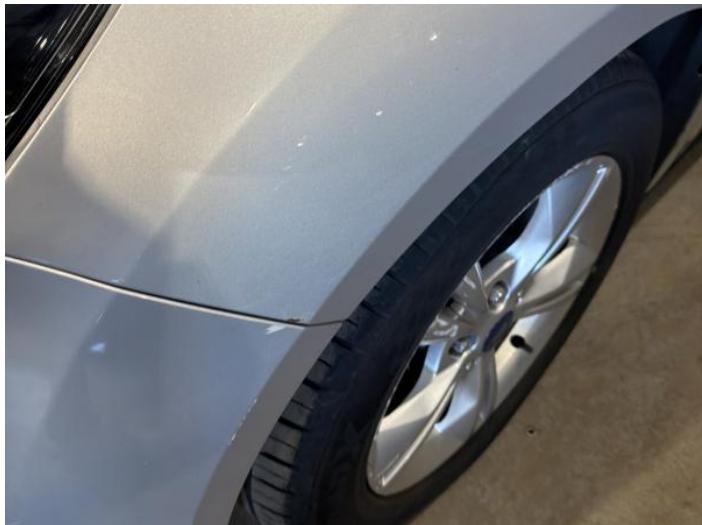
3: Wing nsf
Chipped
Multiple Chips

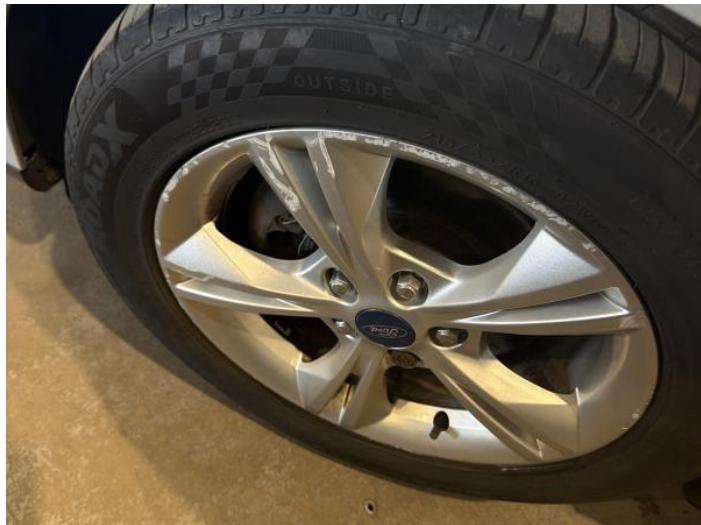
4: Wheel nsf
Scratched
Over 50mm

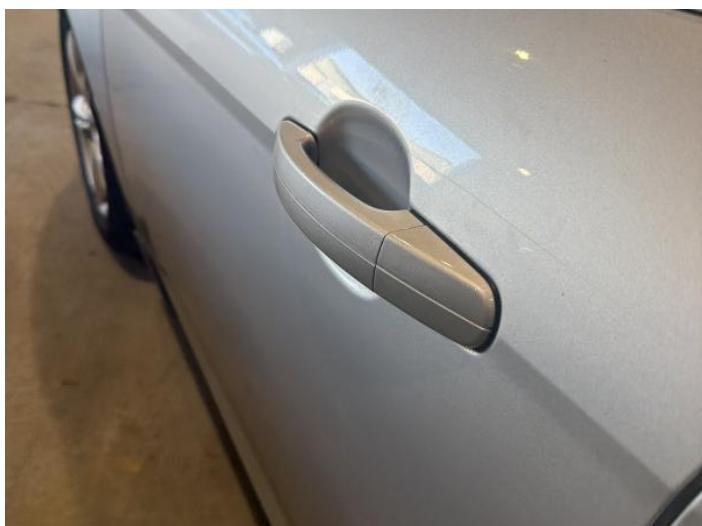
5: Door nsf
Dented
Over 2 UpTo 10mm

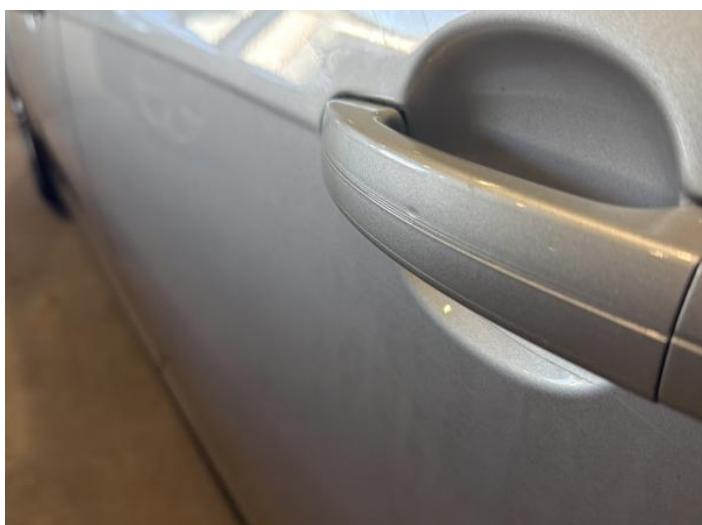
7: Door nsr
Dented
Over 30mm

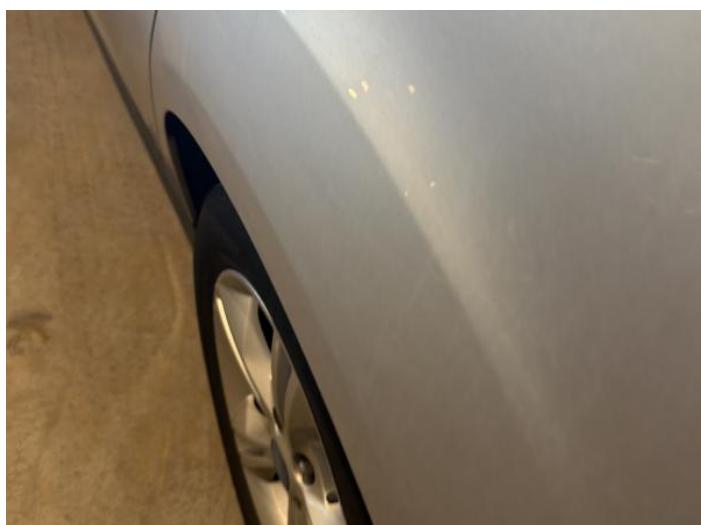
8: Qtr Panel nsr
Dented
Over 2 UpTo 10mm

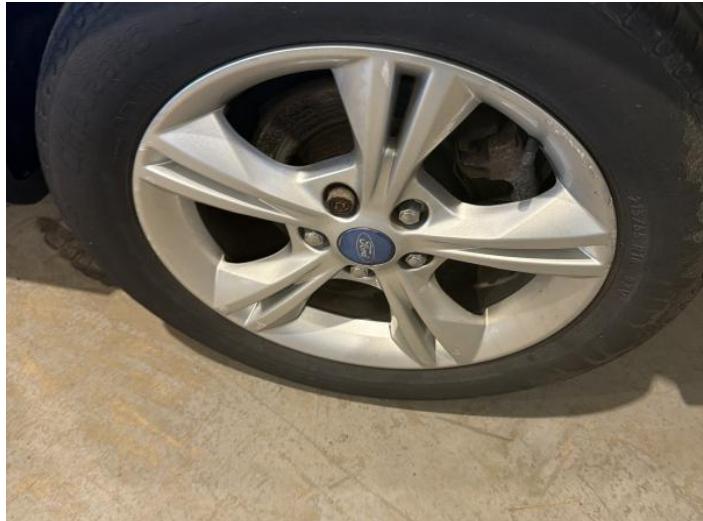
10: Wheel nsr
Scratched
Over 50mm

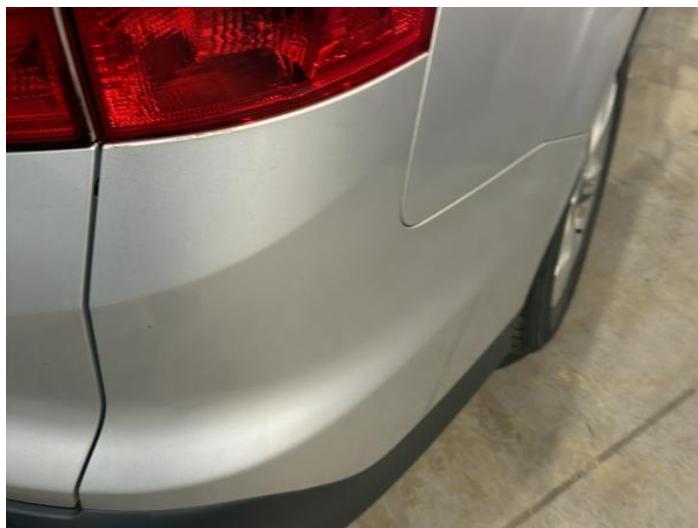
11: Bumper Rear
Scratched
25 to 100mm Thru Paint

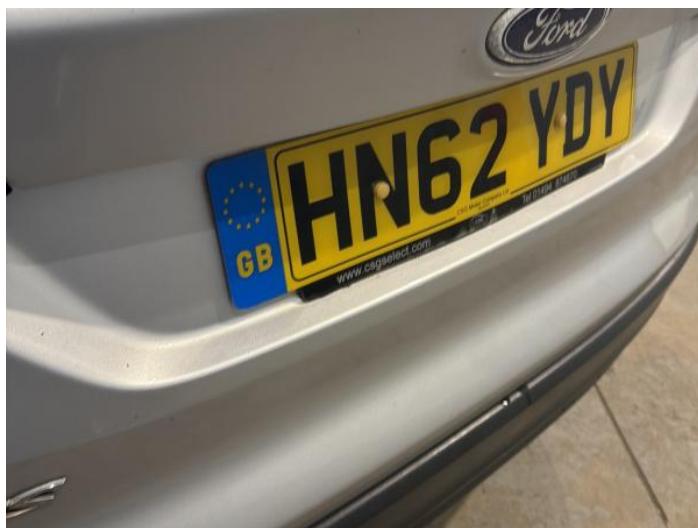
13: Boot Lid
Chipped
1 To 5

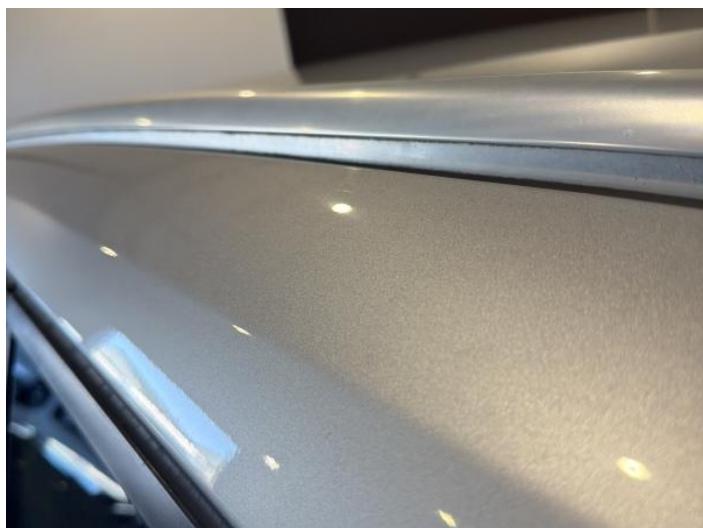
14: D Post ns
Dented
Over 2 UpTo 10mm

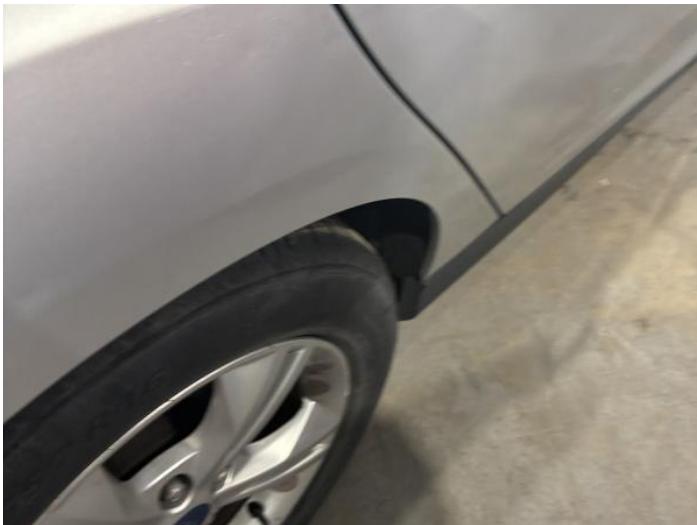
15: Qtr Panel osr
Chipped
1 To 5

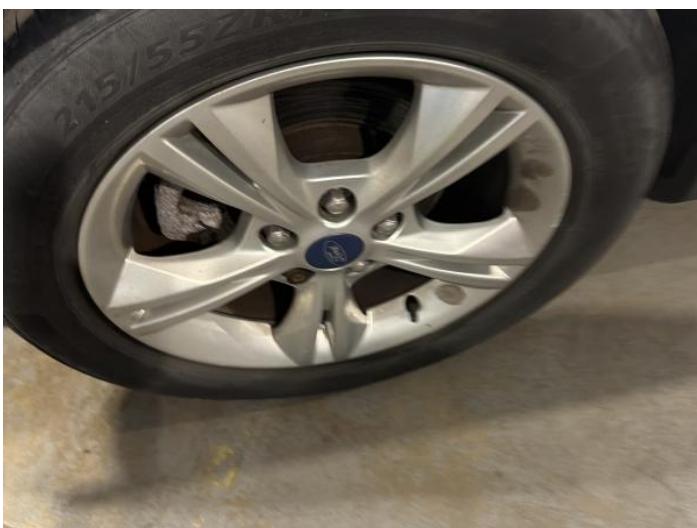
17: Wheel osr
Scratched
Over 50mm

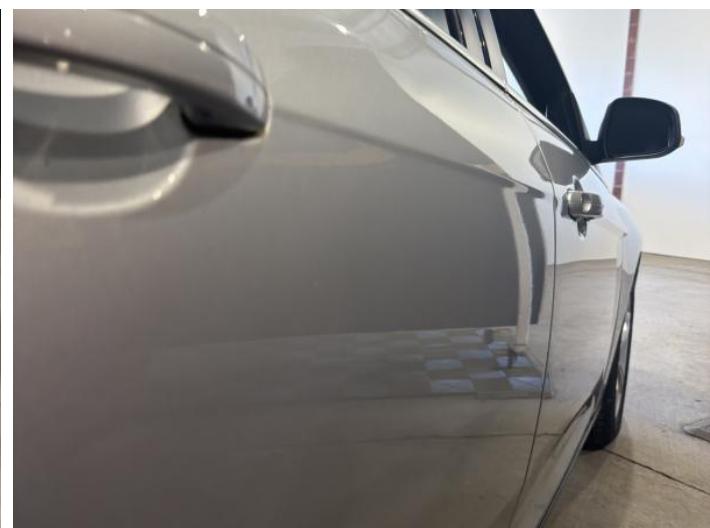
18: Door osr
Dented
2 Or Less UpTo 10mm

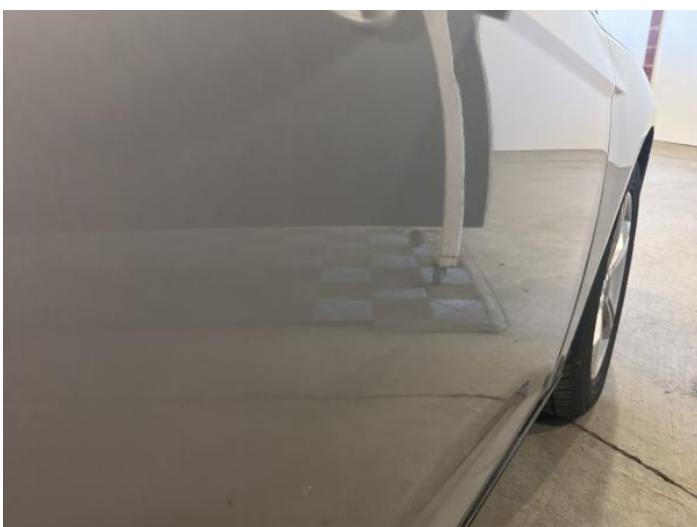
19: Door osf
Chipped
1 To 5

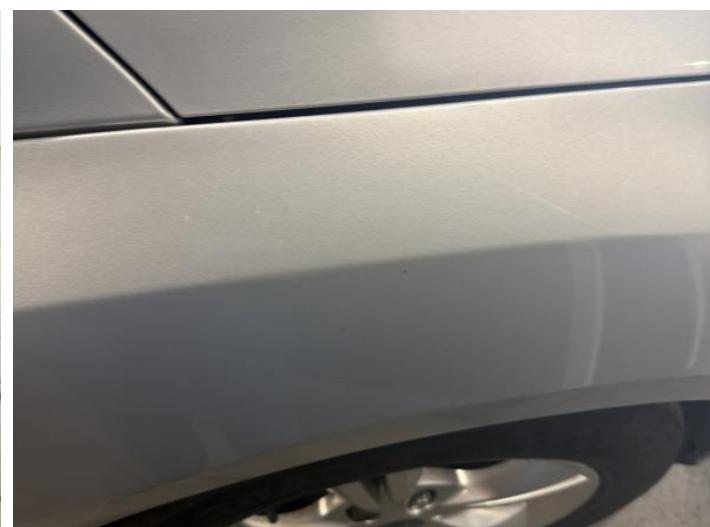
20: Wing osf
Chipped
1 To 5

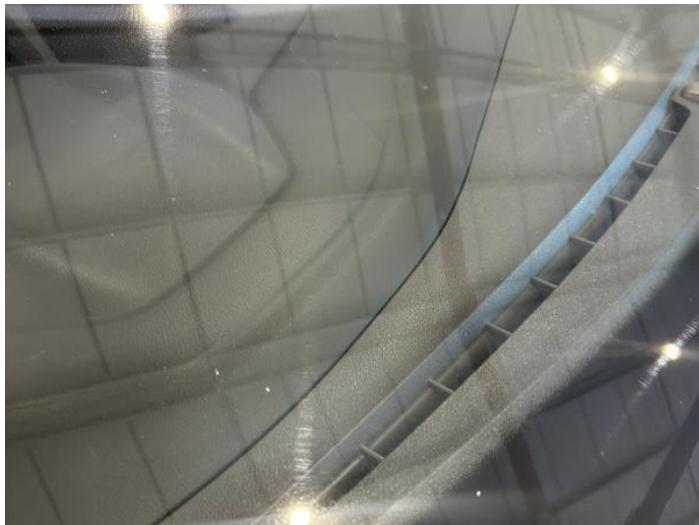
21: Screen Front
Chipped
UpTo 10mm

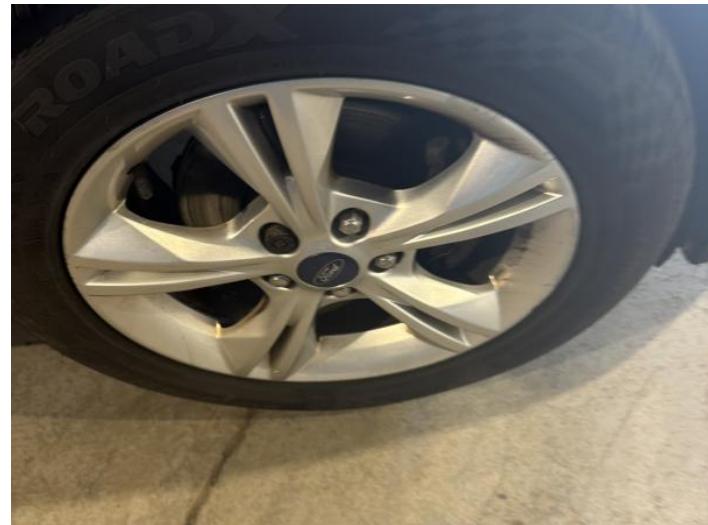
22: Wheel osf
Scratched
Over 50mm
