## VEHICLE INSPECTION REPORT

BP73POV

### Lexus RX 450h+ 2.5 5dr E-CVT [Premium Plus Pack]

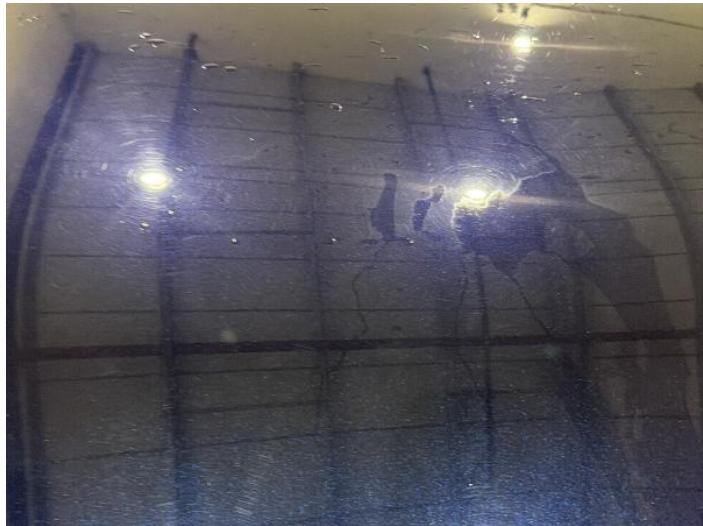
1: Bonnet  
Chipped  
1 To 5

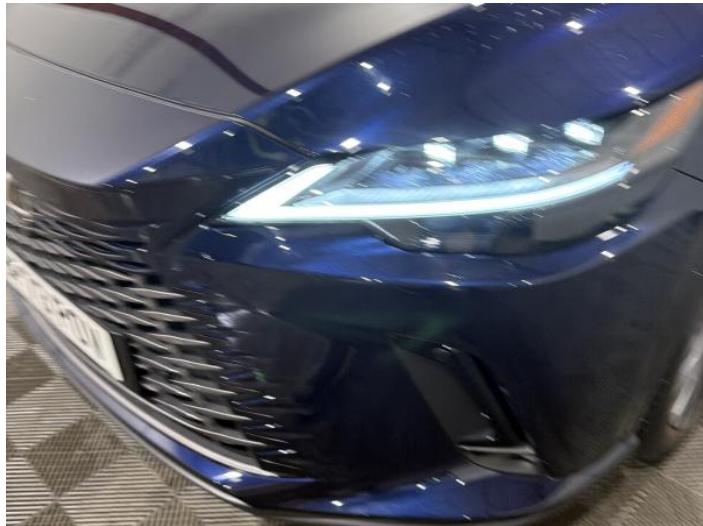
2: Bumper Front  
Chipped  
Multiple Chips

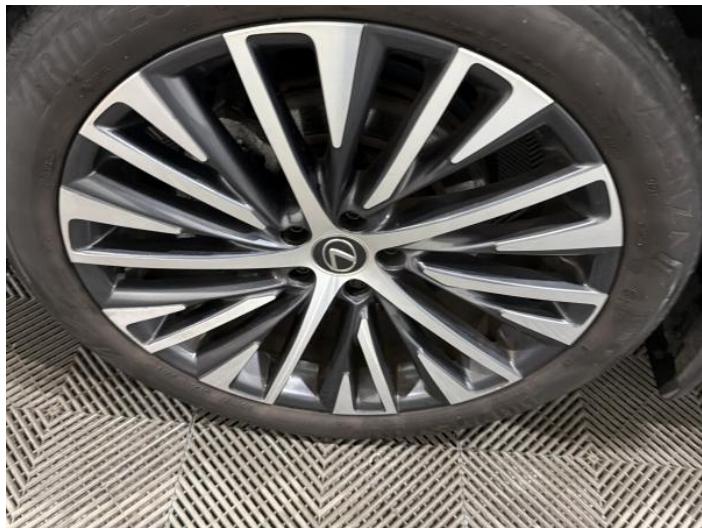
5: Wheel nsf  
Scratched  
Up To 50mm

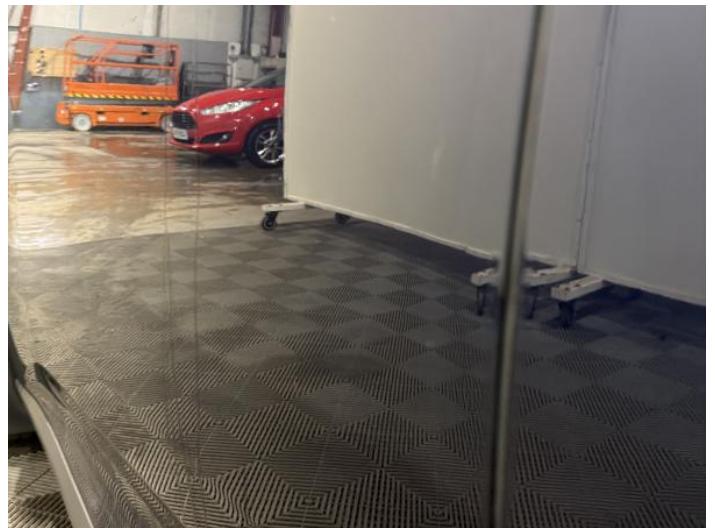
6: Door nsf  
Chipped  
1 To 5

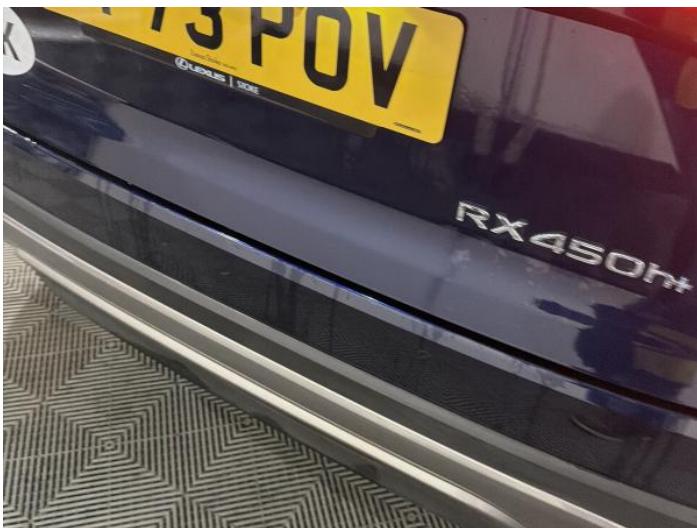
9: Bumper Rear  
Chipped  
Multiple Chips

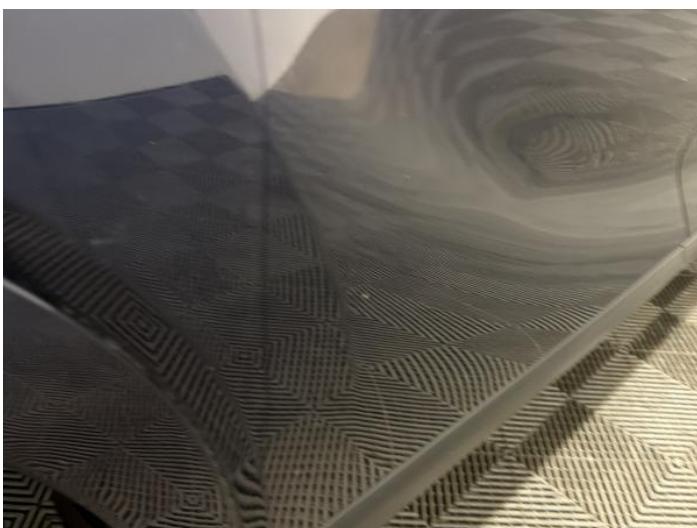
11: Door osr  
Scratched  
UpTo 25mm Thru Paint

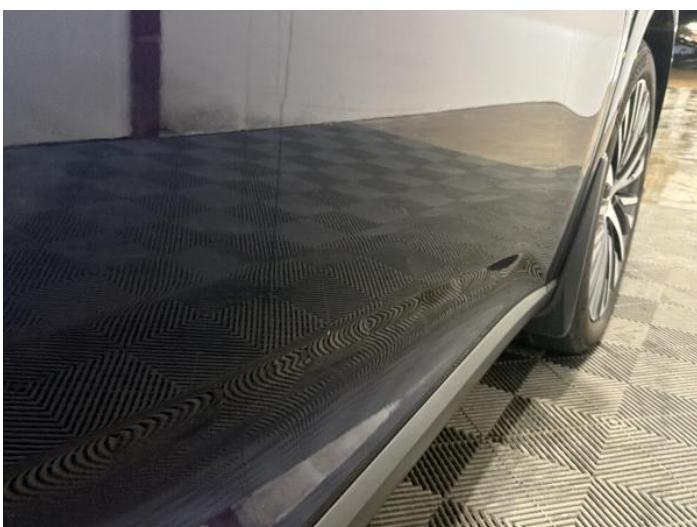
13: Door osf  
Chipped  
1 To 5
