VEHICLE INSPECTION REPORT

GV16NXH

Toyota Auris 1.8 Hybrid Excel 5dr CVT

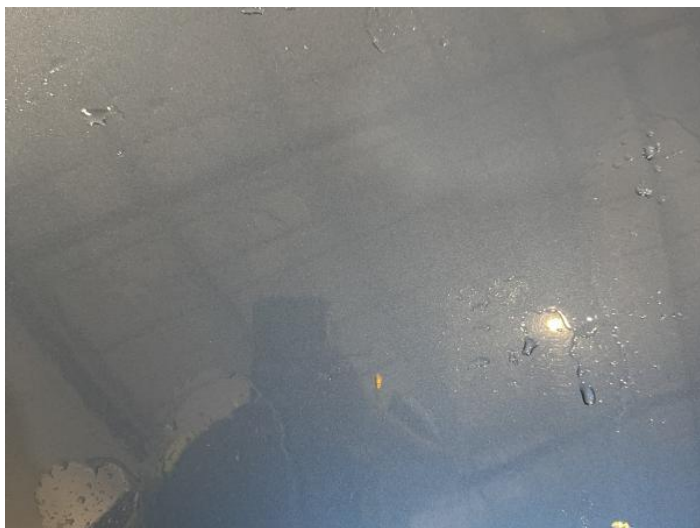
1: Bonnet
Chipped
1 To 5

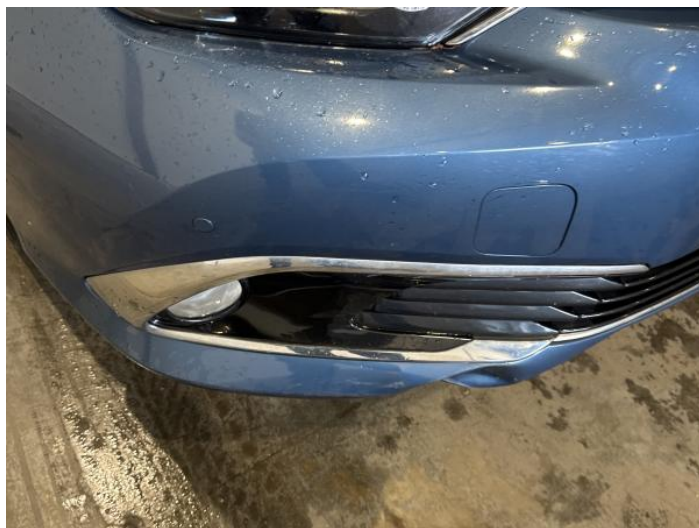
2: Bumper Front
Dented
With Paint Damage

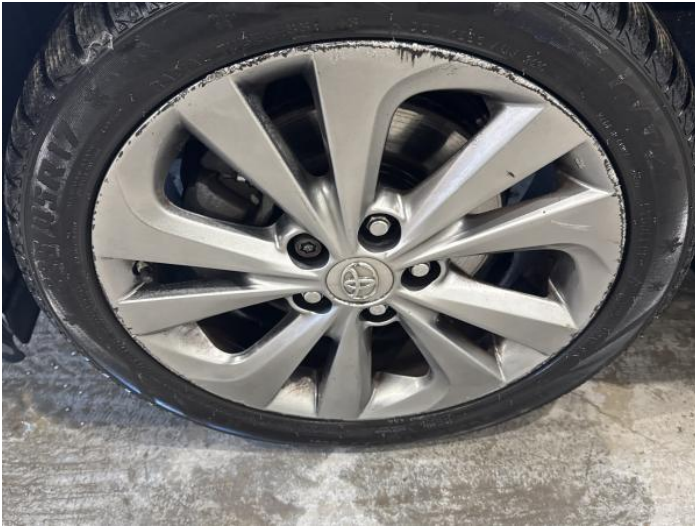
3: Wheel nsf
Scratched
Over 50mm

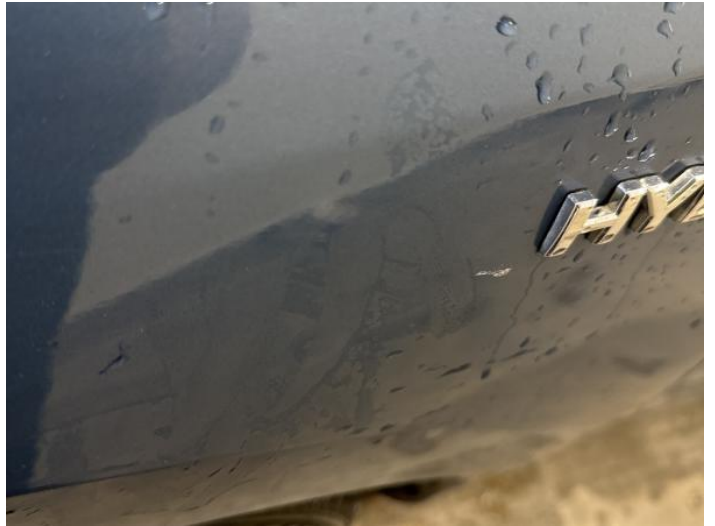
4: Wing nsf
Dented
Over 30mm

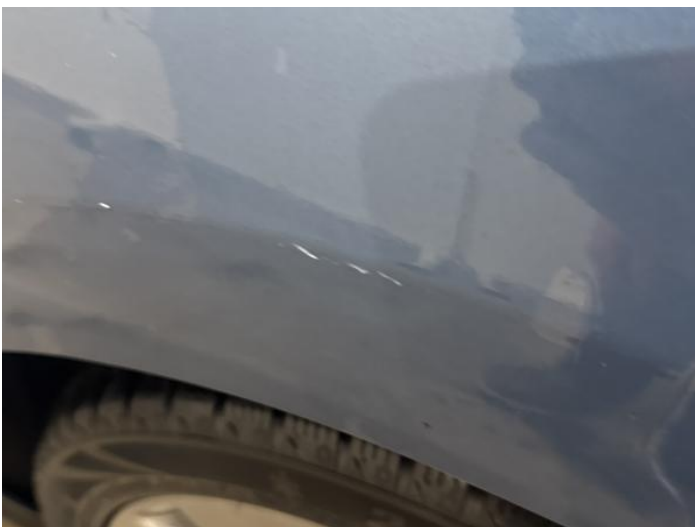
7: Qtr Panel nsr
Chipped
Multiple Chips

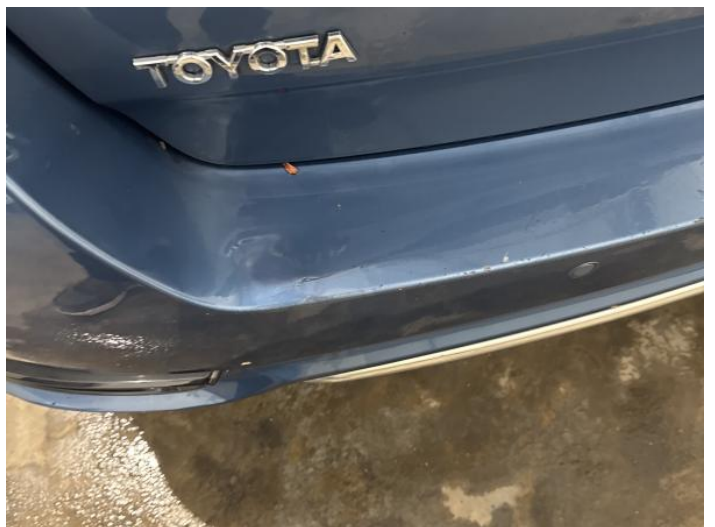
£65 ADDITIONAL FEE Rear bumper misaligned

8: Bumper Rear
Poor Previous Repair
Rippled Over 30%

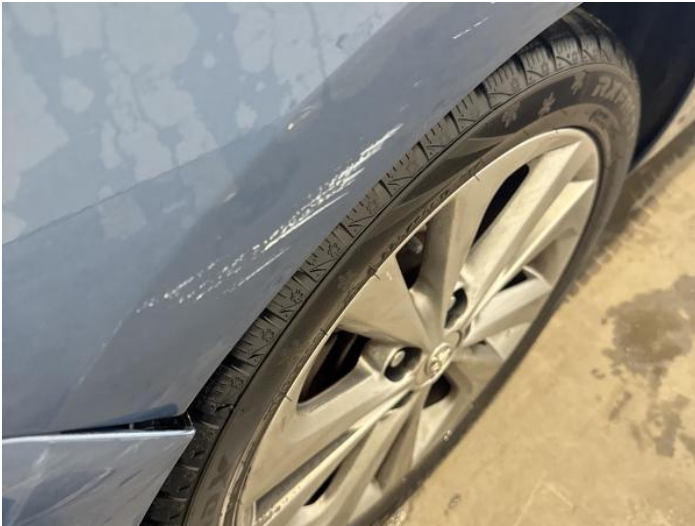
9: Qtr Panel osr
Dented
With Paint Damage

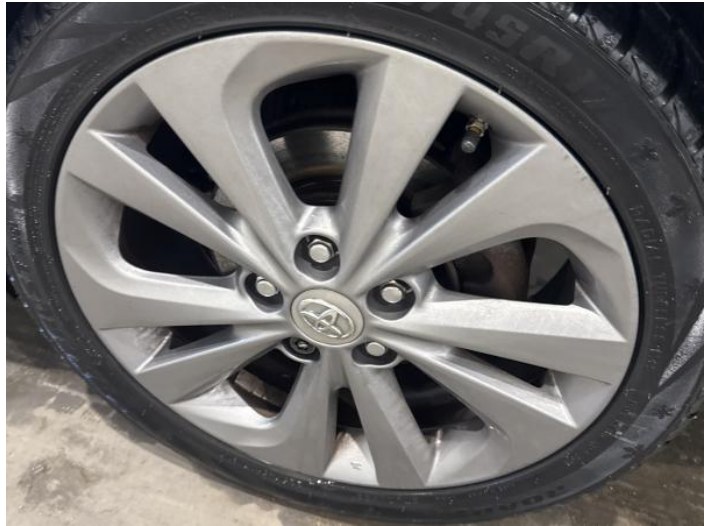
10: Wheel nsr
Scratched
Up To 50mm

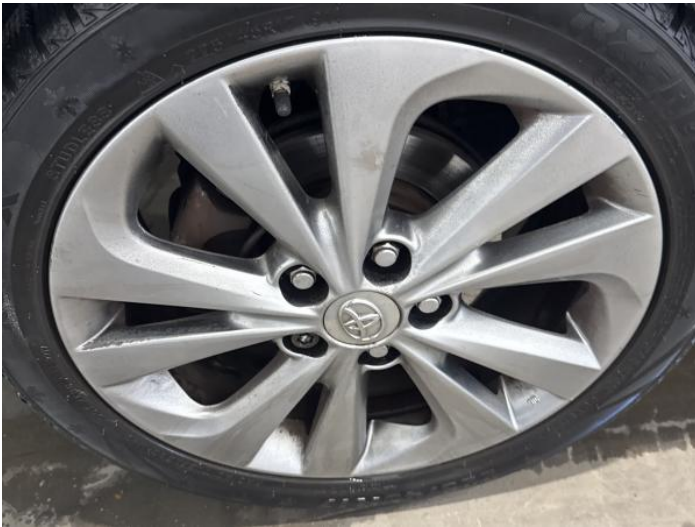
11: Wheel osr
Corroded
Light

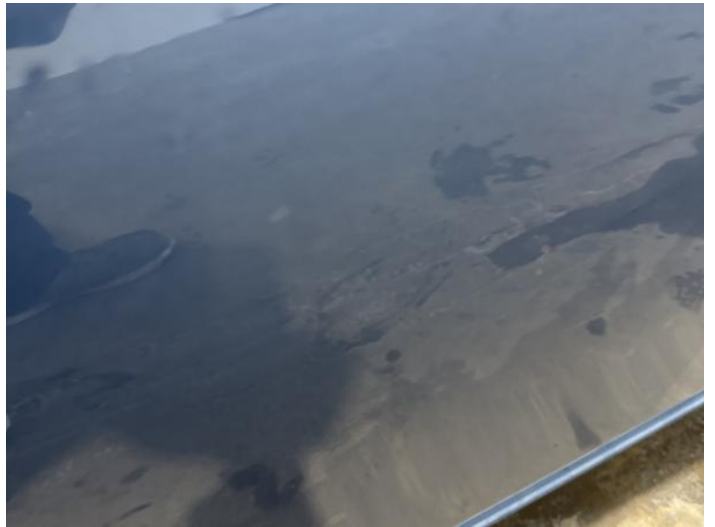
12: Door osr
Chipped
1 To 5

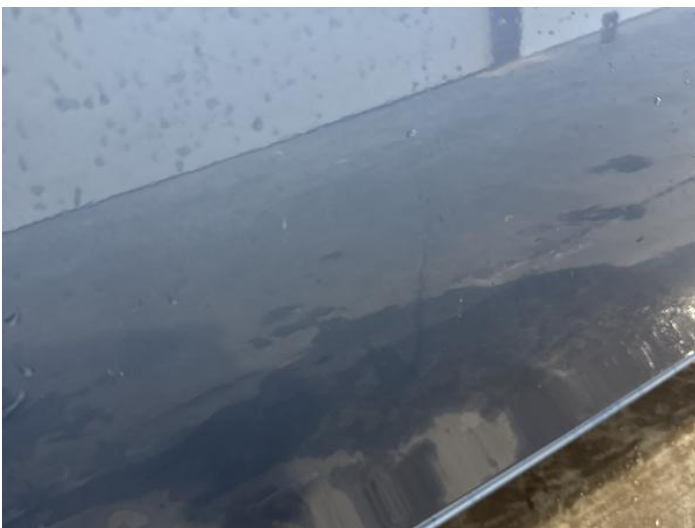
13: Door osf
Chipped
1 To 5

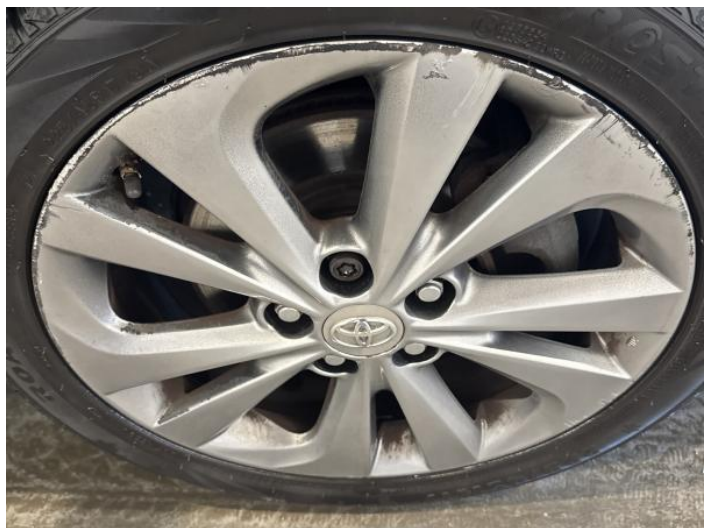
14: Wheel osf
Scratched
Over 50mm
