VEHICLE INSPECTION REPORT

RV09BZP

BMW 3 Series 318i ES 4dr

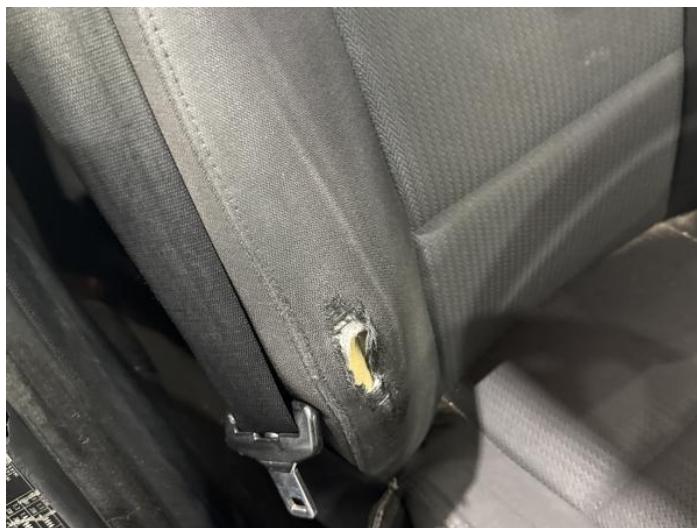
1: Seat Back Cover osf
Holed
Over 3mm

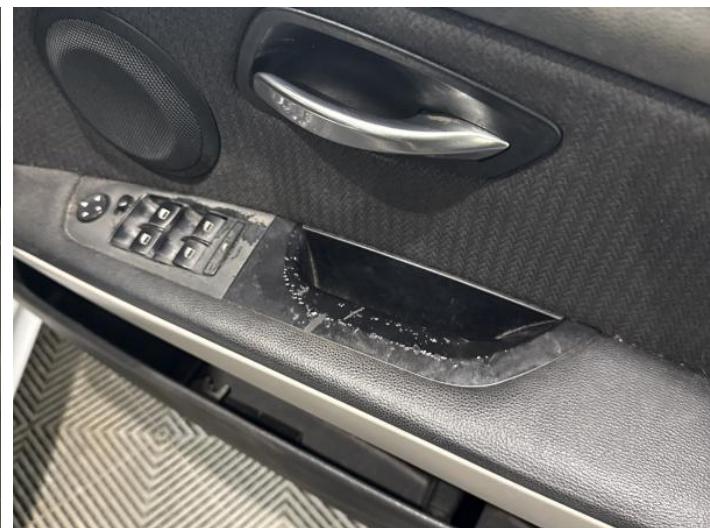
2: Door Pad osf
Scuffed
Over 25mm

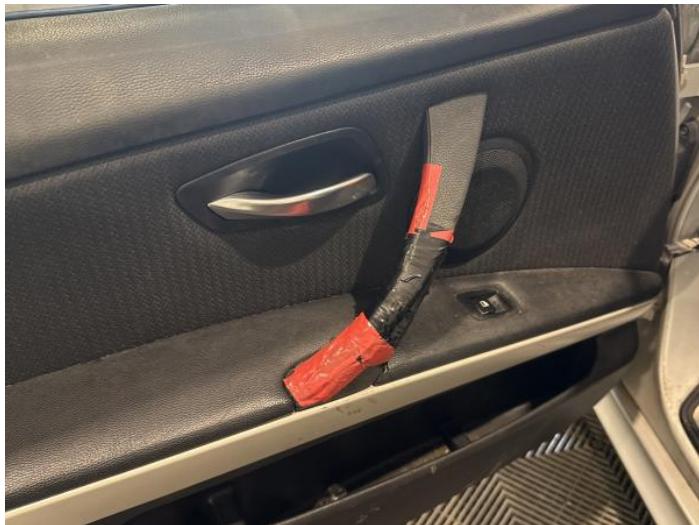
3: Door Pad nsf
Scuffed
Over 25mm

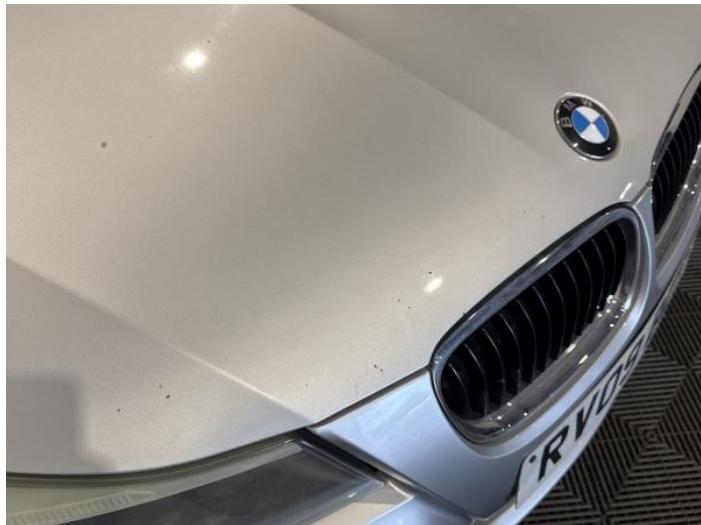
4: Bonnet
Chipped
Multiple Chips

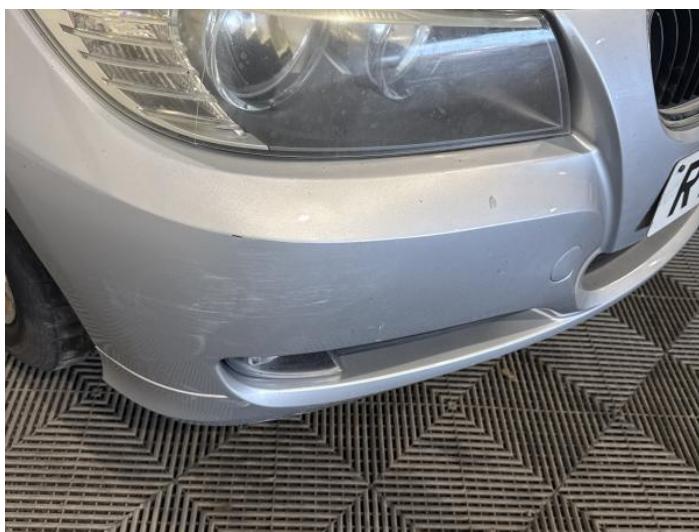
5: Bumper Front
Scratched
Over 100mm Thru Paint

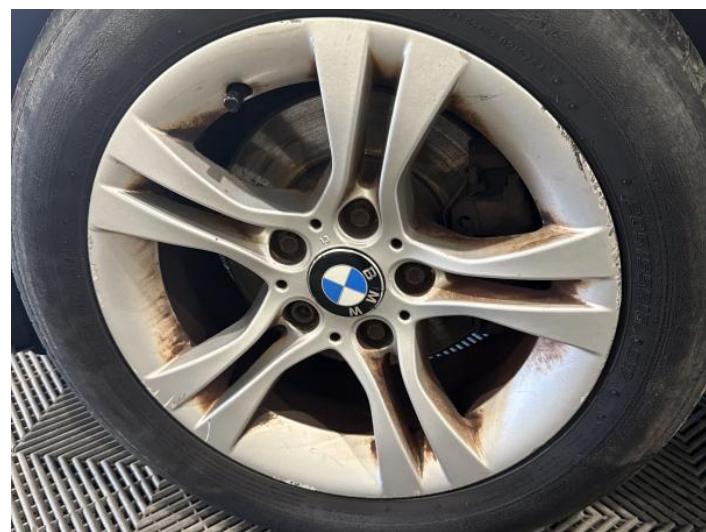
6: Wheel nsf
Scratched
Over 50mm

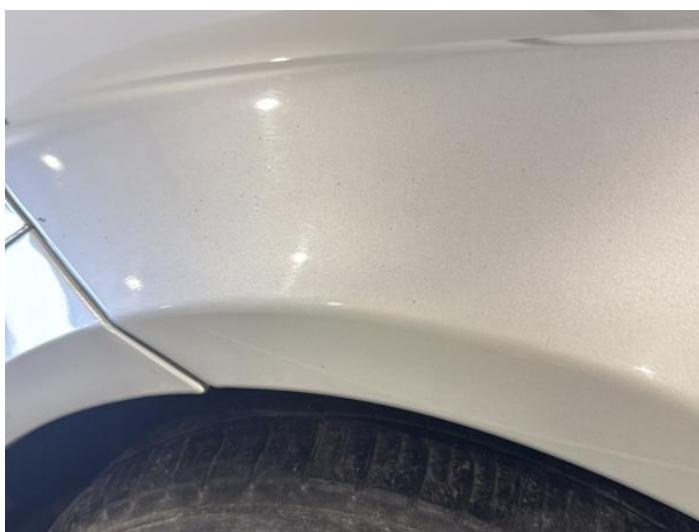
7: Wing nsf
Chipped
1 To 5

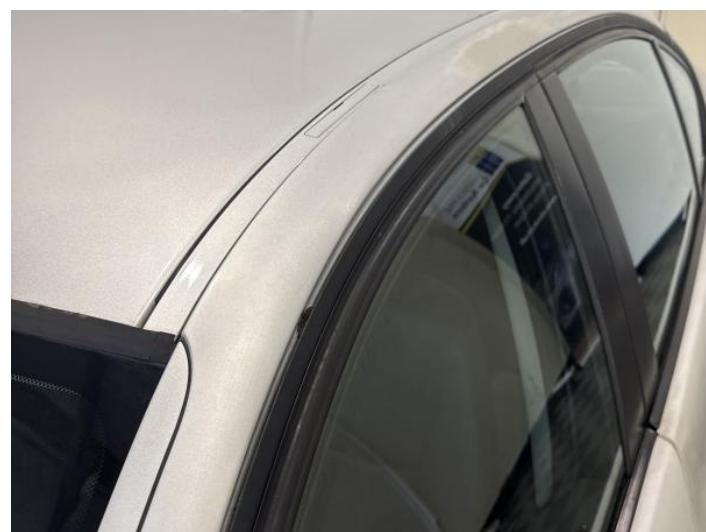
8: A Post nsf
Scratched
Over 25mm Thru Paint

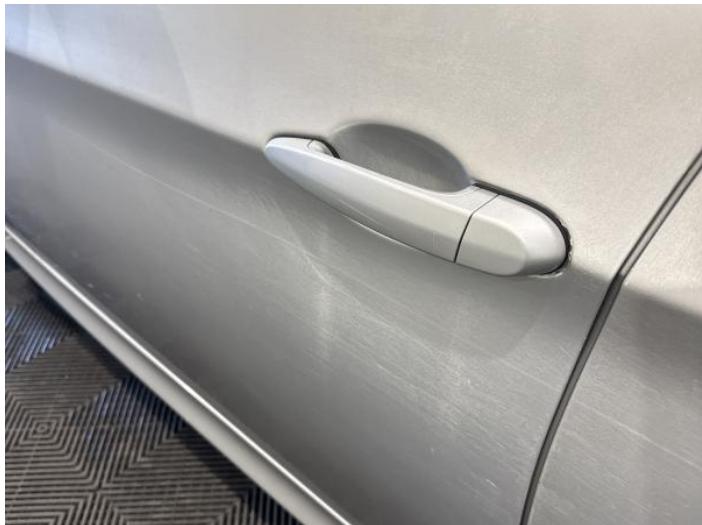
9: Door nsf
Poor Previous Repair
Poor Paint

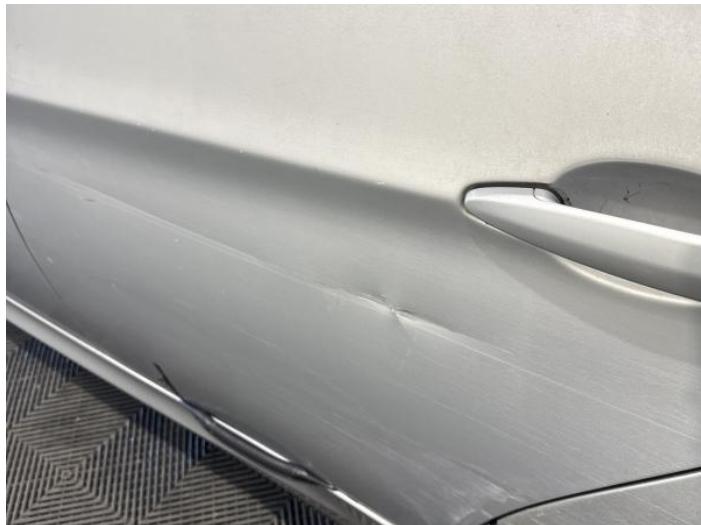
10: Door nsr
Dented
With Paint Damage

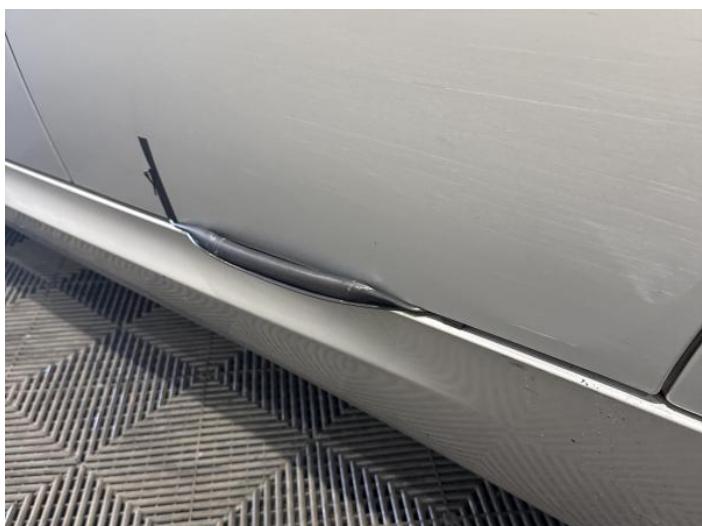
11: Aperture Seal nsr
Broken
Replace

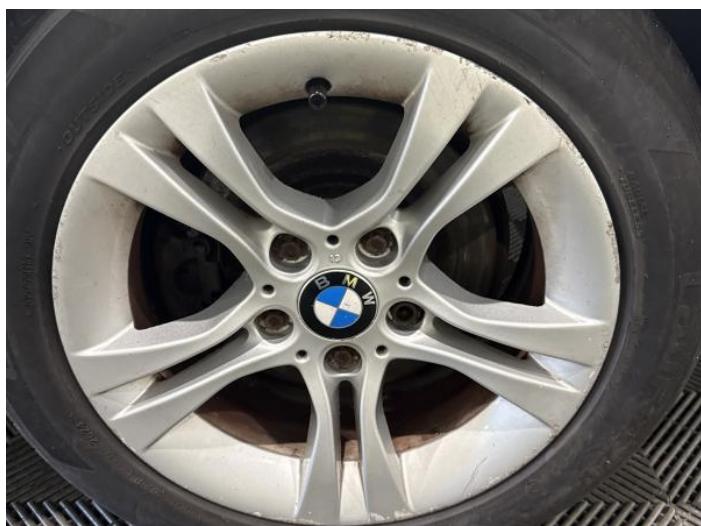
12: Wheel nsr
Scratched
Over 50mm

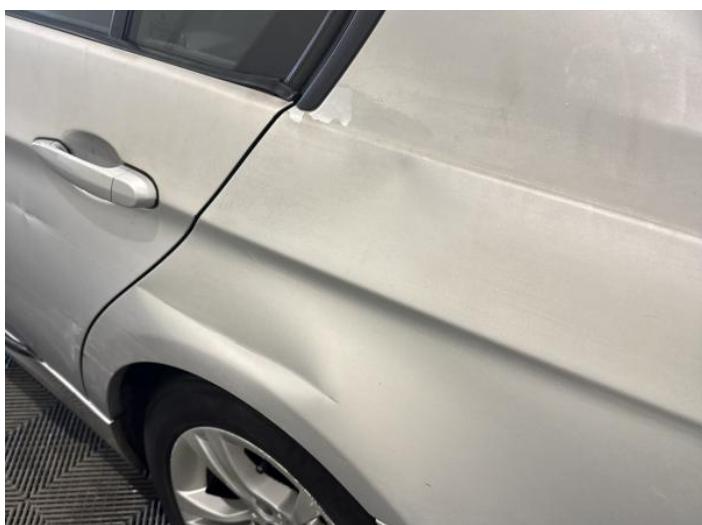
13: Qtr Panel nsr
Dented
With Paint Damage

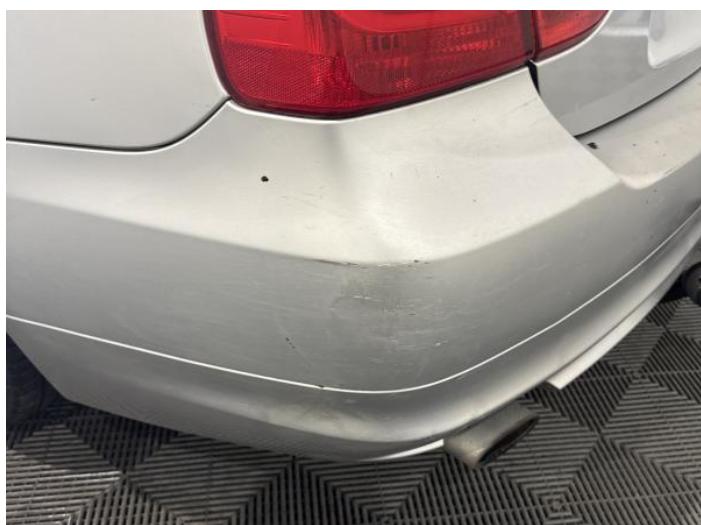
14: Bumper Rear
Scratched
Over 100mm Thru Paint

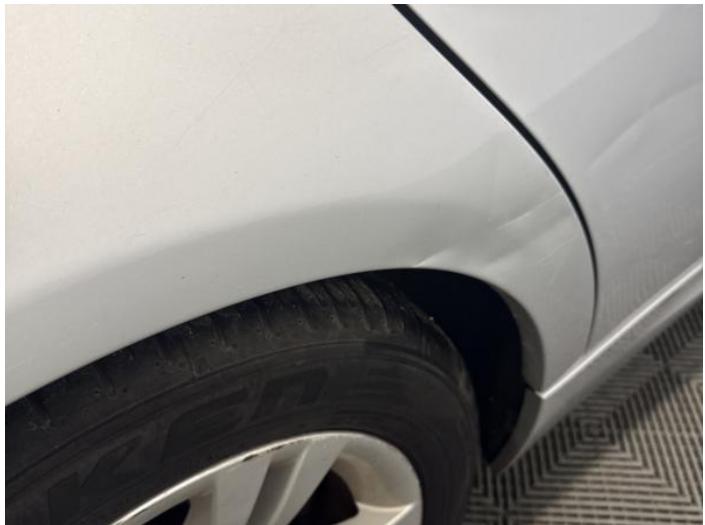
15: Qtr Panel osr
Dented
Over 30mm

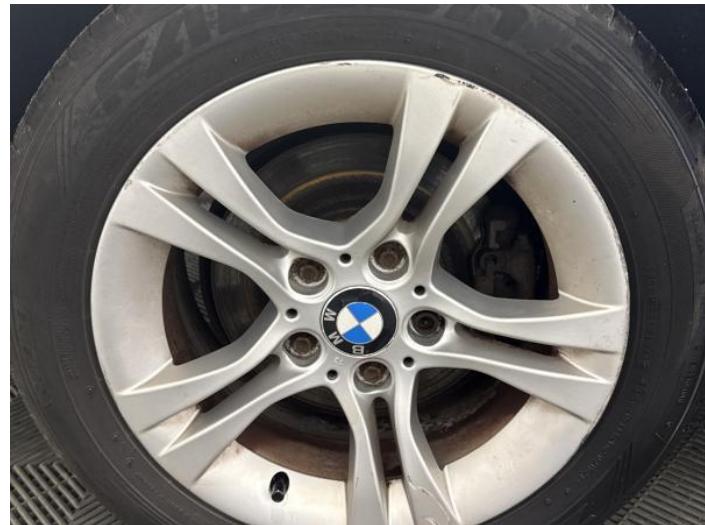
16: Wheel osr
Scratched
Over 50mm

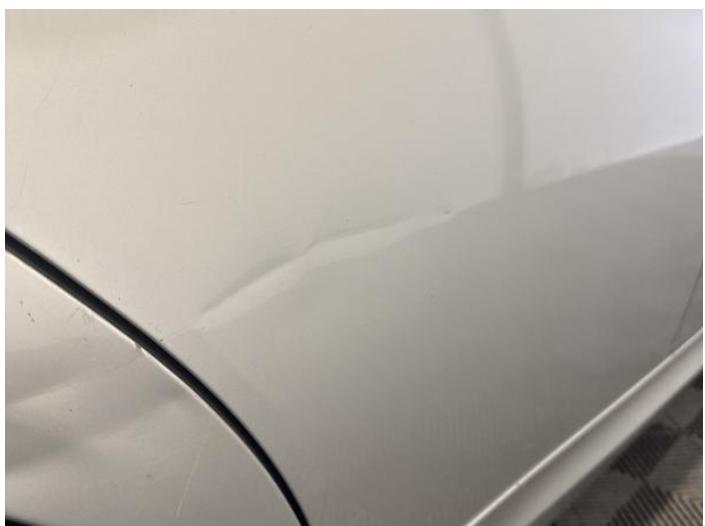
17: Door osr
Dented
Over 30mm

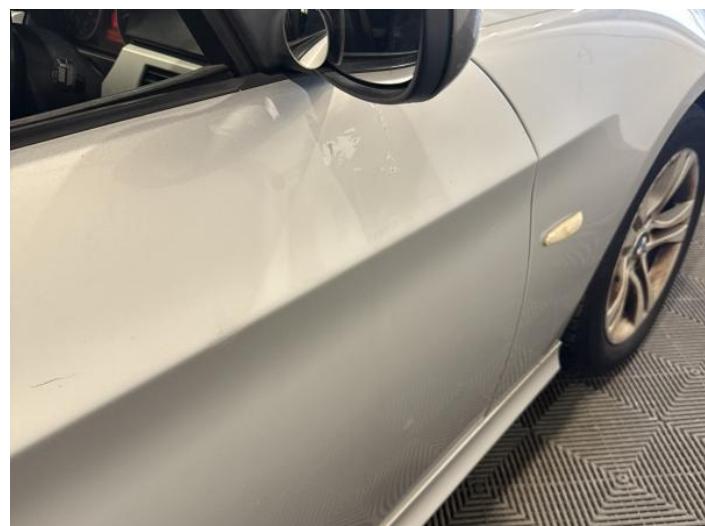
18: Door osf
Dented
With Paint Damage

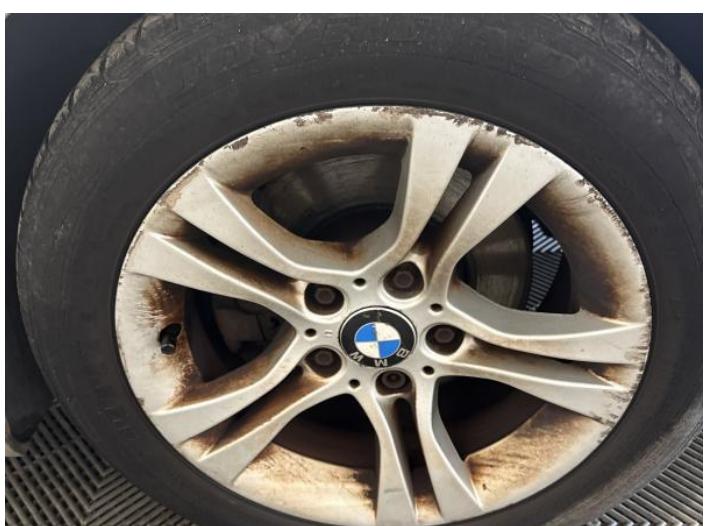
19: Wheel osf
Scratched
Over 50mm

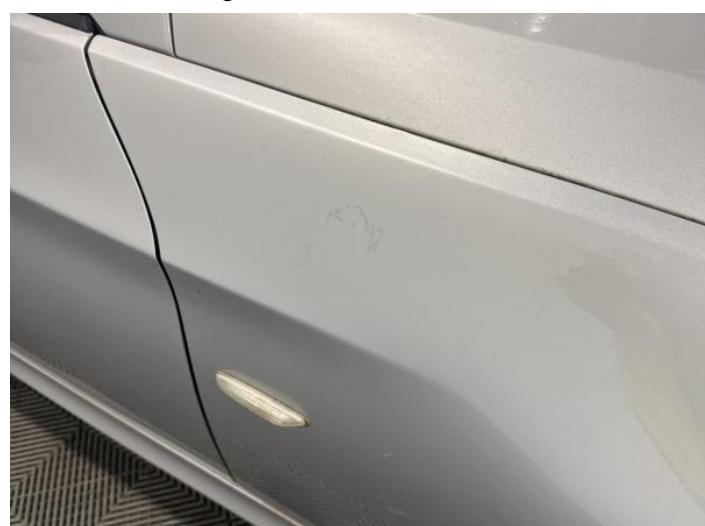
20: Wing osf
Scratched
Over 25mm Thru Paint

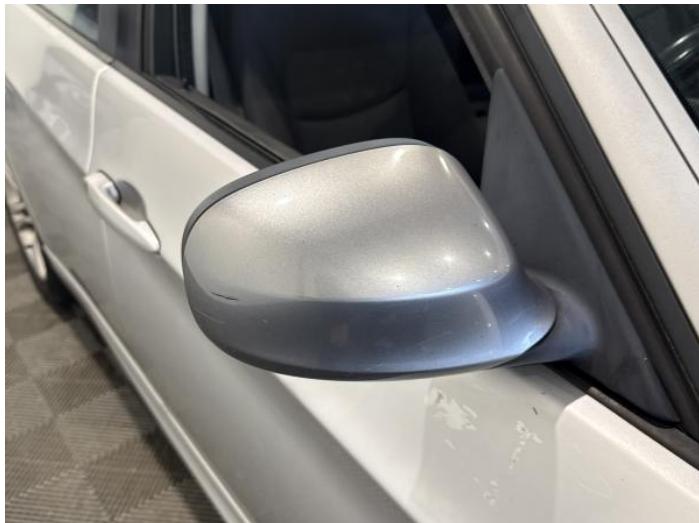
21: Door Mirror Assy osf
Scratched (Painted)
Over 25mm Thru Paint

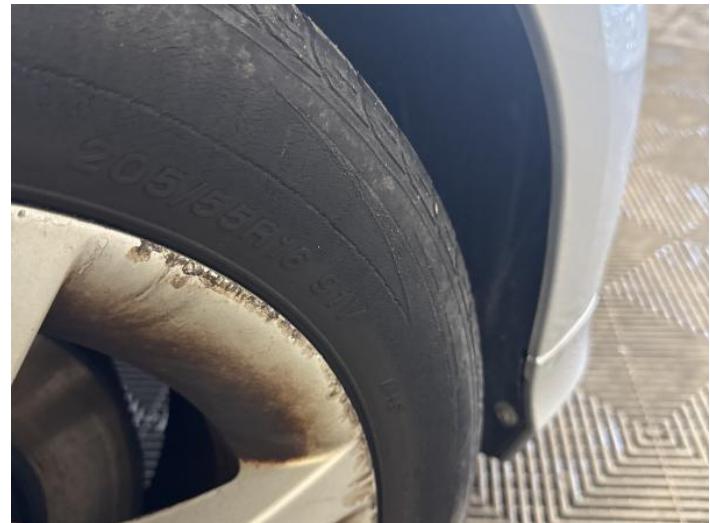
22: Tyre osf
Damaged
Replace

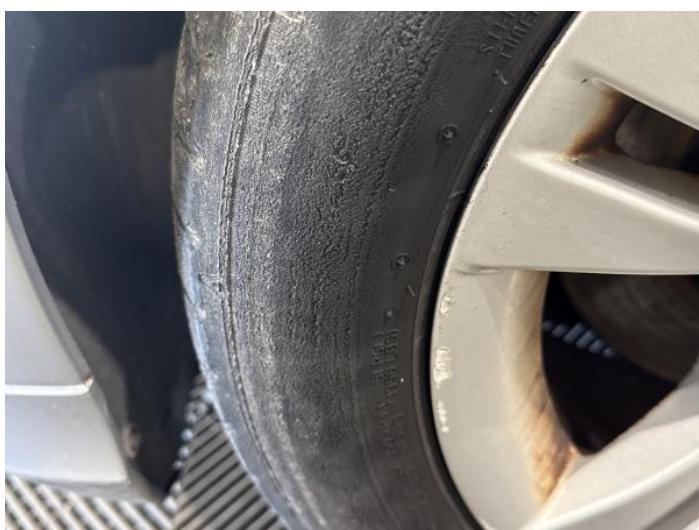
23: Tyre nsf
Damaged
Replace
