VEHICLE INSPECTION REPORT

YK67WBZ

Toyota Yaris 1.5 Hybrid Icon 5dr CVT

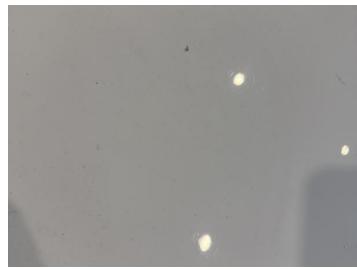
1: Bonnet Chipped 1 To 5

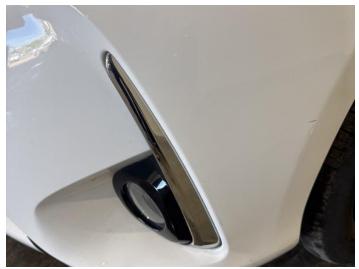
2: Bumper Front Scratched 25 to 100mm Thru Paint

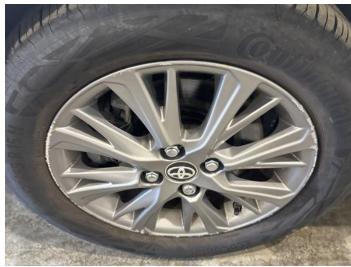
4: Wheel nsf Scratched Over 50mm

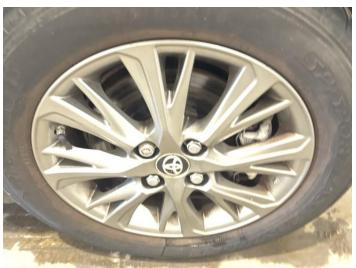
7: Wheel nsr Scratched Up To 50mm

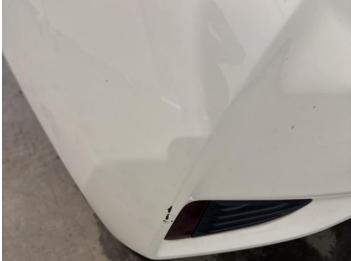
8: Bumper Rear Scratched 25 to 100mm Thru Paint

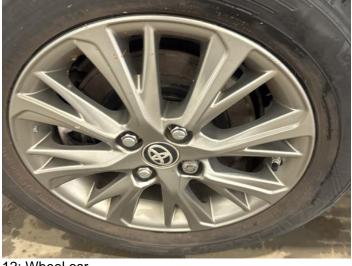
12: Wheel osr Scratched Over 50mm
