## VEHICLE INSPECTION REPORT

YE17XVD

### Lexus CT 200h 1.8 Advance 5dr CVT Auto

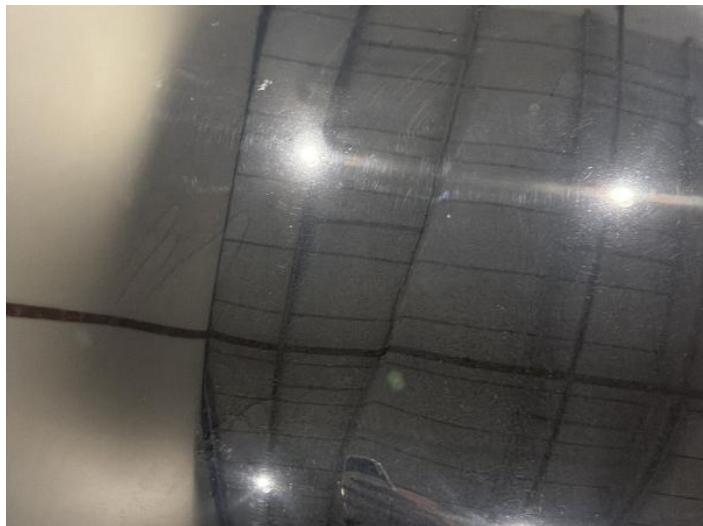
1: Bonnet  
Chipped  
1 To 5

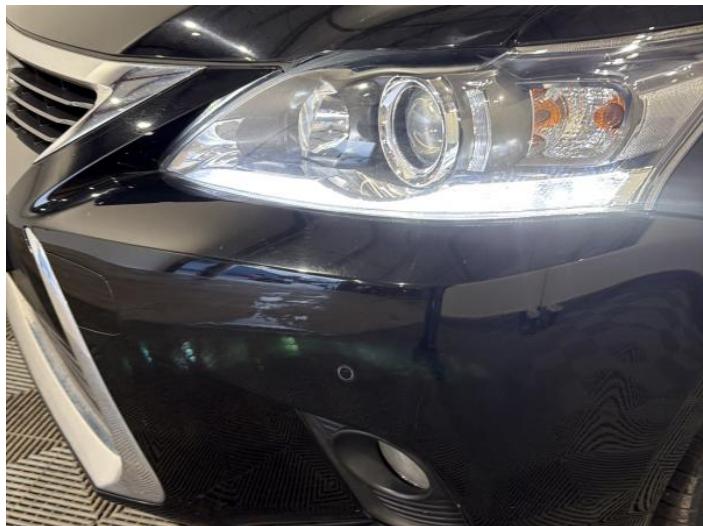
2: Bumper Front  
Chipped  
Multiple Chips

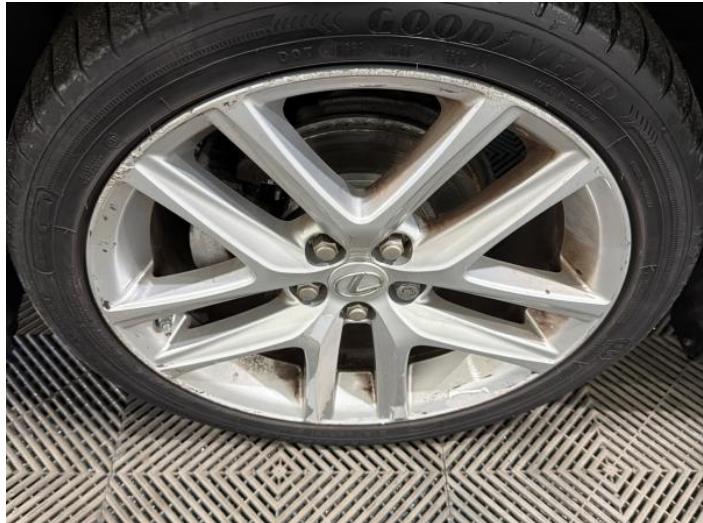
4: Wheel nsf  
Scratched  
Over 50mm

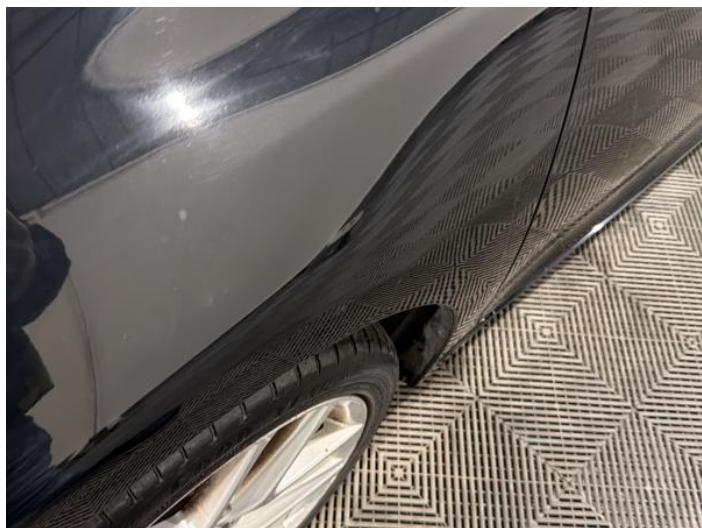
5: Wing nsf  
Chipped  
1 To 5

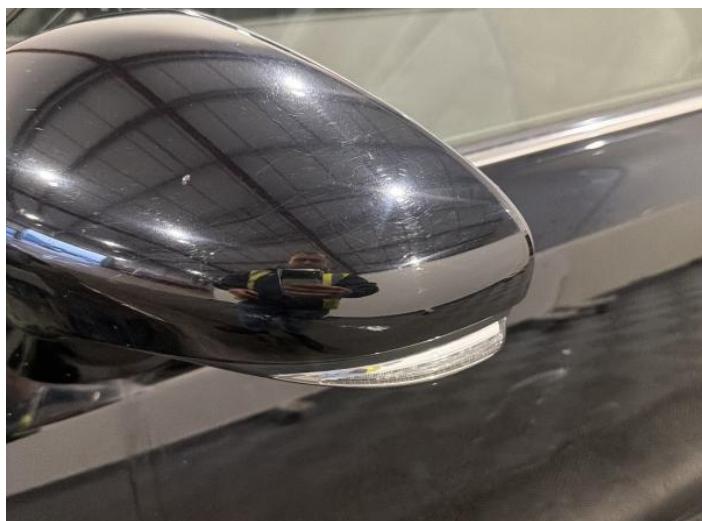
7: Door Mirror Assy nsf  
Scratched (Painted)  
UpTo 25mm Thru Paint

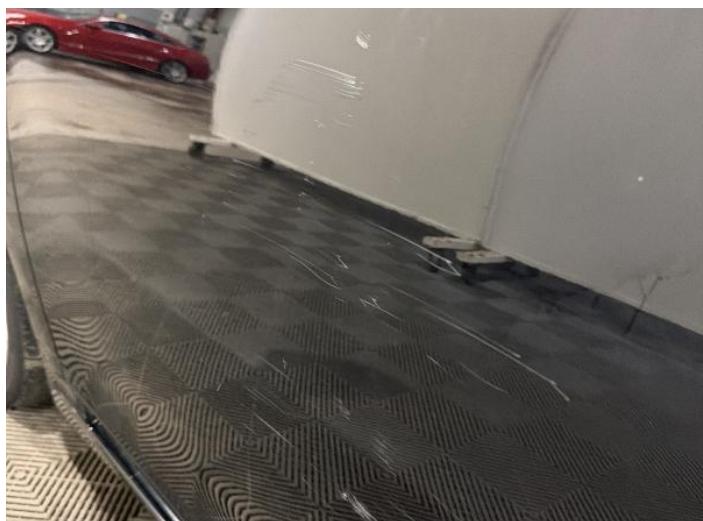
8: Door nsf  
Scratched  
Over 25mm Thru Paint

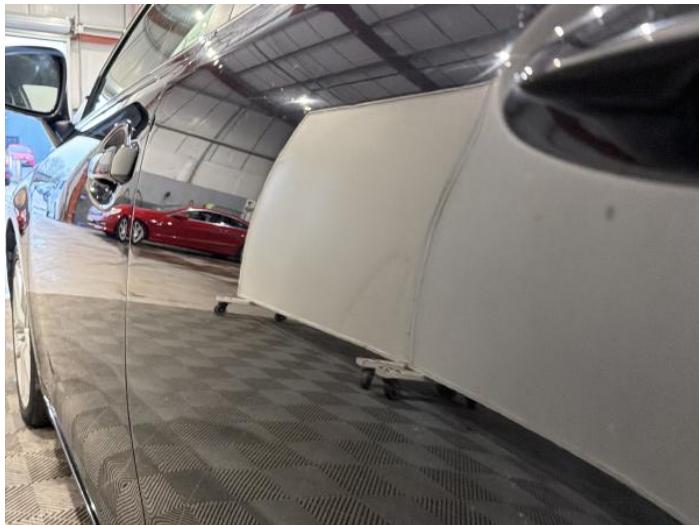
9: Door nsr  
Dented  
2 Or Less UpTo 10mm

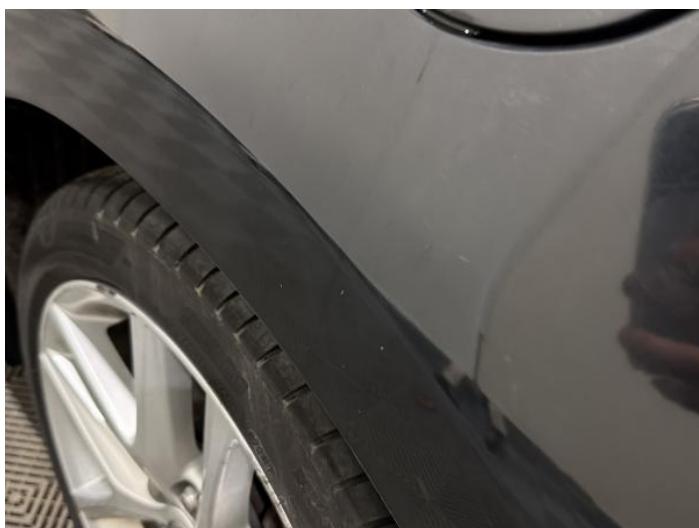
11: Qtr Panel nsr  
Chipped  
1 To 5

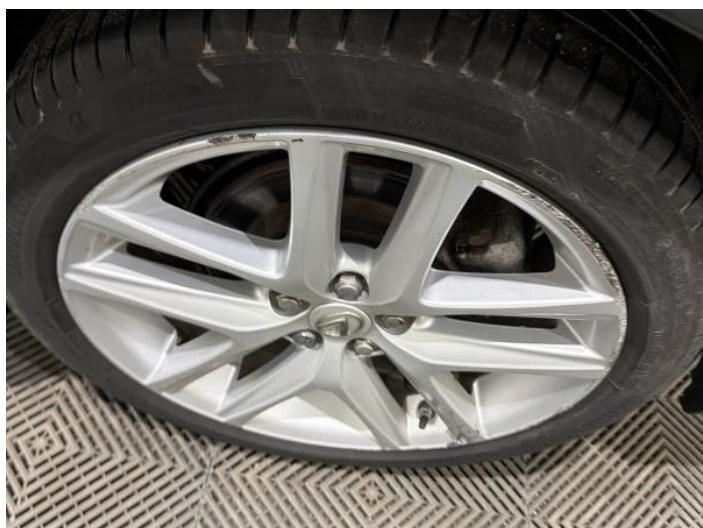
12: Wheel nsr  
Scratched  
Over 50mm

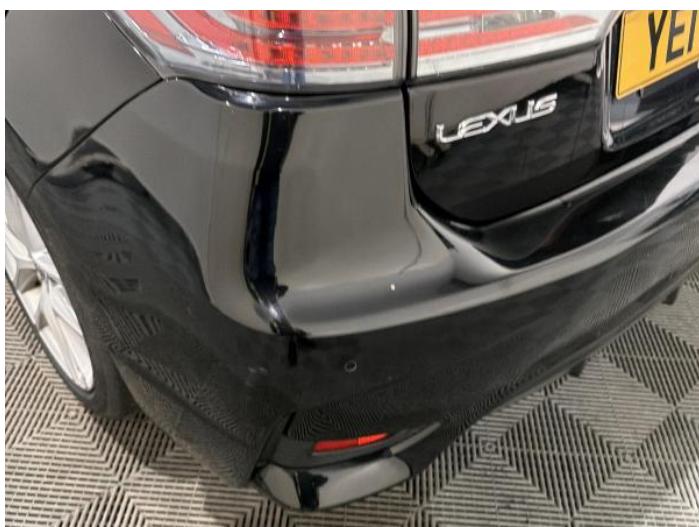
13: Bumper Rear  
Scratched  
Over 100mm Thru Paint

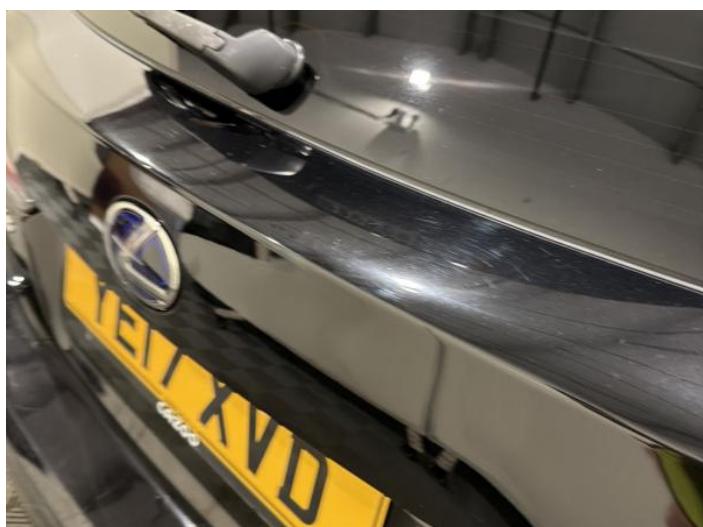
14: Boot Lid  
Chipped  
1 To 5

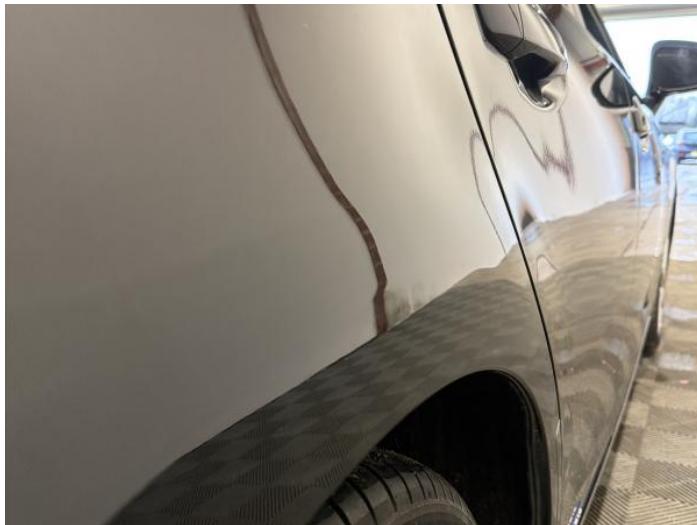
15: Qtr Panel osr  
Poor Previous Repair  
Poor Paint

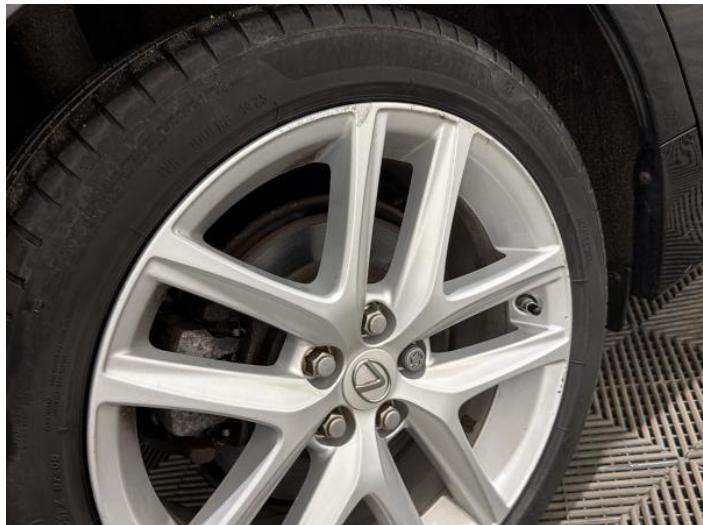
16: Wheel osr  
Scratched  
Over 50mm

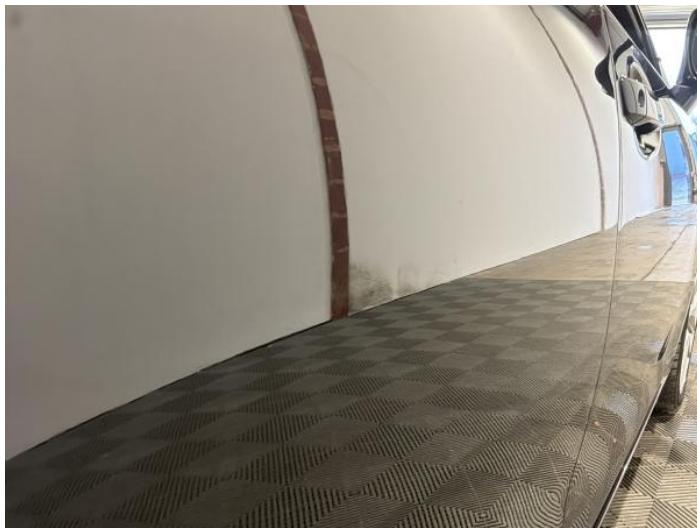
17: Door osr  
Chipped  
1 To 5

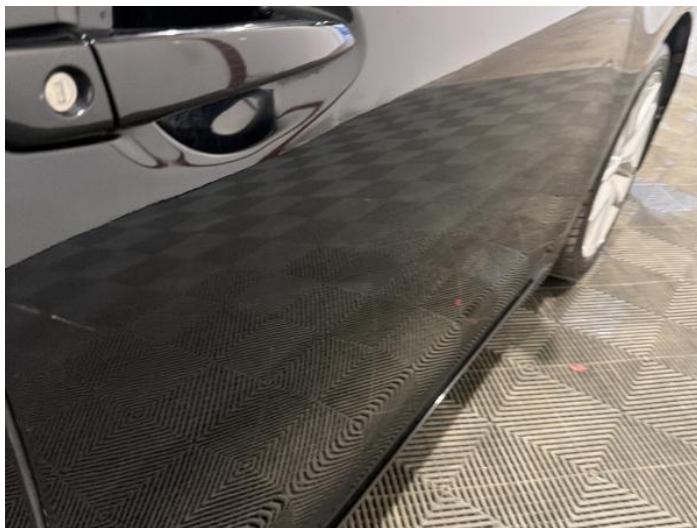
19: Door osf  
Chipped  
1 To 5

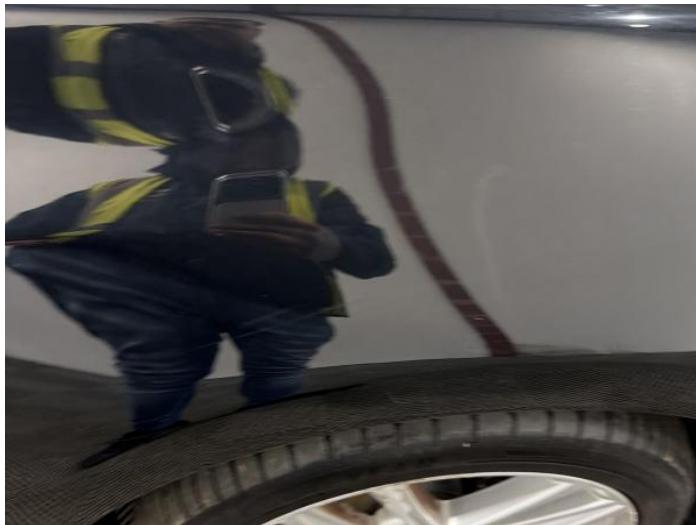
21: Wing osf  
Chipped  
1 To 5

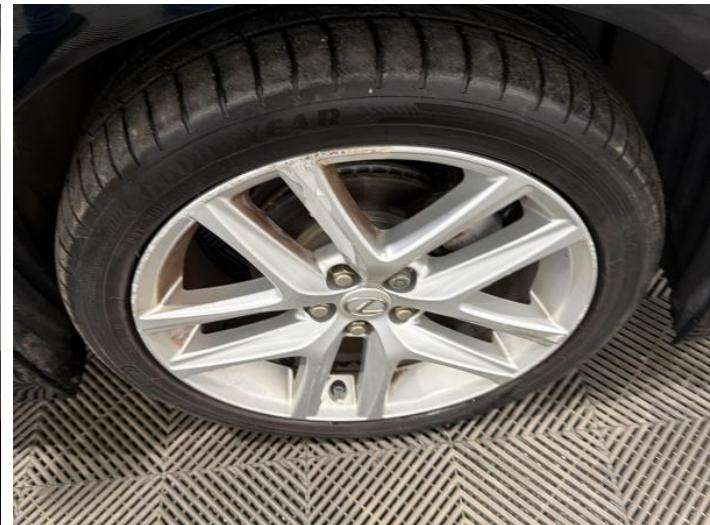
22: Wheel osf  
Scratched  
Over 50mm

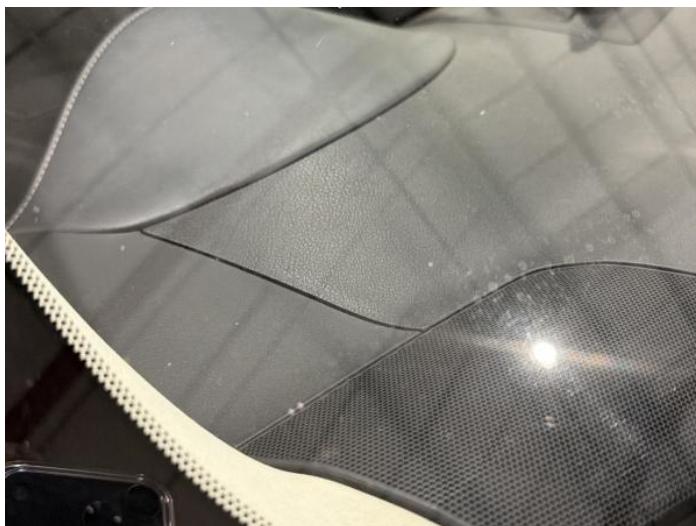
23: Screen Front  
Chipped  
UpTo 10mm
