# VEHICLE INSPECTION REPORT

**MJ13JZL**

## Nissan Juke 1.6 Tekna 5dr CVT

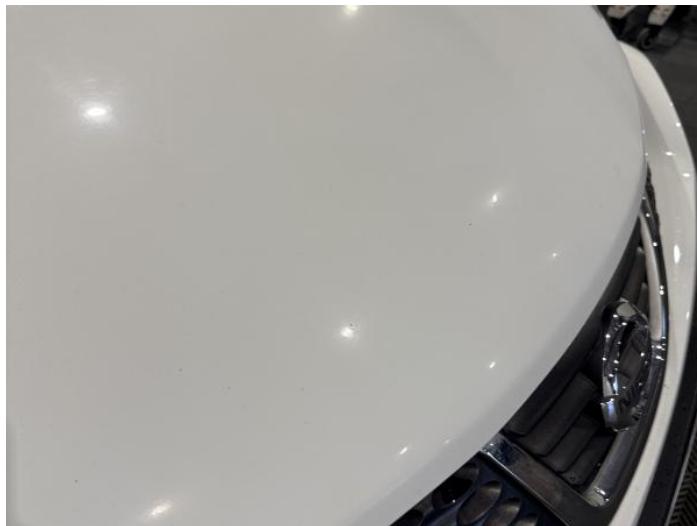
1: Bonnet  
Chipped  
1 To 5

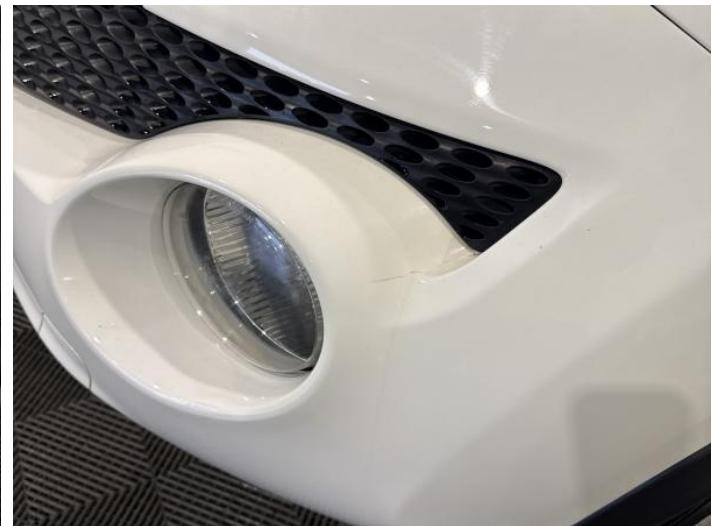
2: Bumper Front  
Scratched  
UpTo 25mm Thru Paint

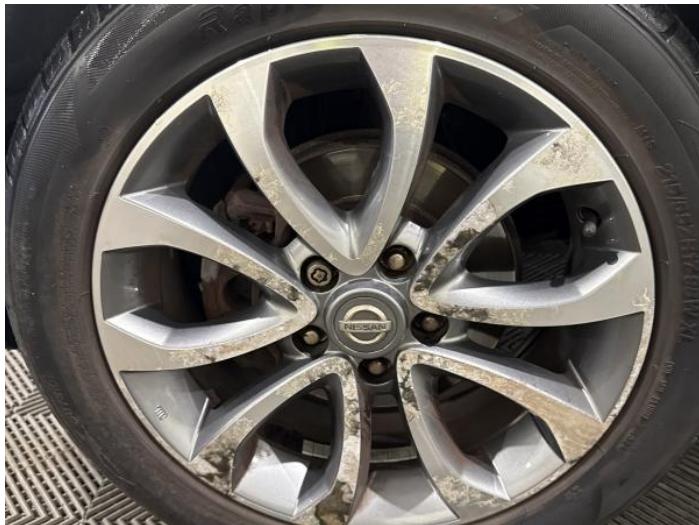
3: Wheel nsf  
Corroded  
Light

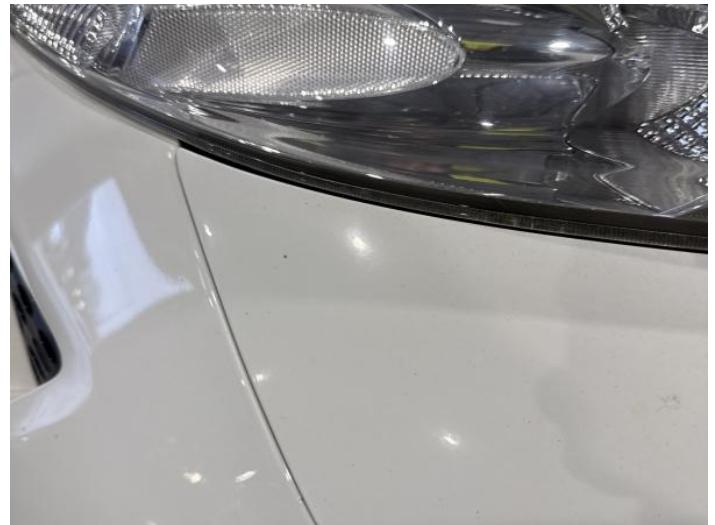
4: Wing nsf  
Chipped  
1 To 5

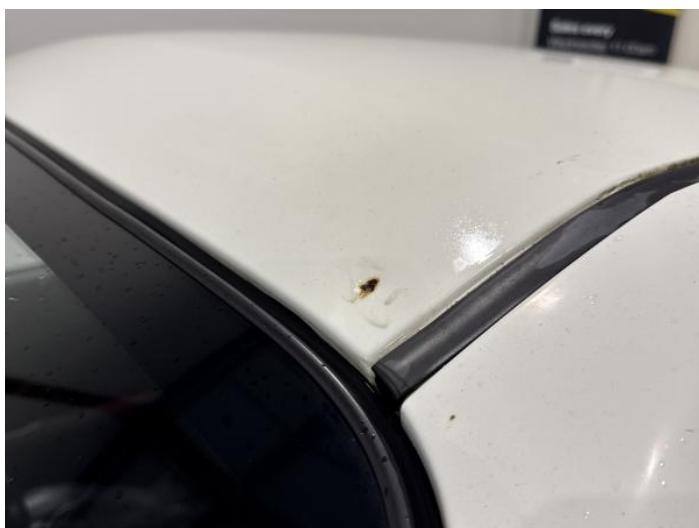
5: Roof  
Dented  
With Paint Damage

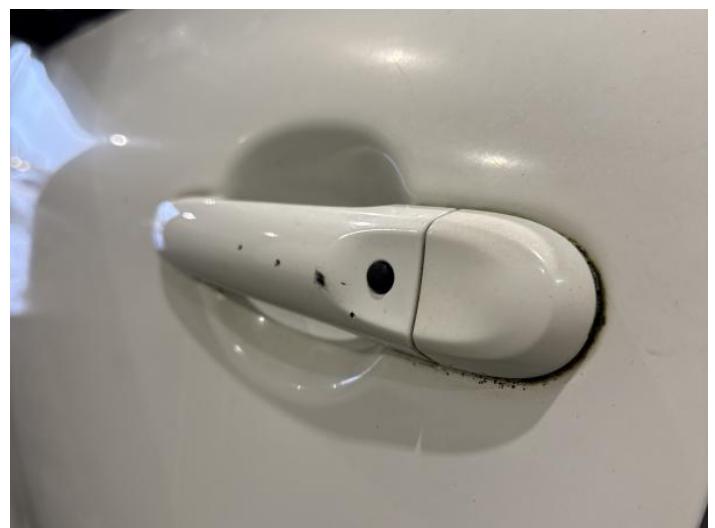
6: Handle Outer nsf  
Scratched (Painted)  
Over 25mm Thru Paint

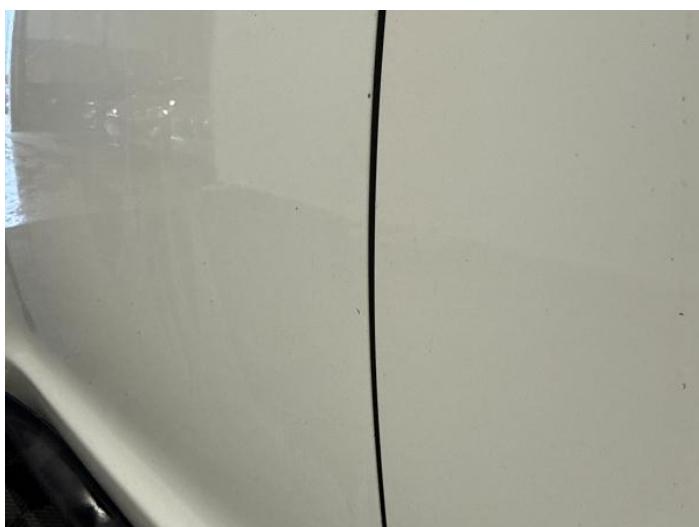
7: Door nsf  
Chipped  
1 To 5

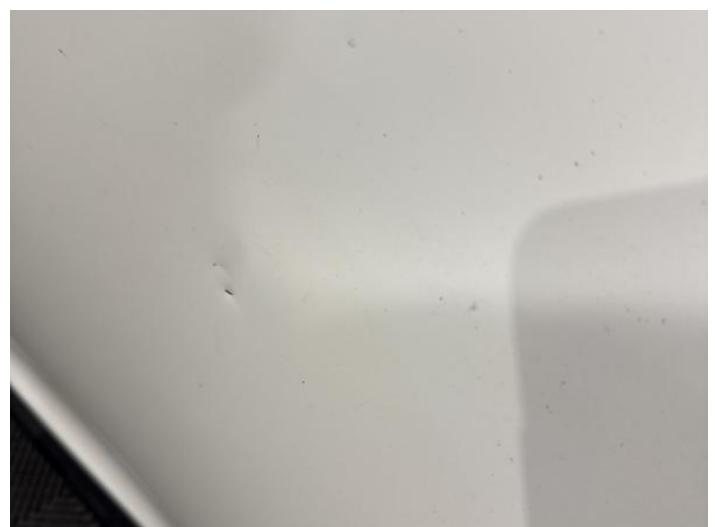
8: Door nsr  
Dented  
Between 10mm + 30mm

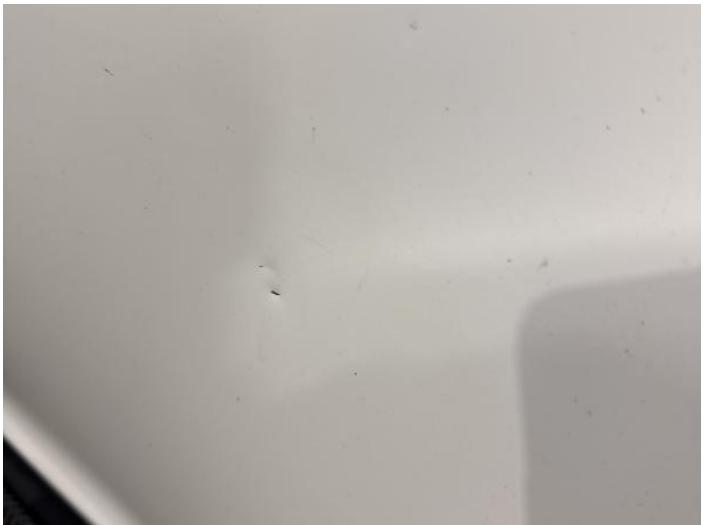
9: Door nsr  
Scratched  
UpTo 25mm Thru Paint

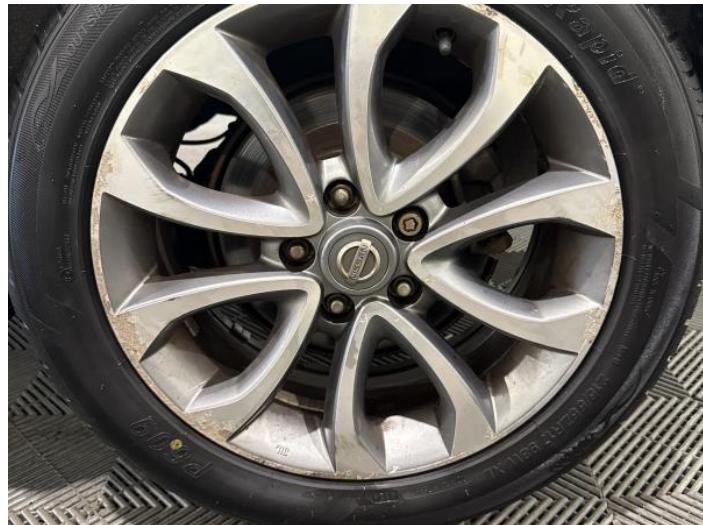
10: Wheel nsr  
Scratched  
Over 50mm

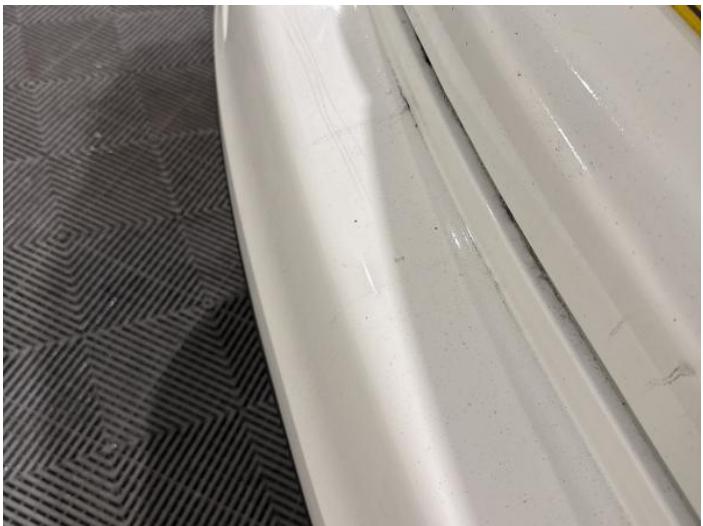
11: Bumper Rear  
Scratched  
25 to 100mm Thru Paint

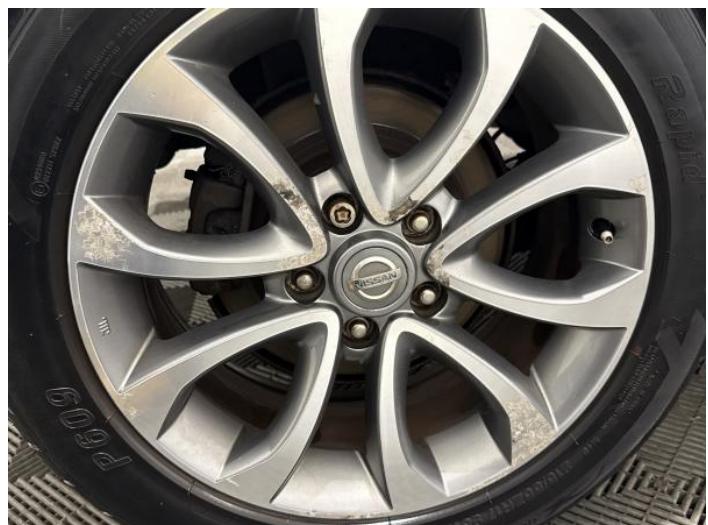
13: Wheel osr  
Corroded  
Light

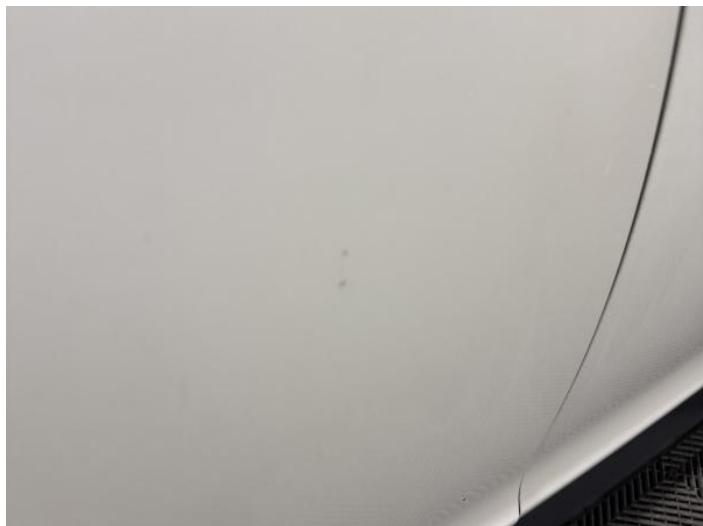
14: Door osr  
Scratched  
UpTo 25mm Thru Paint

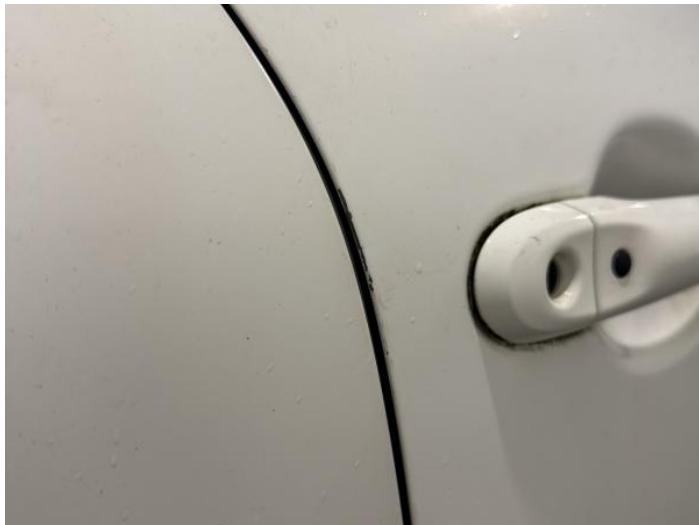
15: Door osf  
Chipped  
Edge Chip

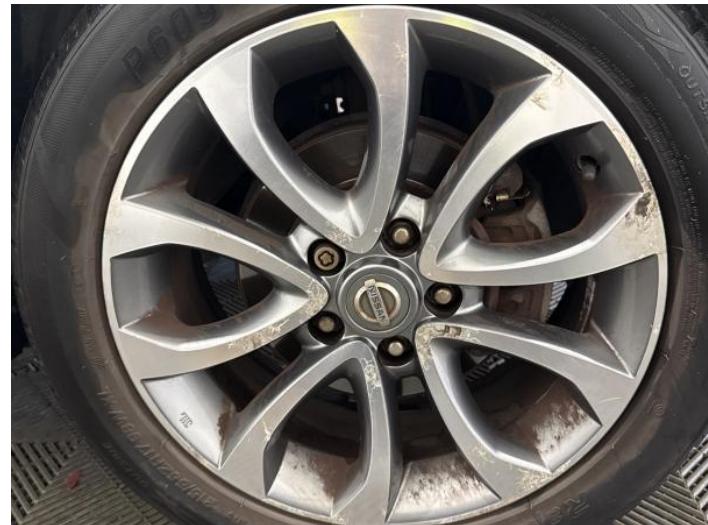
16: Wheel osf  
Scratched  
Over 50mm

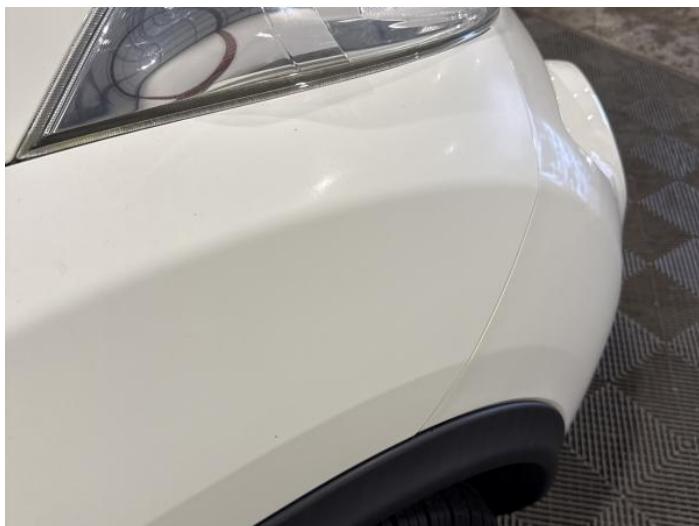
17: Wing osf  
Chipped  
1 To 5
