VEHICLE INSPECTION REPORT

FV14OOY

Mini Hatchback 1.5 Cooper 3dr

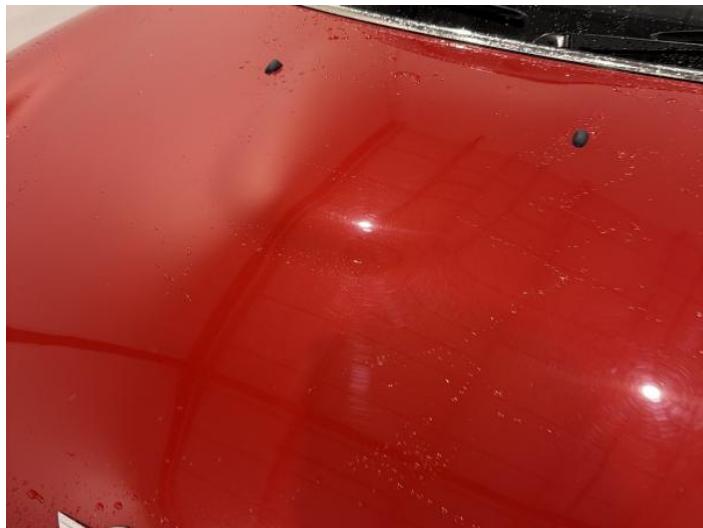
1: Bonnet
Chipped
1 To 5

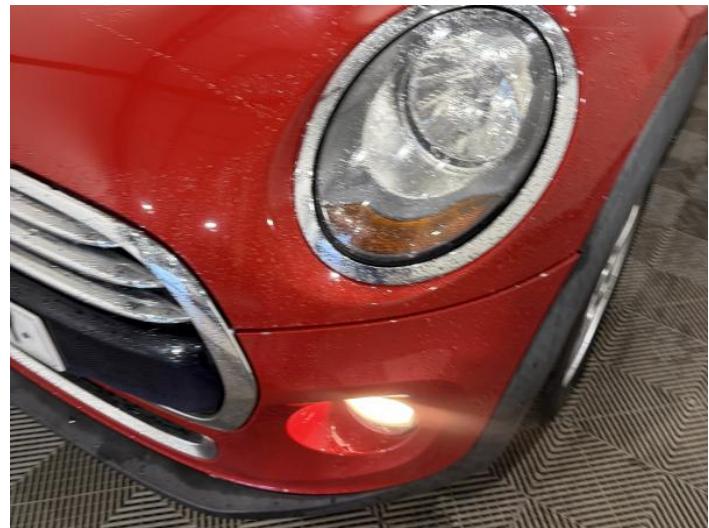
2: Bumper Front
Chipped
Multiple Chips

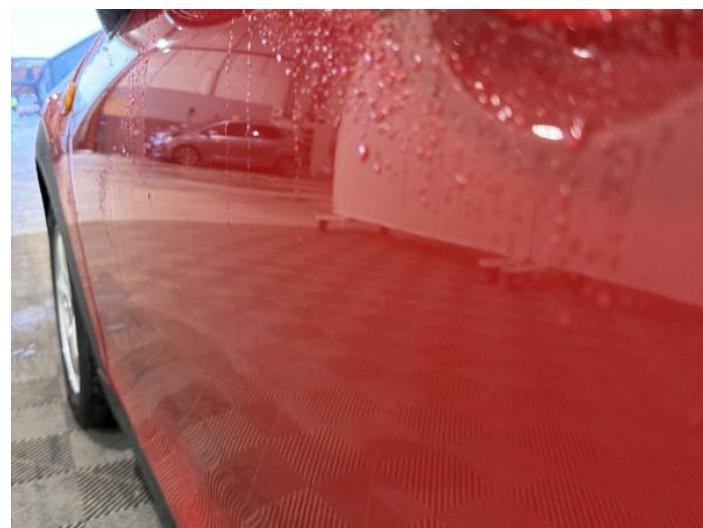
5: Door nsf
Chipped
1 To 5

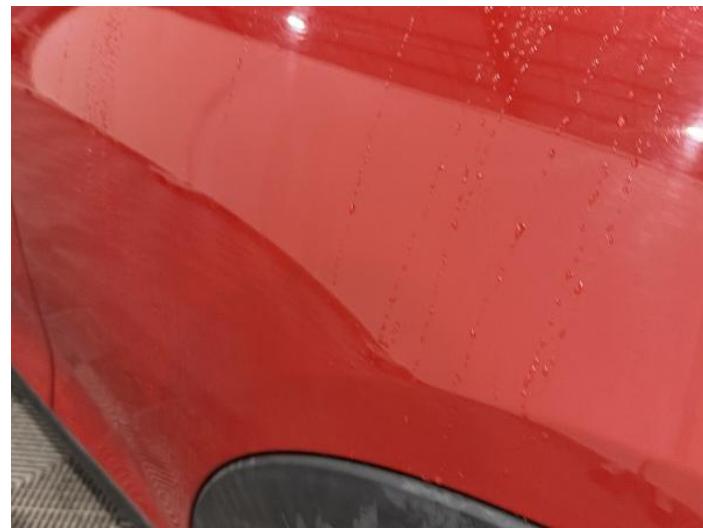
7: Qtr Panel nsr
Dented
Over 2 UpTo 10mm

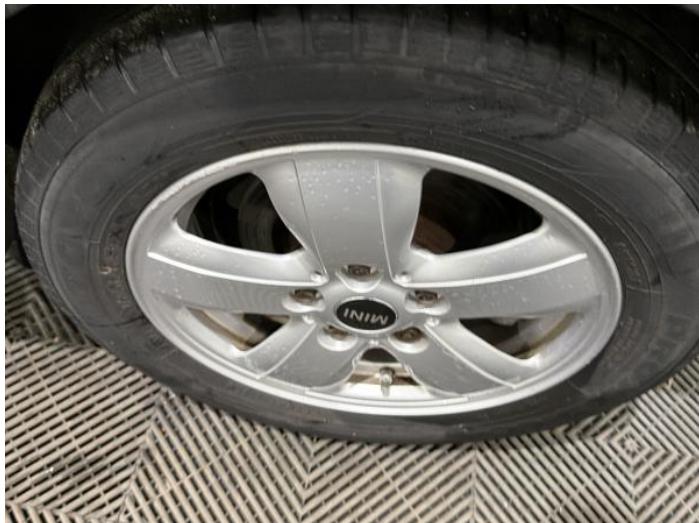
9: Wheel nsr
Scratched
Over 50mm

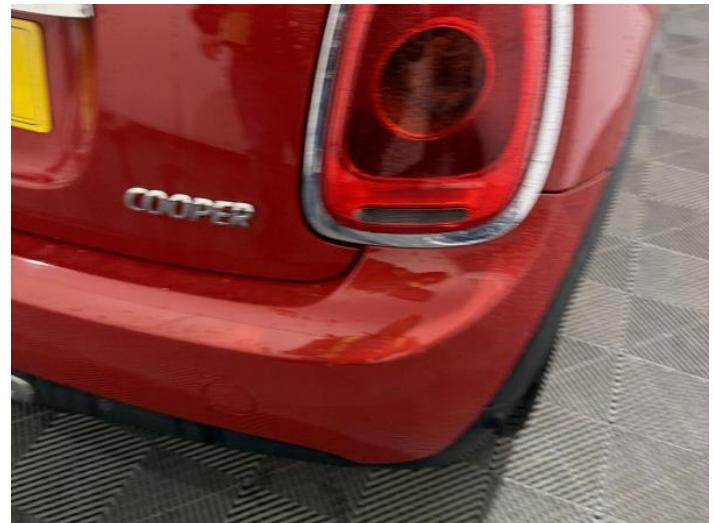
10: Bumper Rear
Poor Previous Repair
Poor Paint

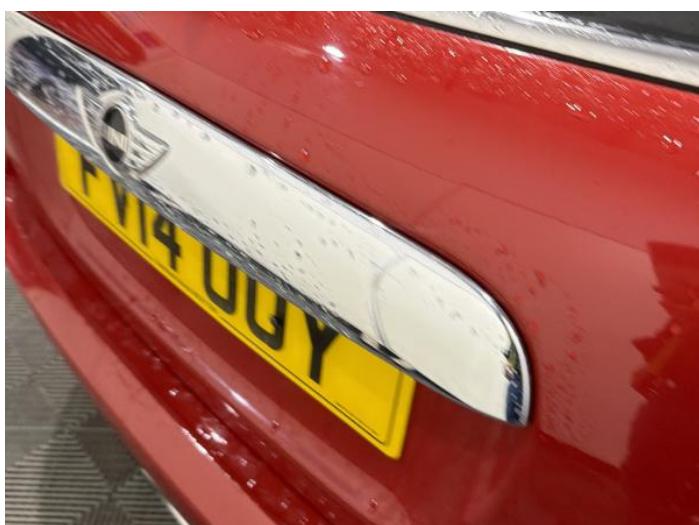
11: Boot Lid
Dented
Over 2 UpTo 10mm

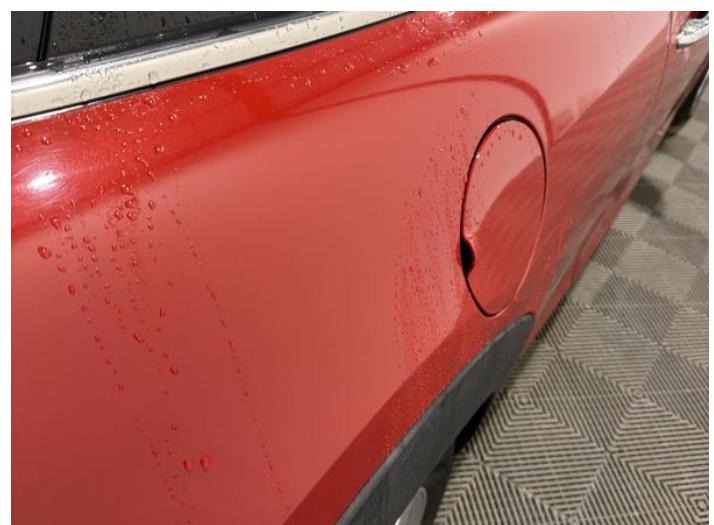
12: Qtr Panel osr
Dented
2 Or Less UpTo 10mm

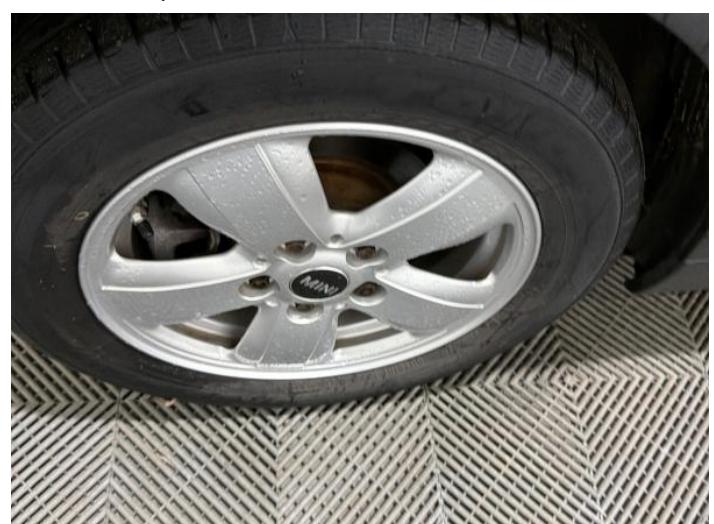
14: Wheel osr
Scratched
Up To 50mm

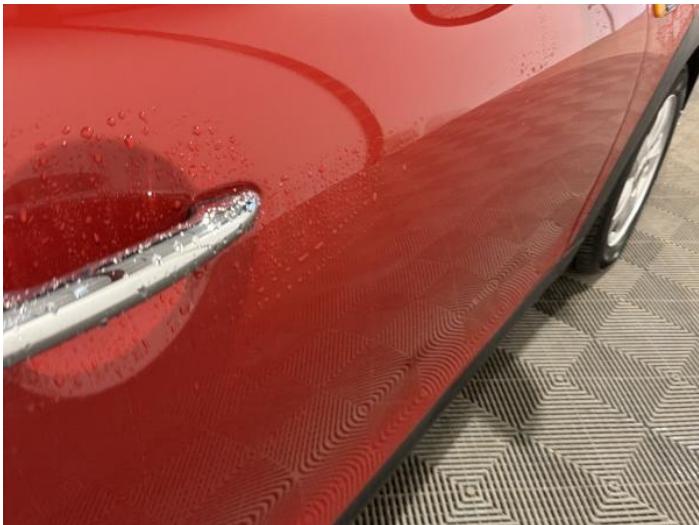
15: Door osf
Dented
Over 2 UpTo 10mm

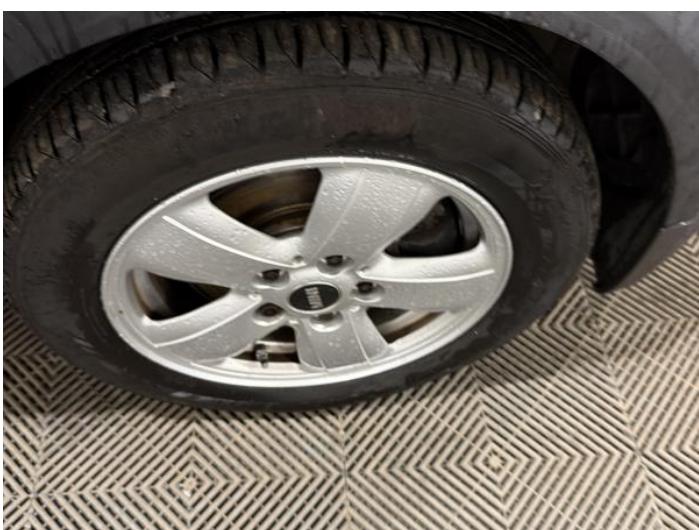
17: Wheel osf
Scratched
Up To 50mm
