# VEHICLE INSPECTION REPORT

FE05WCV

## Mini Hatchback 1.6 One 3dr

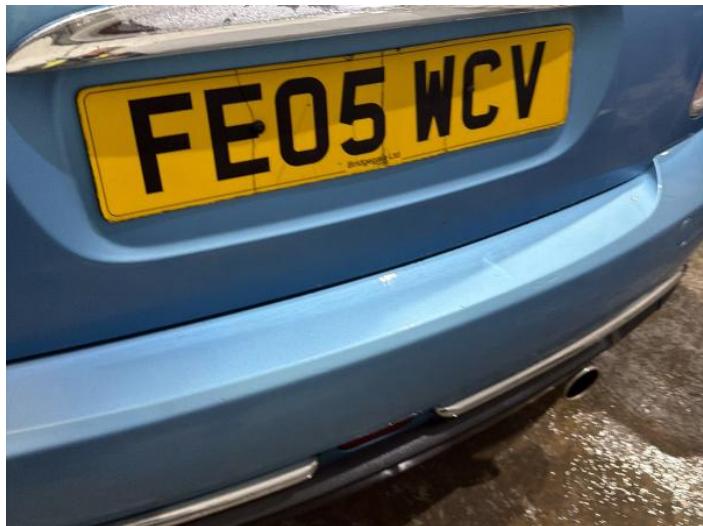
1: Bumper Rear  
Poor Previous Repair  
Poor Paint

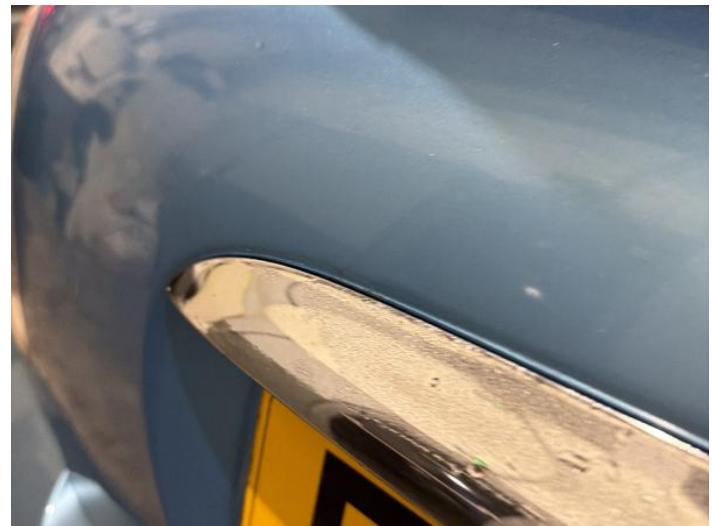
2: Boot Lid  
Dented  
Over 30mm

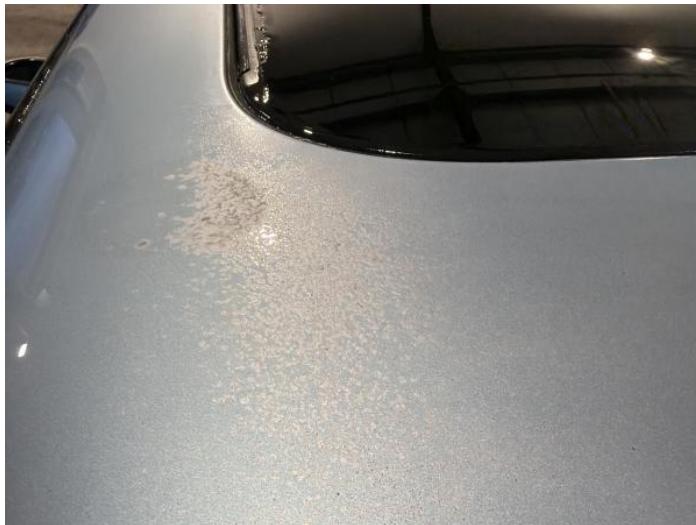
3: Roof  
Poor Previous Repair  
Poor Paint

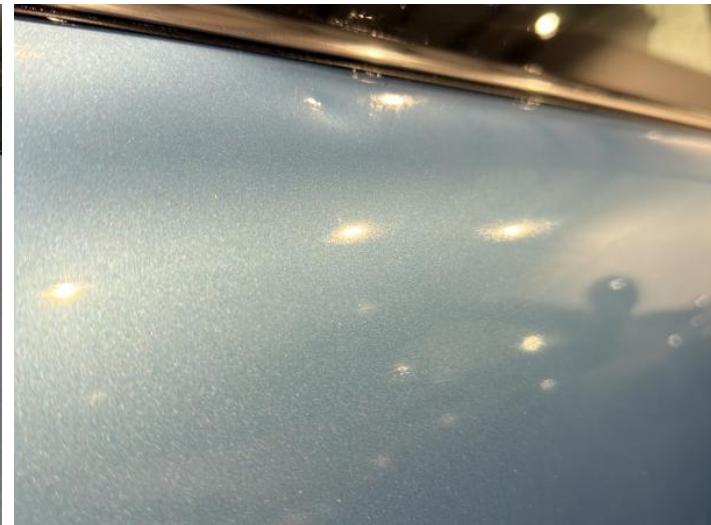
4: Qtr Panel osr  
Dented  
2 Or Less UpTo 10mm

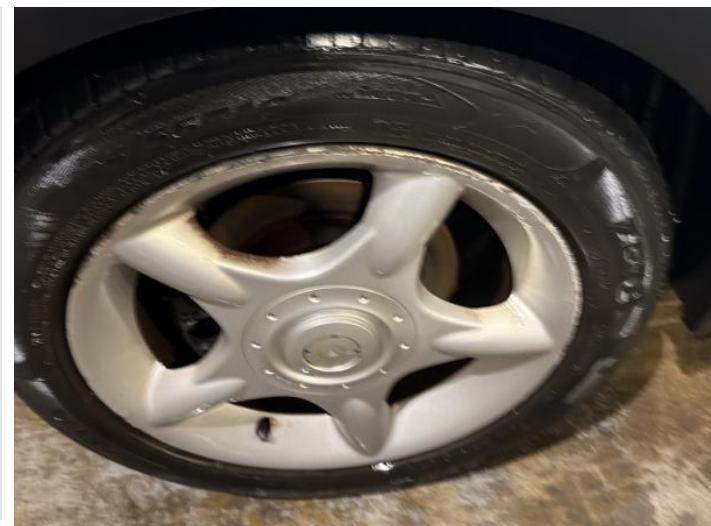
6: Wheel osr  
Scratched  
Over 50mm

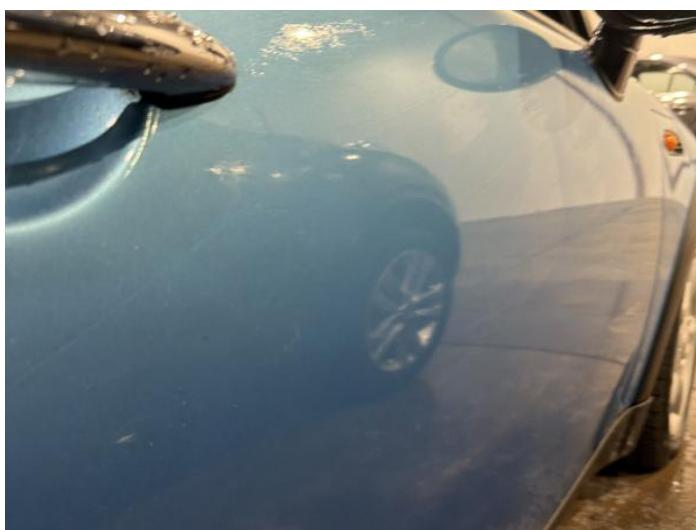
7: Door osf  
Dented  
Over 2 UpTo 10mm

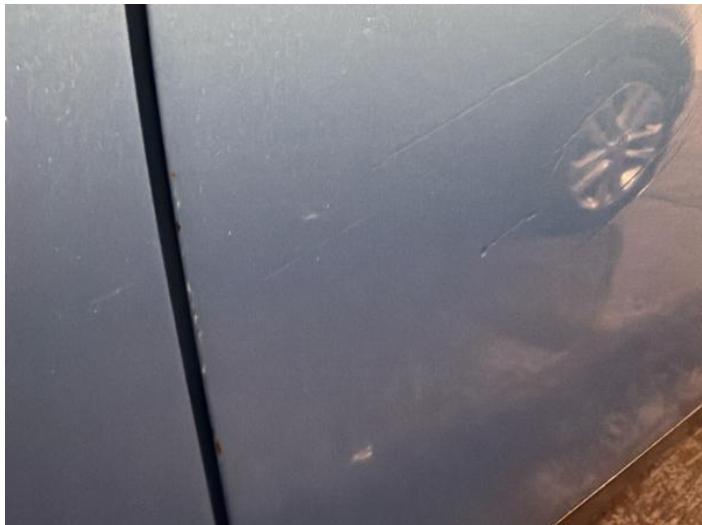
9: Door osf  
Chipped  
Edge Chip

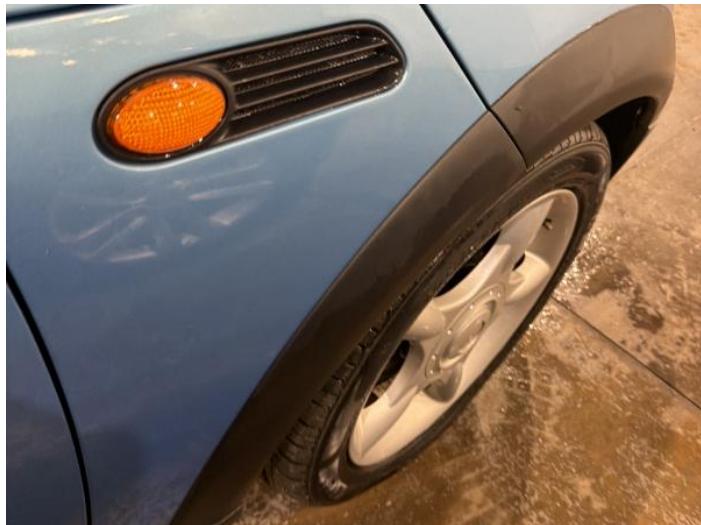
10: Wing osf  
Chipped  
1 To 5

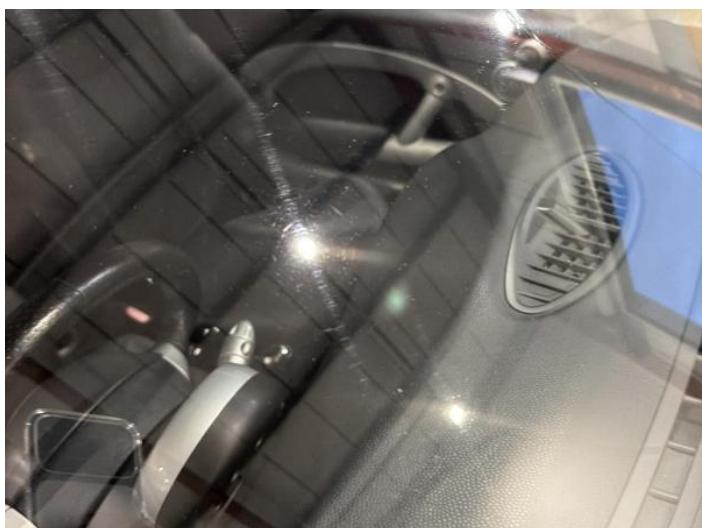
11: Screen Front  
Chipped  
UpTo 10mm

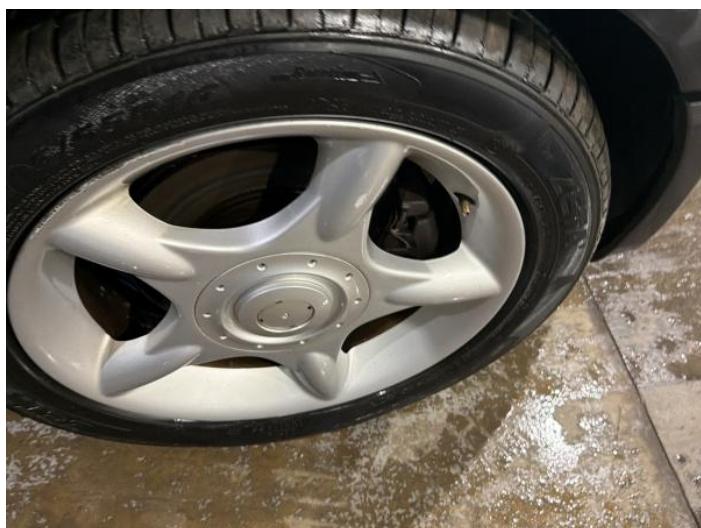
12: Wheel osf  
Scratched  
Over 50mm

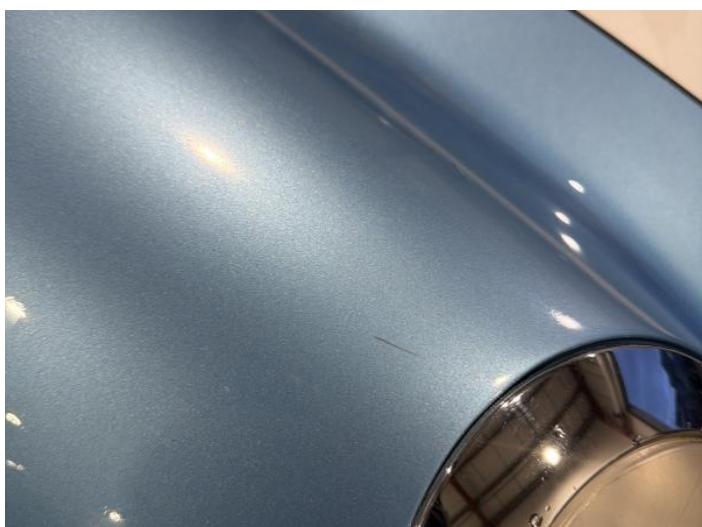
13: Bonnet  
Scratched  
Over 25mm Thru Paint

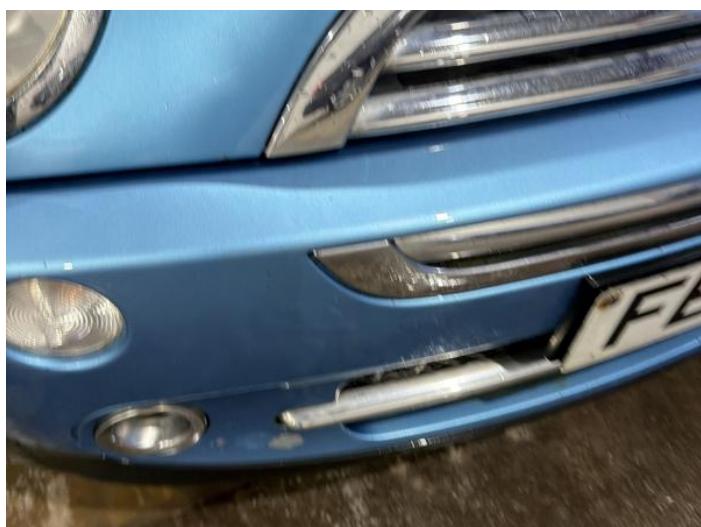
14: Bumper Front  
Poor Previous Repair  
Paint Flake

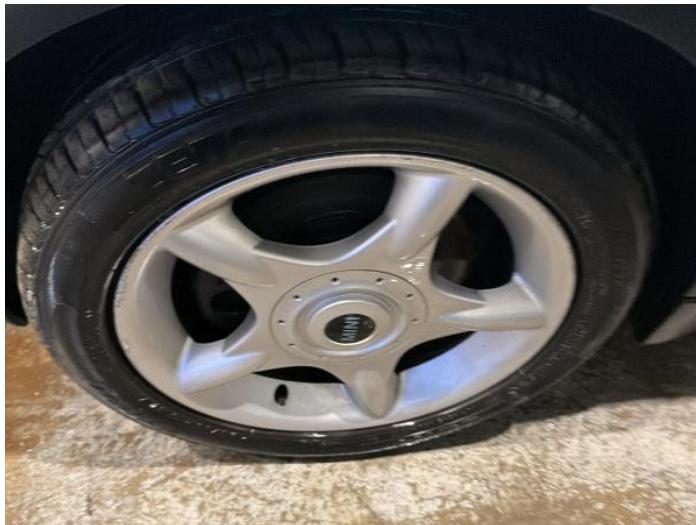
15: Wheel nsf  
Scratched  
Over 50mm

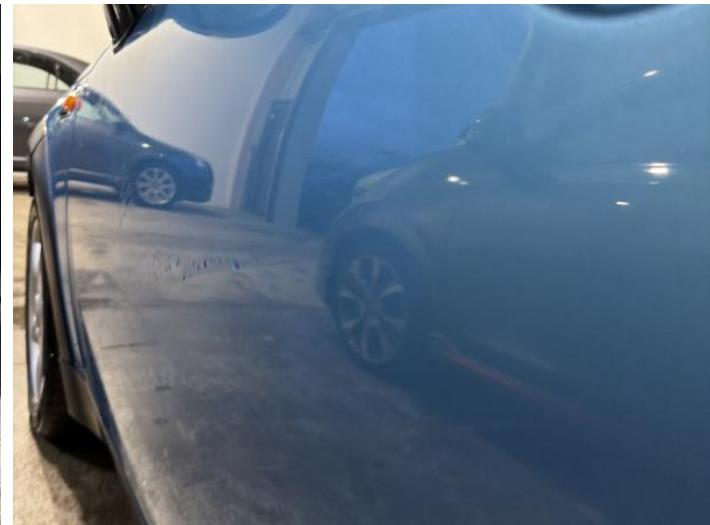
16: Door nsf  
Dented  
Over 2 UpTo 10mm

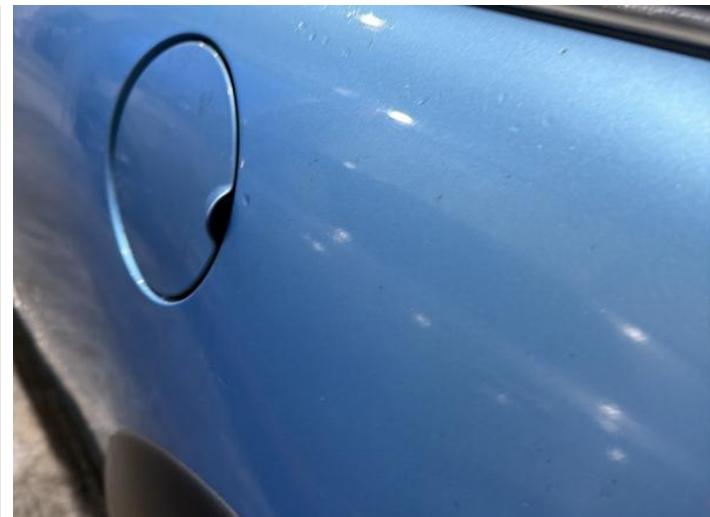
18: Qtr Panel nsr  
Dented  
Over 2 UpTo 10mm

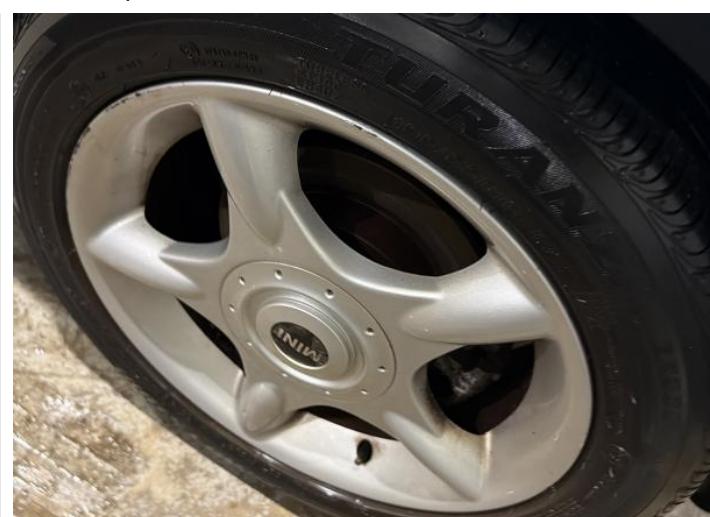
20: Wheel nsr  
Scratched  
Over 50mm
