VEHICLE INSPECTION REPORT

HY65OMG

Volkswagen Tiguan 2.0 TDi BlueMotion Tech R-Line 5dr 150 DSG [NAV]

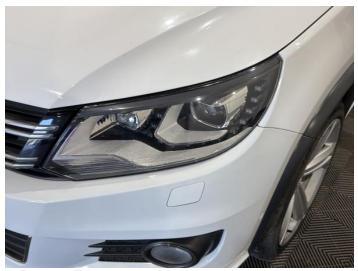
2: Bumper Front Poor Previous Repair Poor Paint

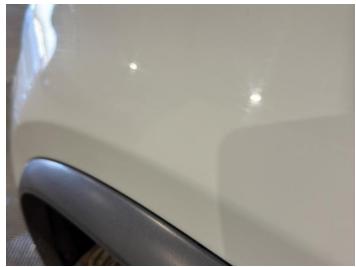
3: Wing nsf Chipped 1 To 5

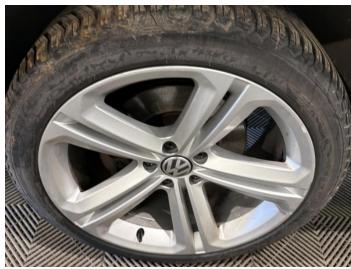
4: Wheel nsf Scratched Over 50mm

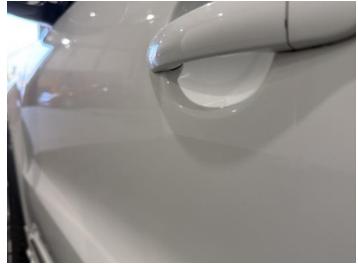
5: Door nsf Chipped 1 To 5

6: Door nsf Scratched Over 25mm Not Thru Paint

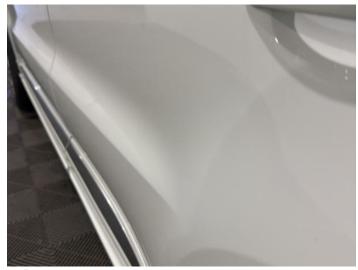
7: Door nsr Chipped 1 To 5

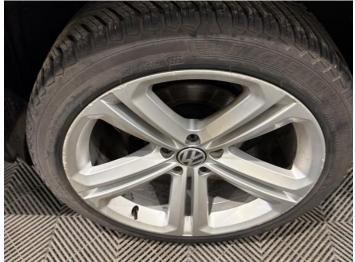
8: Wheel nsr Scratched Over 50mm

9: Qtr Panel nsr Scratched Over 25mm Not Thru Paint

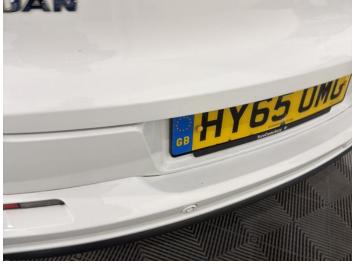
11: Bumper Rear Chipped Multiple Chips

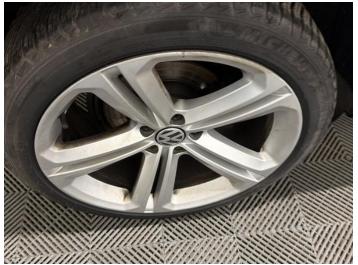
15: Wheel osr Scratched Over 50mm

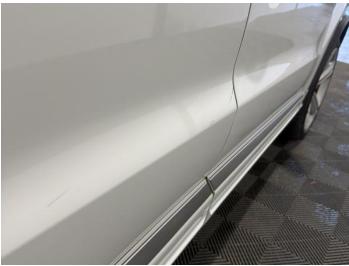
16: Door osf Scratched UpTo 25mm Thru Paint

17: Door osr Scratched Over 25mm Not Thru Paint

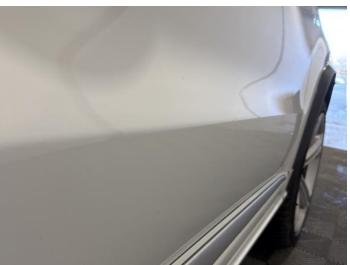
18: Door osf Dented Over 2 UpTo 10mm

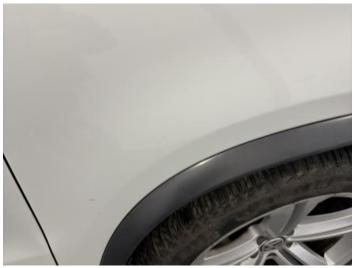
20: Wing osf Scratched UpTo 25mm Thru Paint

21: Wing osf Scratched Over 25mm Not Thru Paint

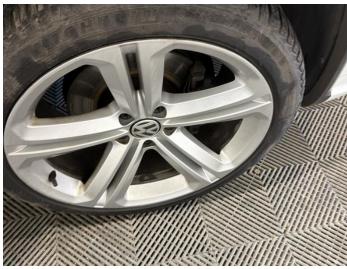
22: Wheel osf Scratched Over 50mm

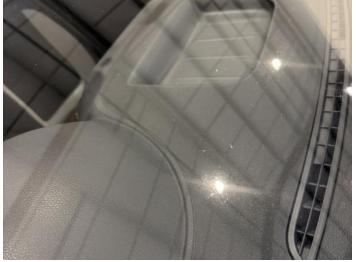
23: Screen Front Chipped UpTo 10mm
