VEHICLE INSPECTION REPORT

HK15VPA

Nissan Leaf 80kW Acenta 24kWh 5dr Auto

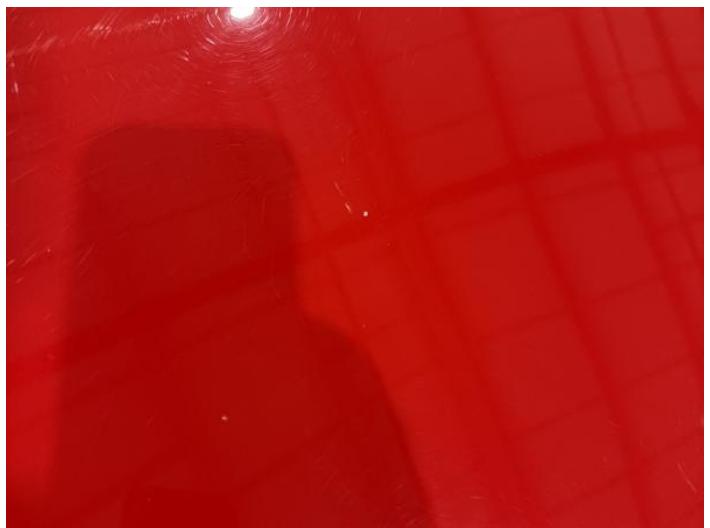
1: Bonnet
Scratched
Over 25mm Thru Paint

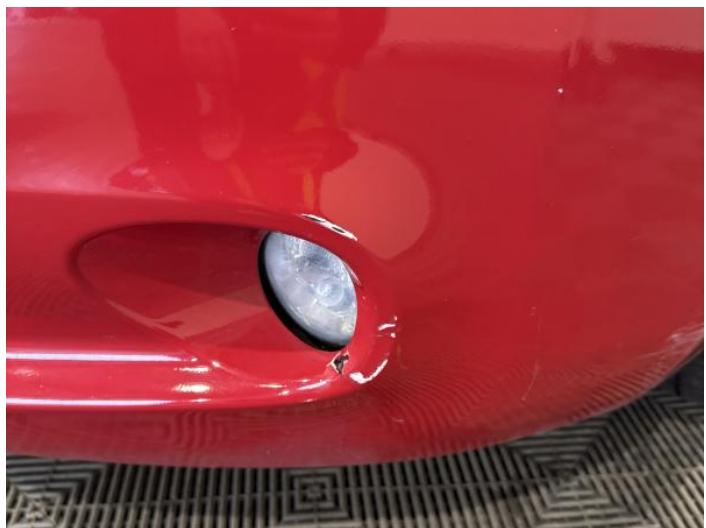
2: Bumper Front
Cracked
UpTo 25mm

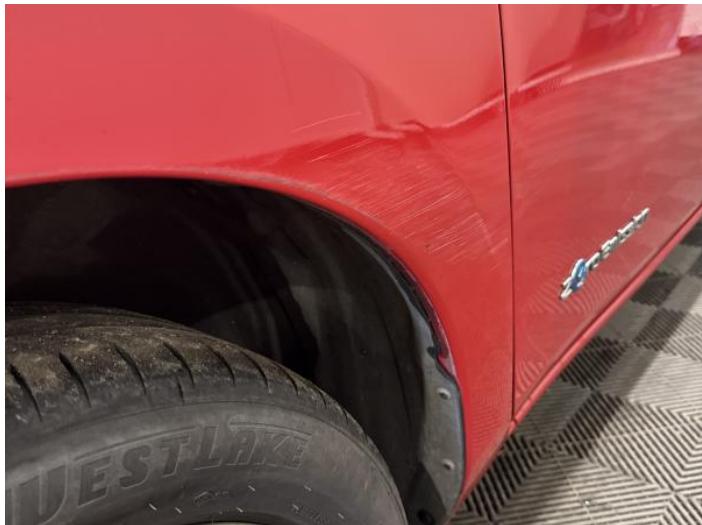
3: Wing nsf
Scratched
Over 25mm Thru Paint

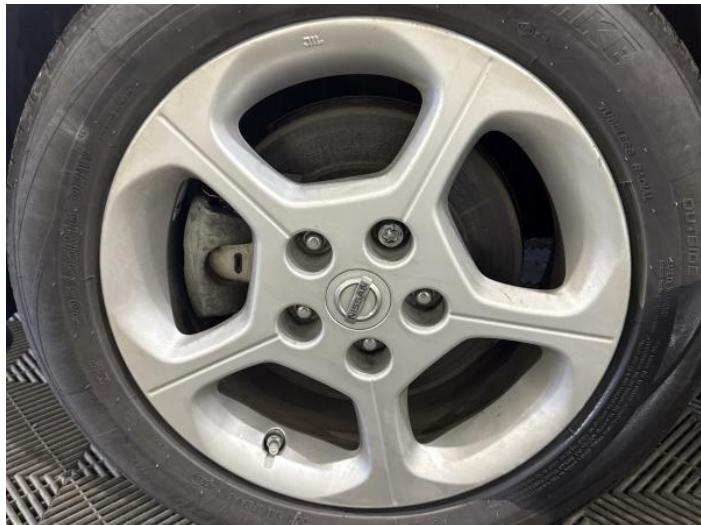
4: Wheel nsf
Scratched
Up To 50mm

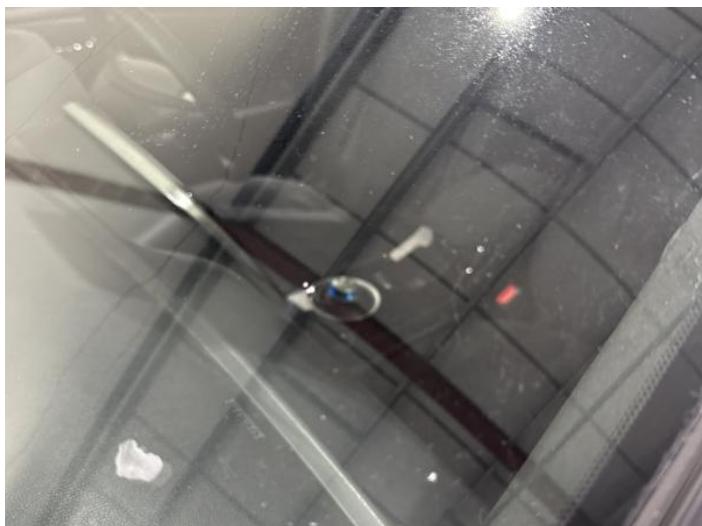
5: Screen Front
Chipped
UpTo 10mm

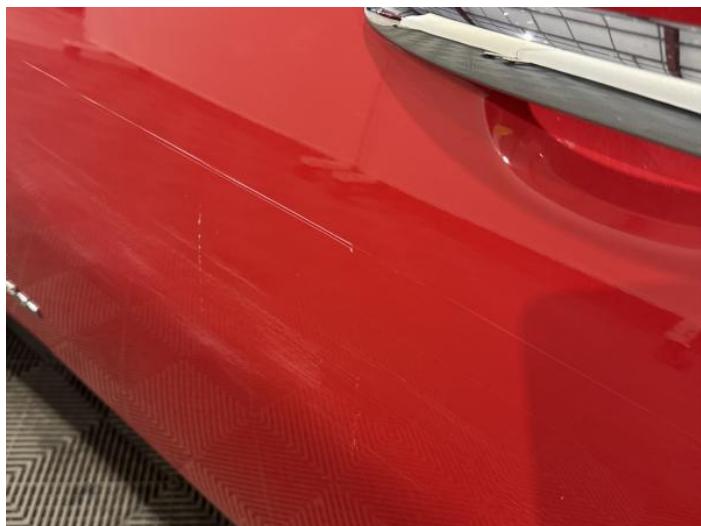
6: Door nsf
Scratched
Over 25mm Thru Paint

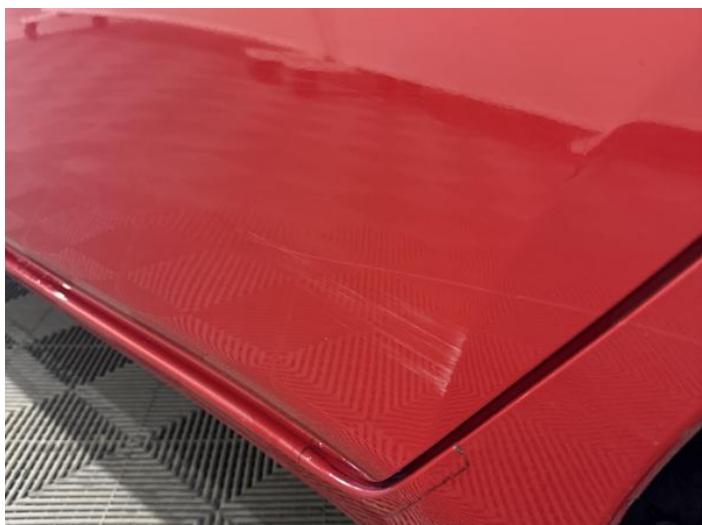
7: Door nsr
Scratched
Over 25mm Thru Paint

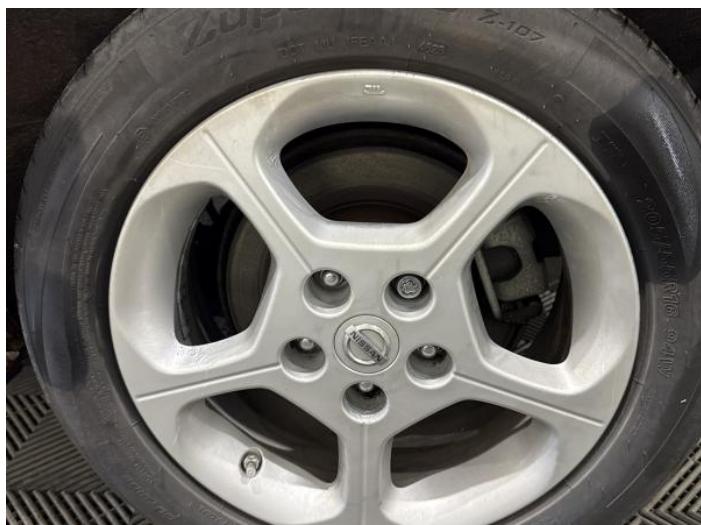
8: Wheel nsr
Corroded
Light

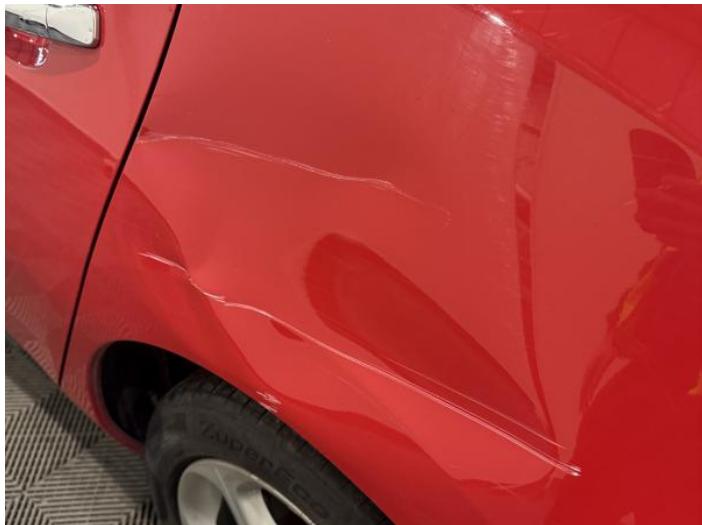
9: Qtr Panel nsr
Dented
With Paint Damage

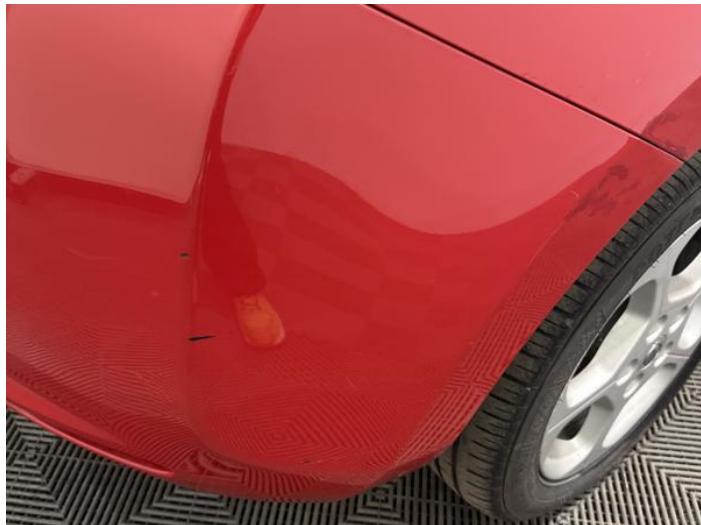
10: Bumper Rear
Scratched
Over 100mm Thru Paint

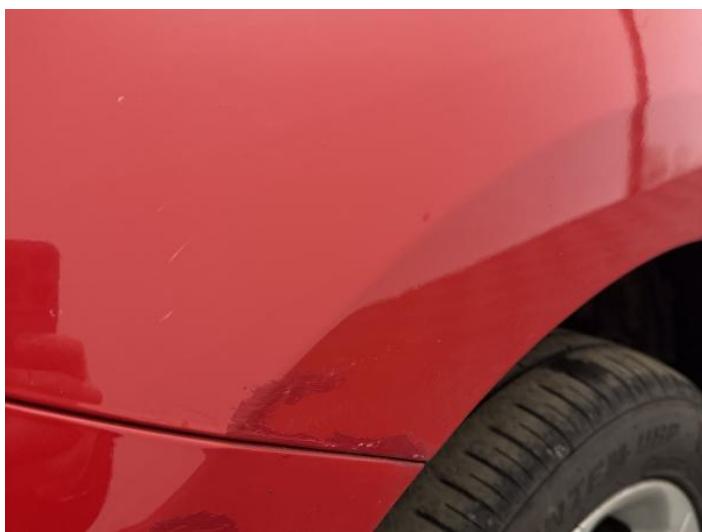
11: Qtr Panel osr
Scratched
Over 25mm Thru Paint

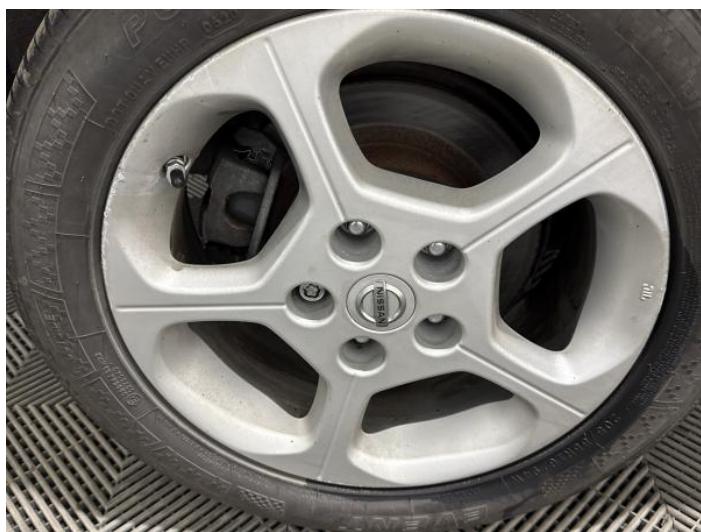
12: Wheel osr
Scratched
Over 50mm

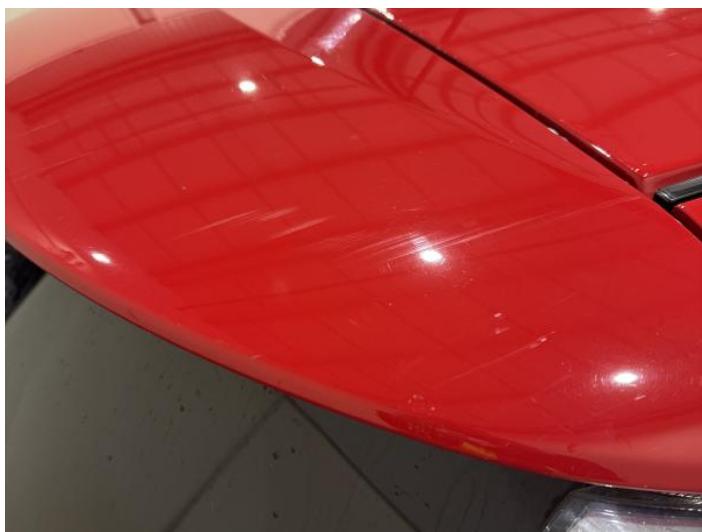
13: Spoiler Rear
Scratched (Painted)
Over 25mm Thru Paint

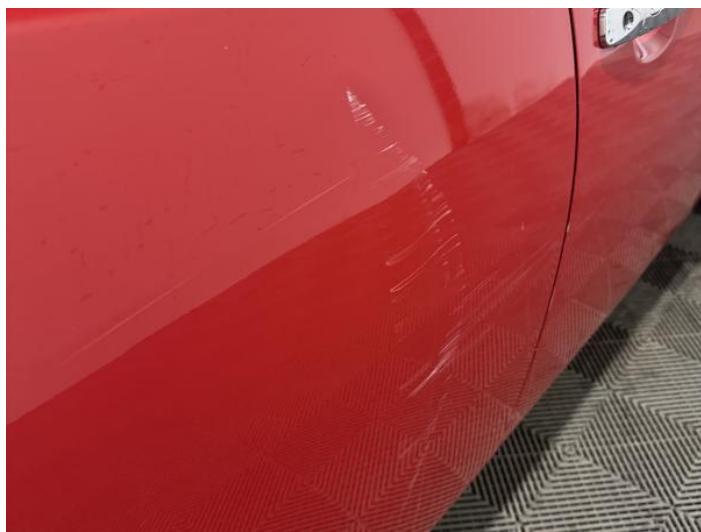
14: Door osr
Dented
With Paint Damage

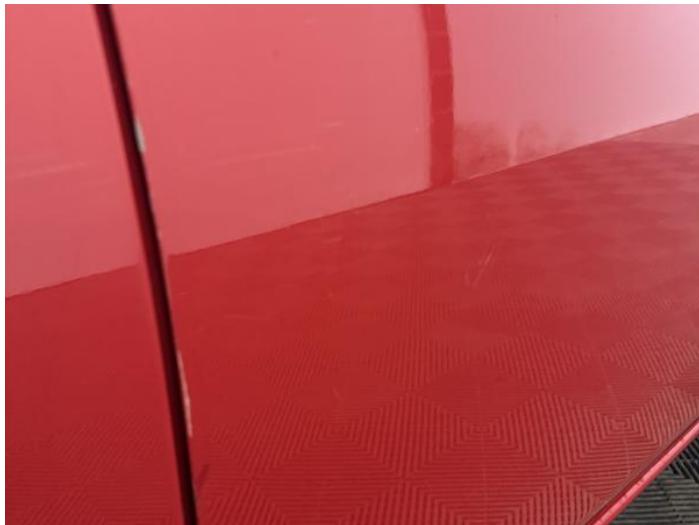
15: Door osf
Scratched
Over 25mm Thru Paint

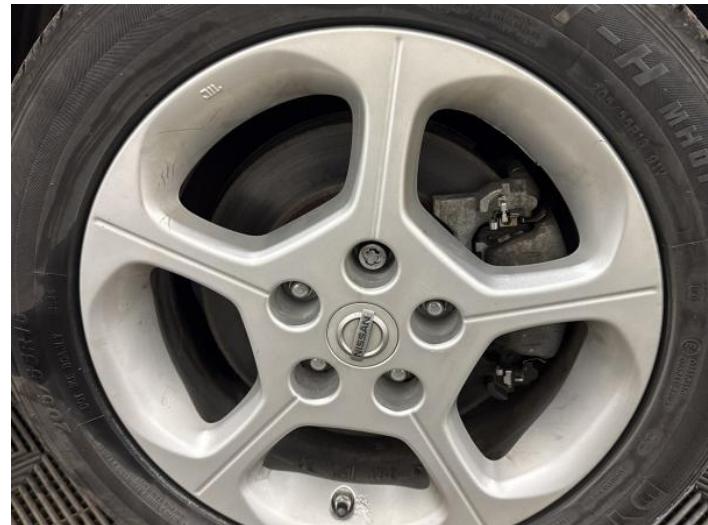
16: Wheel osf
Scratched
Over 50mm

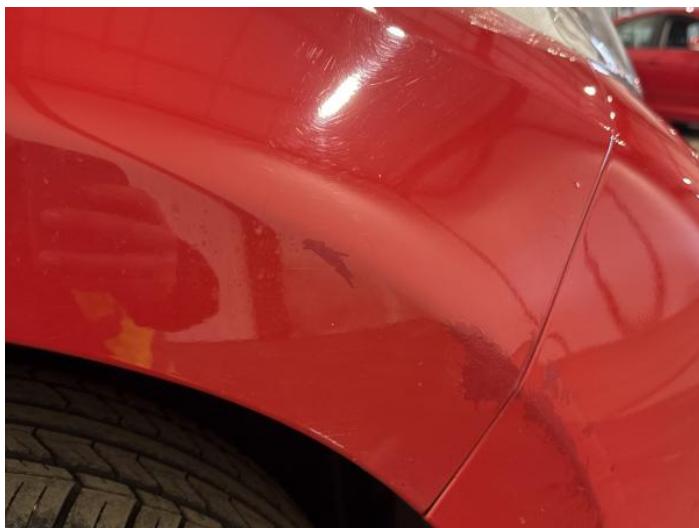
17: Wing osf
Scratched
Over 25mm Thru Paint
