## VEHICLE INSPECTION REPORT

BG19KFD

### Ford Mondeo 1.5 EcoBoost 165 Zetec Edition 5dr

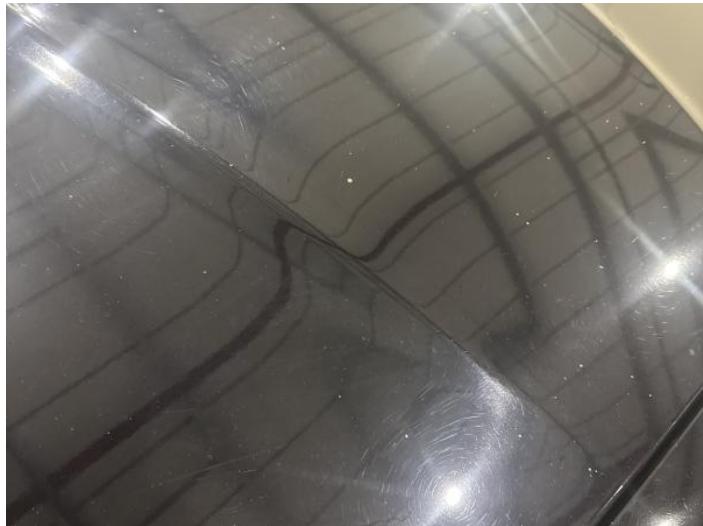
1: Bonnet  
Chipped  
Multiple Chips

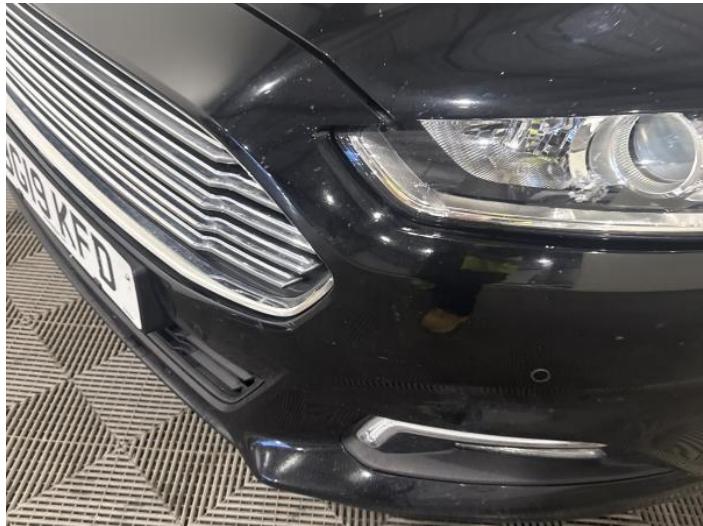
2: Bumper Front  
Chipped  
Multiple Chips

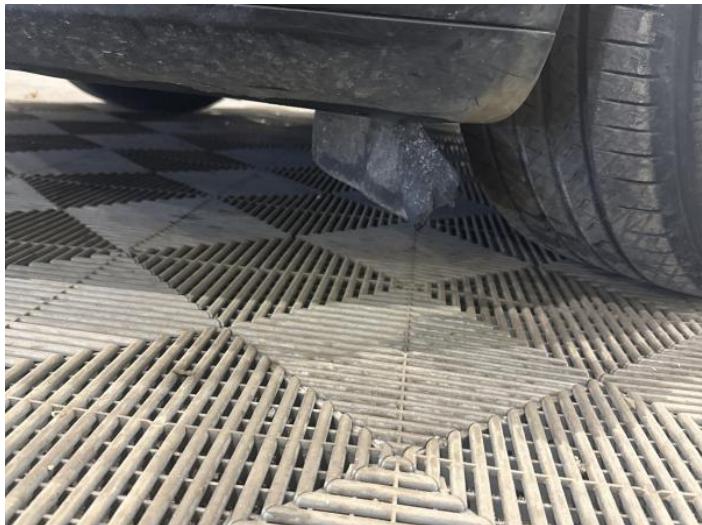
3: Bumper Front Moulding  
Broken  
Replace

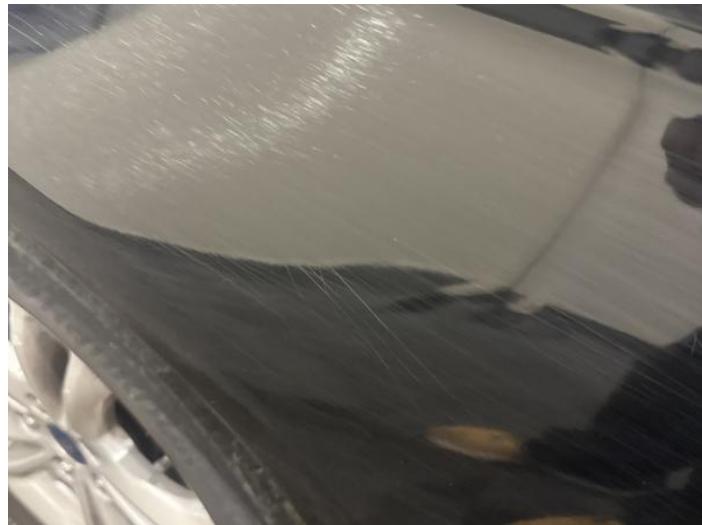
4: Wing nsf  
Scratched  
Over 25mm Thru Paint

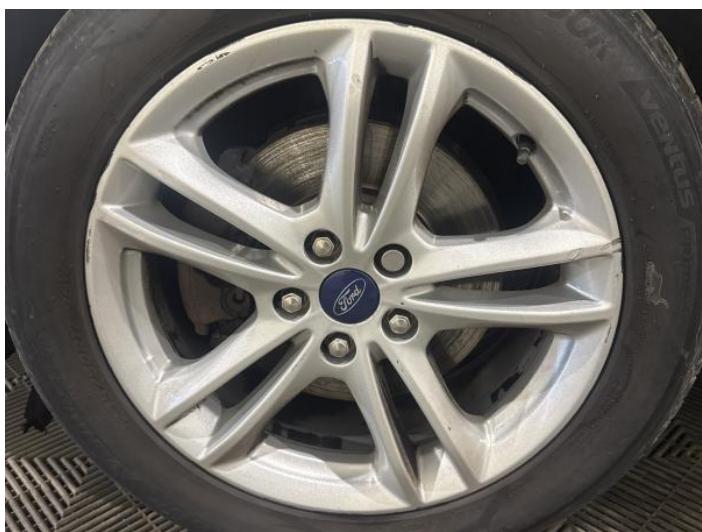
5: Wheel nsf  
Scratched  
Over 50mm

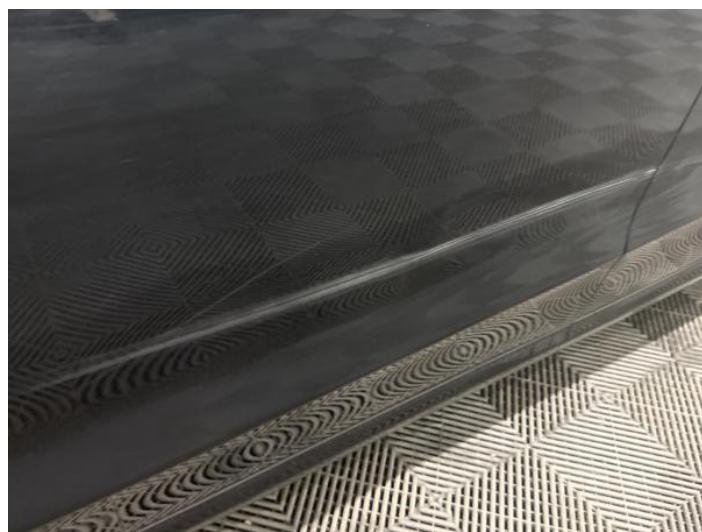
6: Door nsf  
Dented  
With Paint Damage

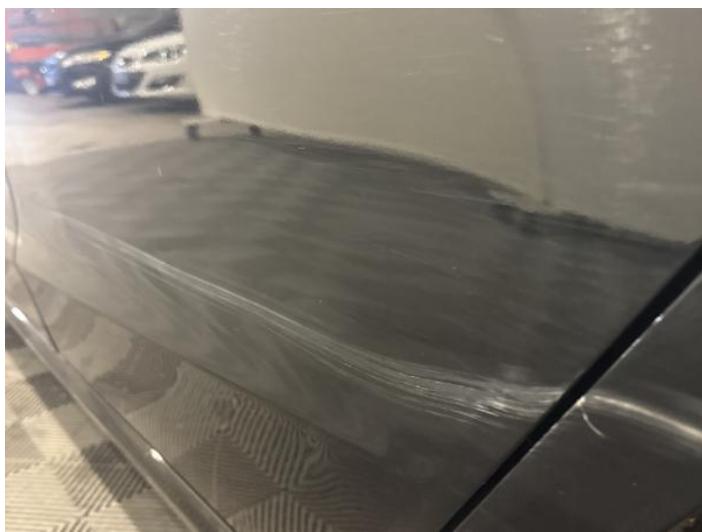
7: Door nsr  
Dented  
With Paint Damage

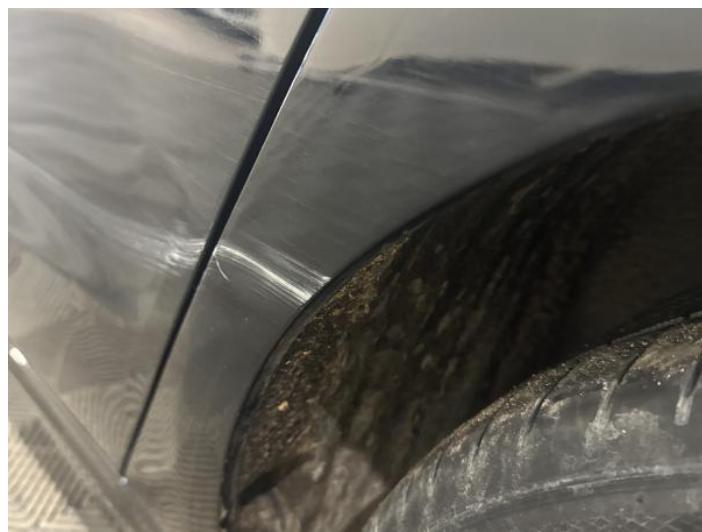
8: Qtr Panel nsr  
Scratched  
Over 25mm Thru Paint

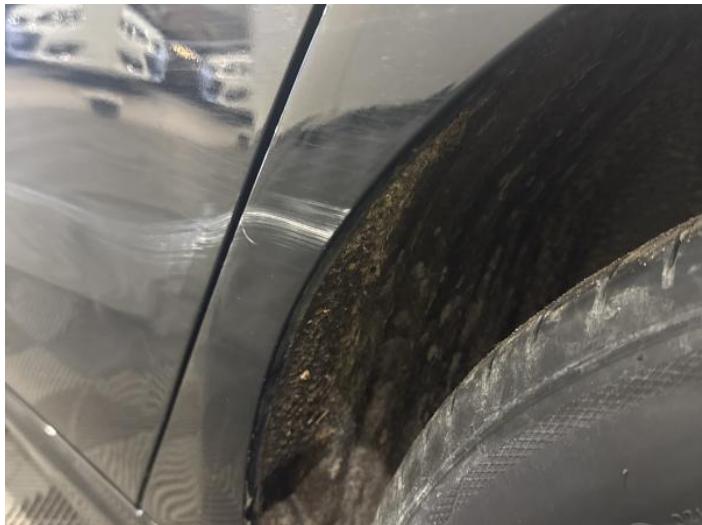
9: Qtr Panel nsr  
Dented  
Between 10mm + 30mm

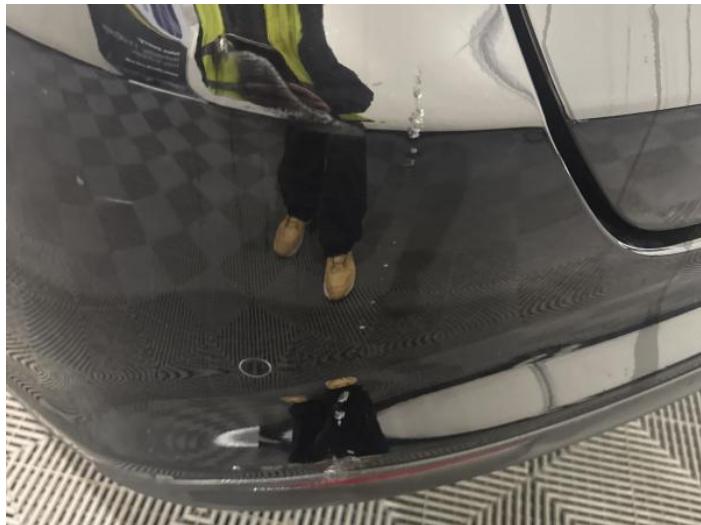
10: Bumper Rear  
Dented  
With Paint Damage

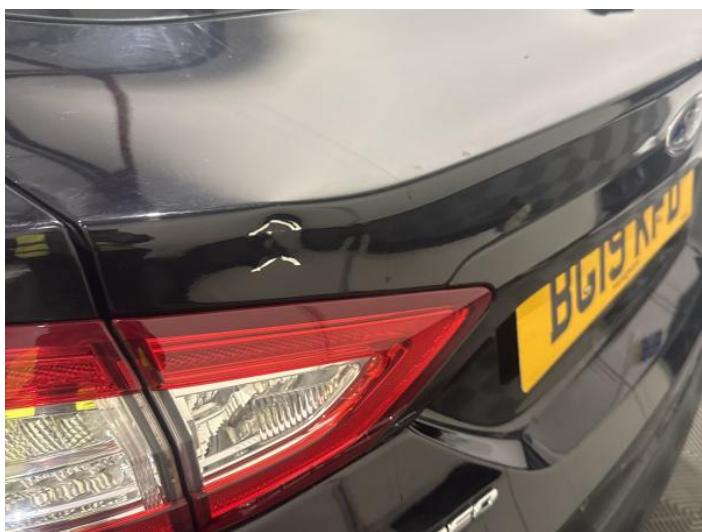
11: Tailgate  
Dented  
Over 30mm

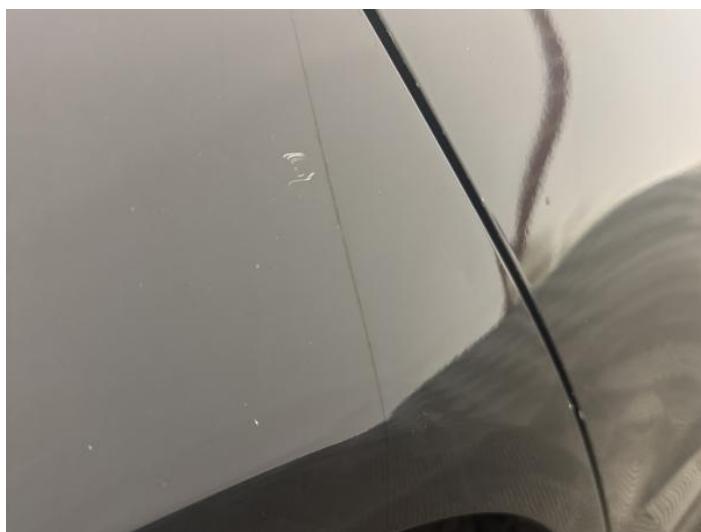
12: Qtr Panel osr  
Dented  
Between 10mm + 30mm

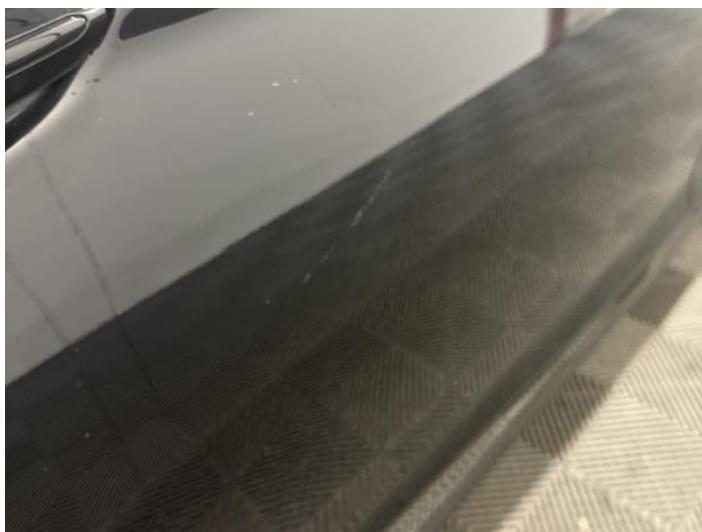
13: Door osr  
Scratched  
Over 25mm Thru Paint

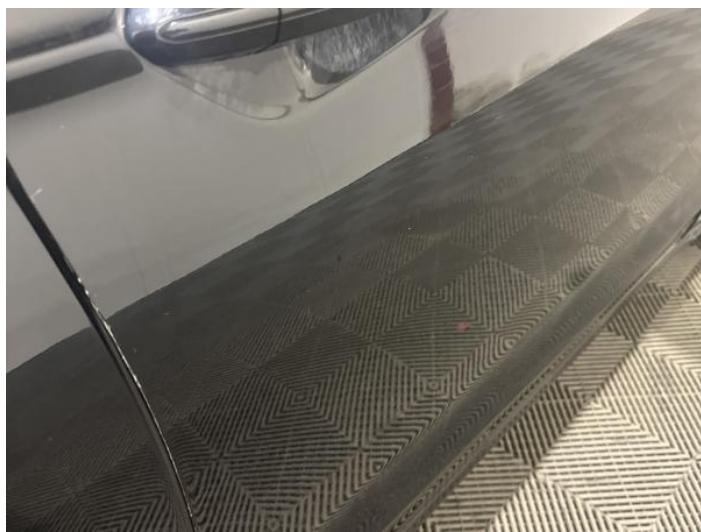
14: Door osf  
Scratched  
Over 25mm Thru Paint

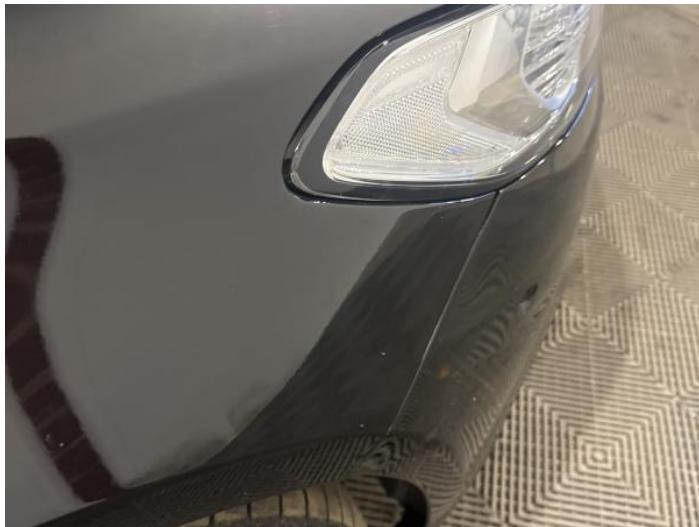
15: Wing osf  
Chipped  
1 To 5

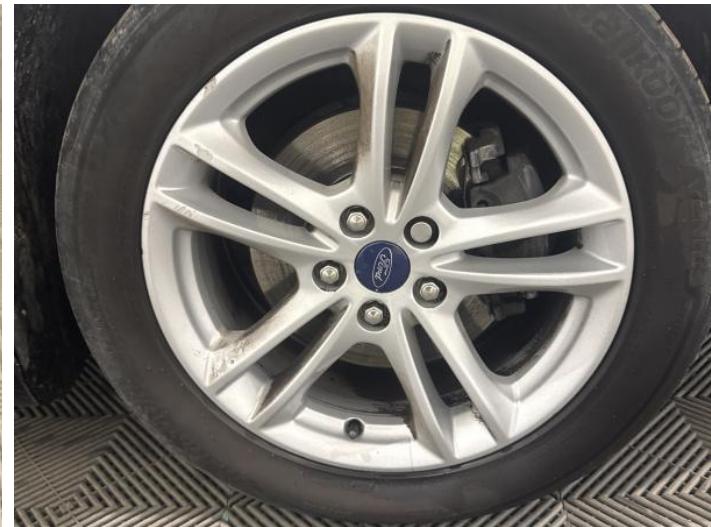
16: Wheel osf  
Scratched  
Over 50mm

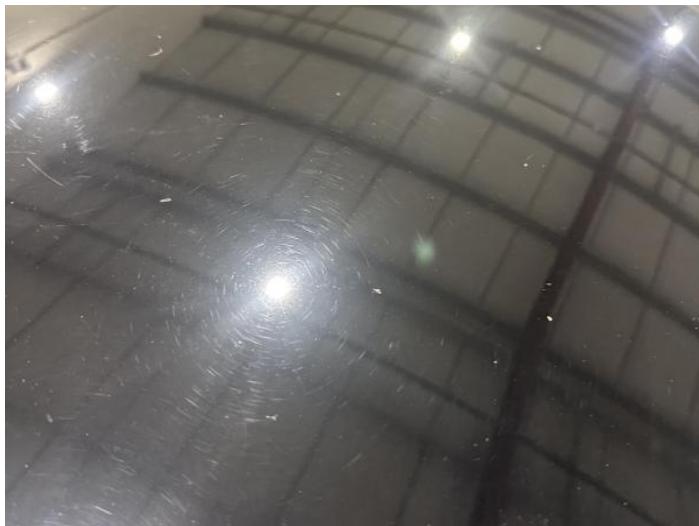
17: Roof  
Chipped  
Multiple Chips
