VEHICLE INSPECTION REPORT

RX14NZZ

Fiat 500 1.2 S 3dr

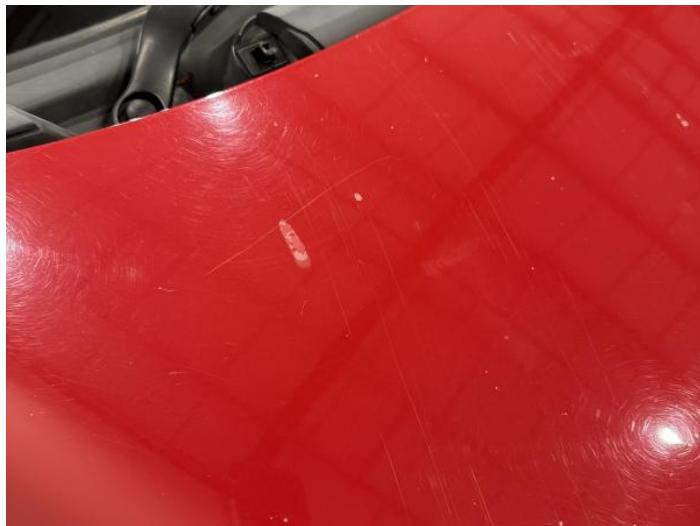
1: Bonnet
Poor Previous Repair
Paint Flake

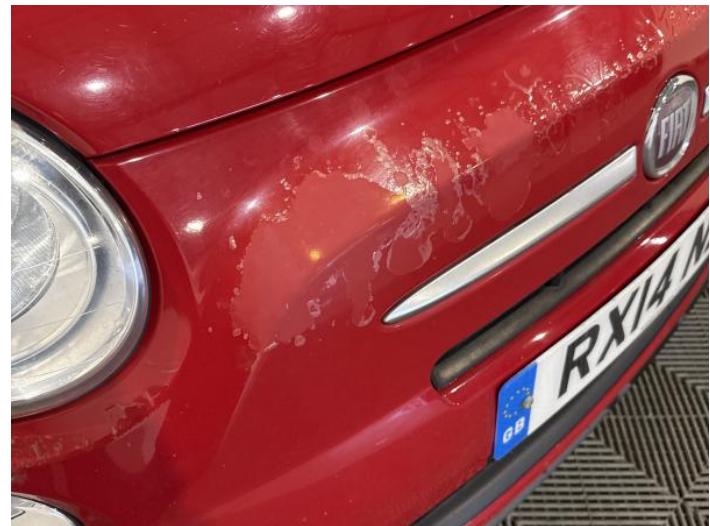
2: Bumper Front
Poor Previous Repair
Paint Flake

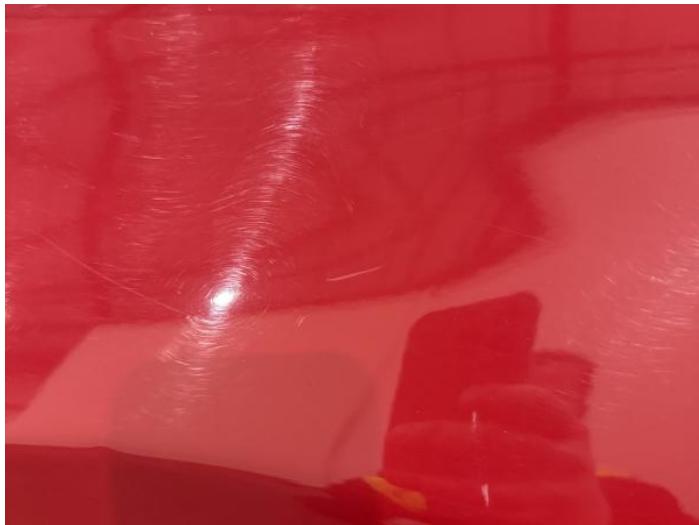
3: Wing nsf
Scratched
UpTo 25mm Thru Paint

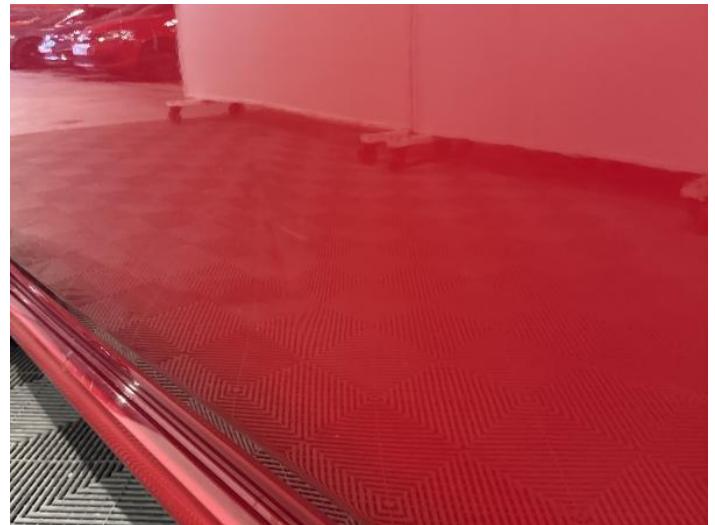
4: Door nsf
Dented
Over 30mm

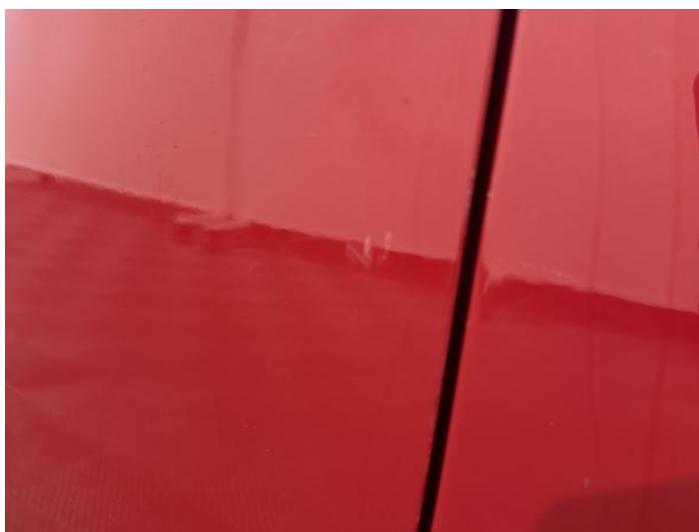
5: Door nsf
Scratched
UpTo 25mm Thru Paint

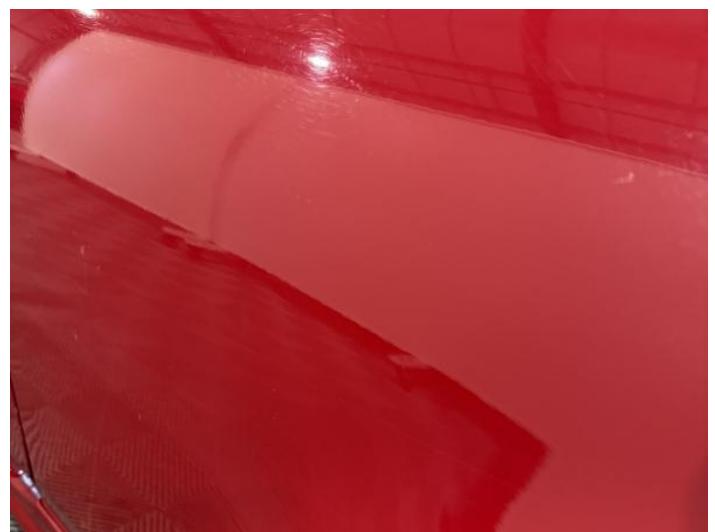
6: Qtr Panel nsr
Dented
Between 10mm + 30mm

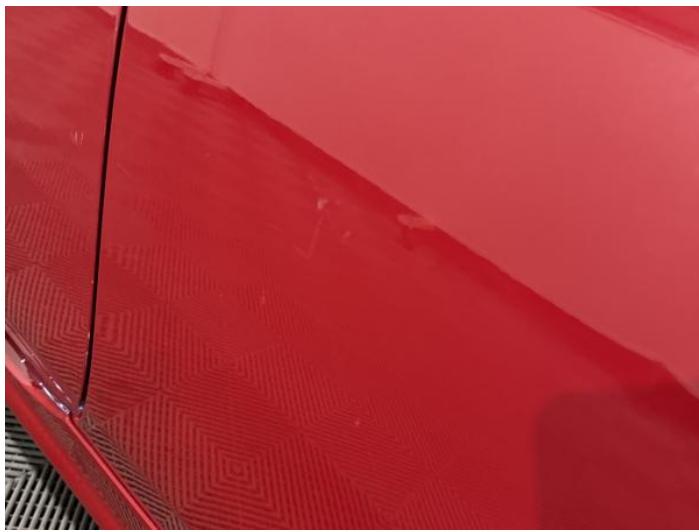
7: Qtr Panel nsr
Scratched
Over 25mm Thru Paint

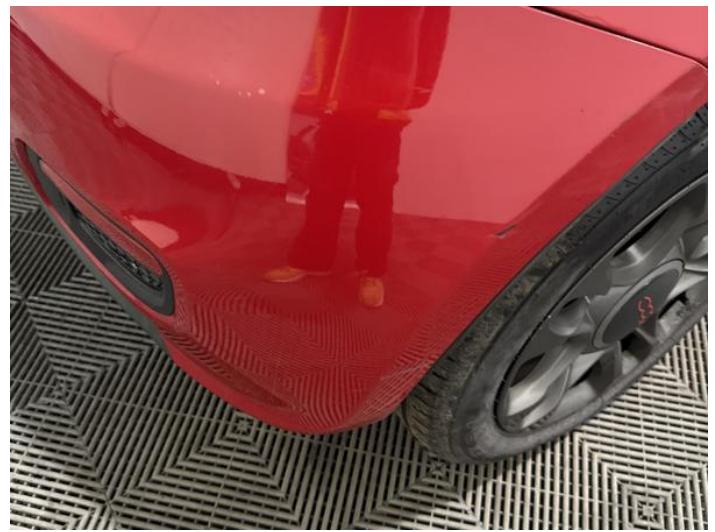
8: Bumper Rear
Scratched
Over 100mm Thru Paint

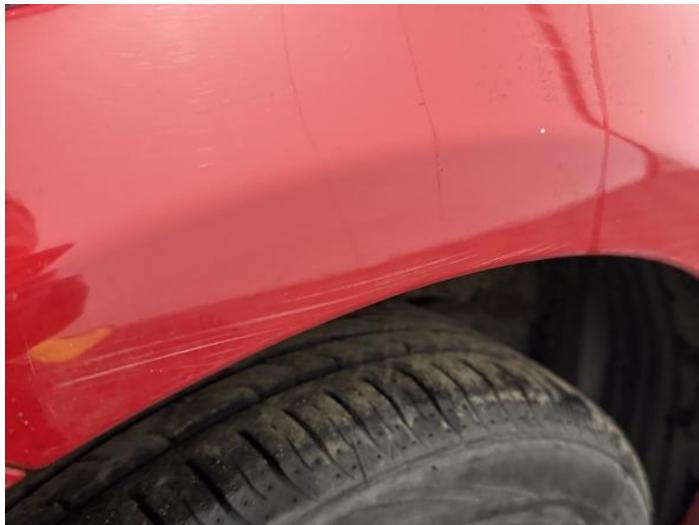
9: Qtr Panel osr
Scratched
Over 25mm Thru Paint

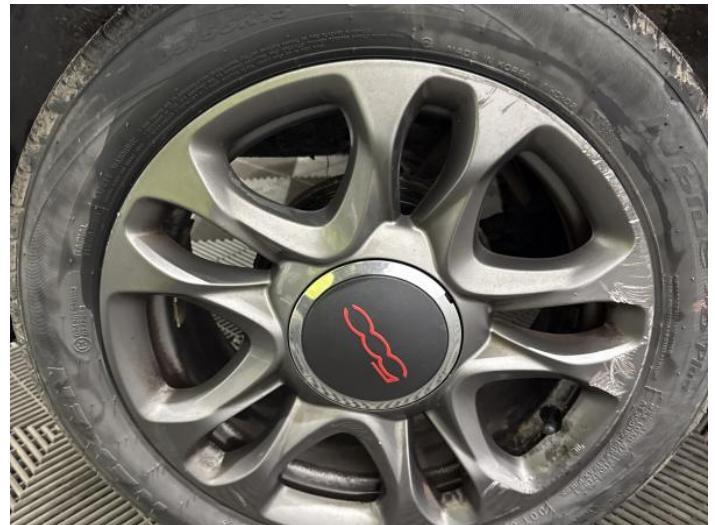
10: Wheel osr
Scratched
Over 50mm

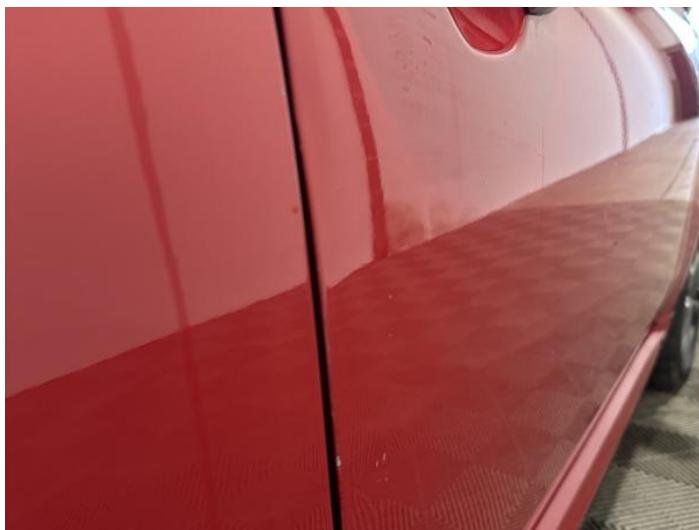
11: Door osf
Dented
With Paint Damage

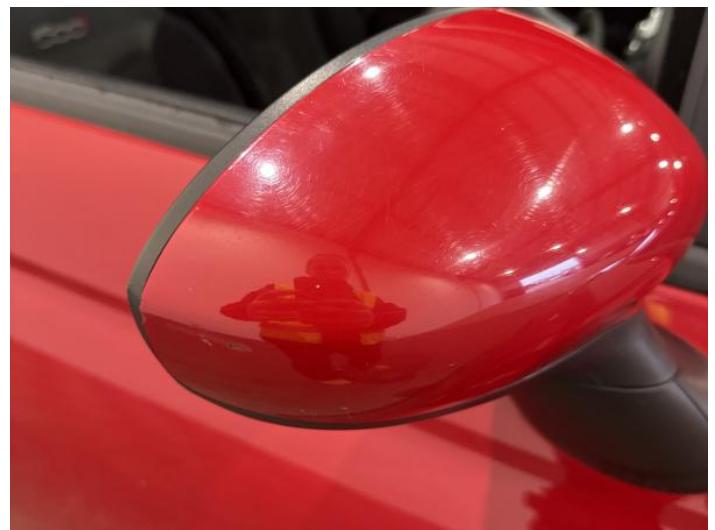
12: Door Mirror Assy osf
Scratched (Painted)
UpTo 25mm Thru Paint

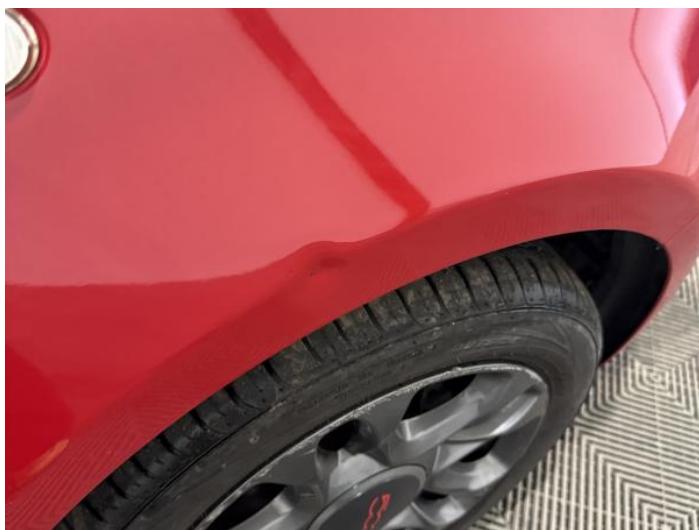
13: Wing osf
Dented
Over 30mm

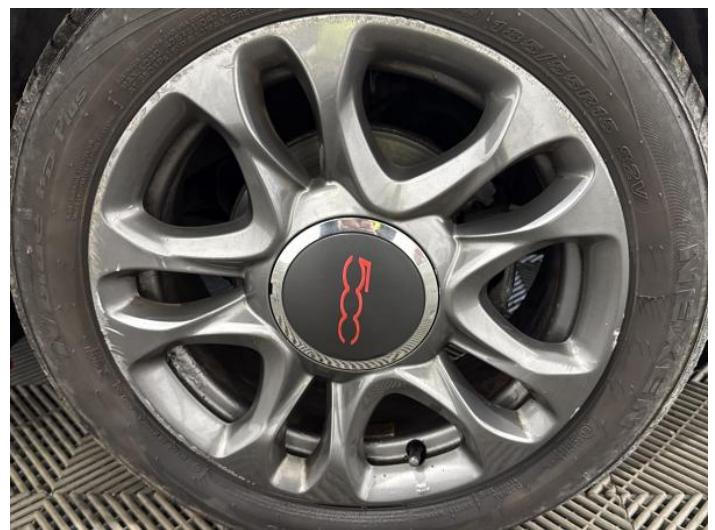
14: Wheel osf
Scratched
Over 50mm

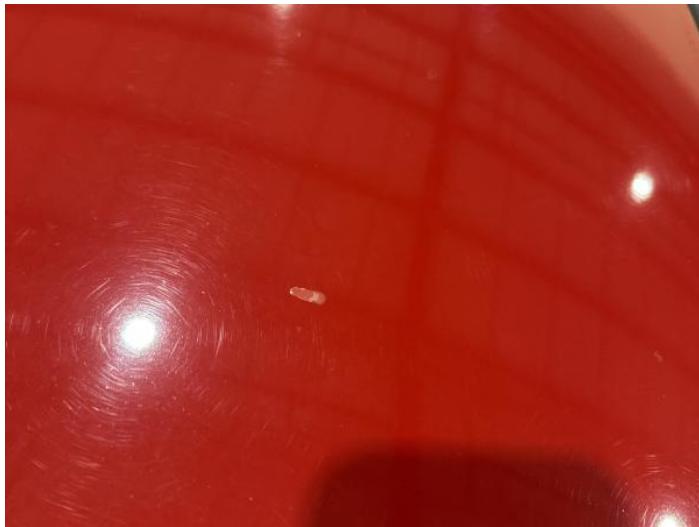
15: Roof
Scratched
UpTo 25mm Thru Paint
