VEHICLE INSPECTION REPORT

HT68FEK

Kia Stonic 1.0T GDi 4 5dr Auto

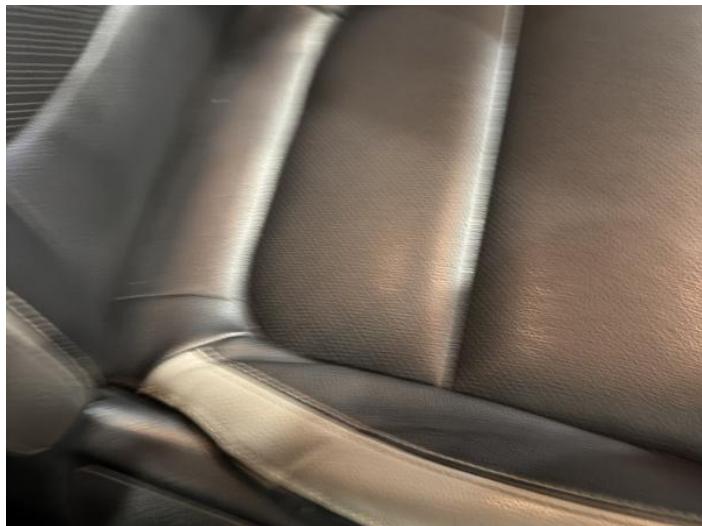
1: Seat Base Cover osf
Torn
Over 3mm

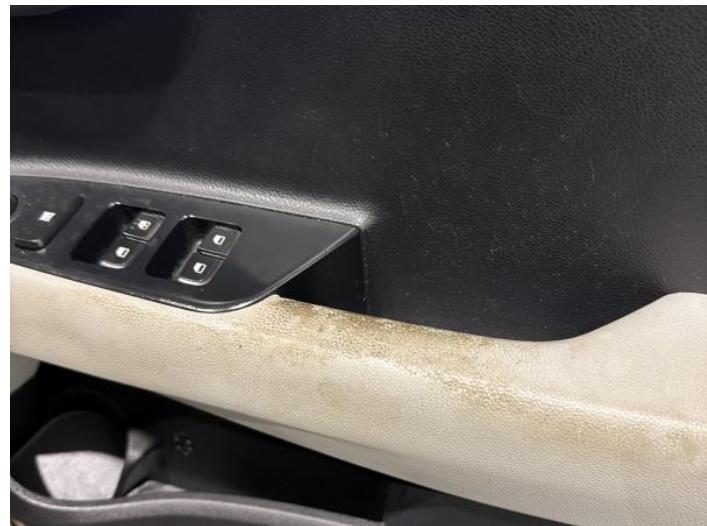
2: Door Pad osf
Scuffed
Over 25mm

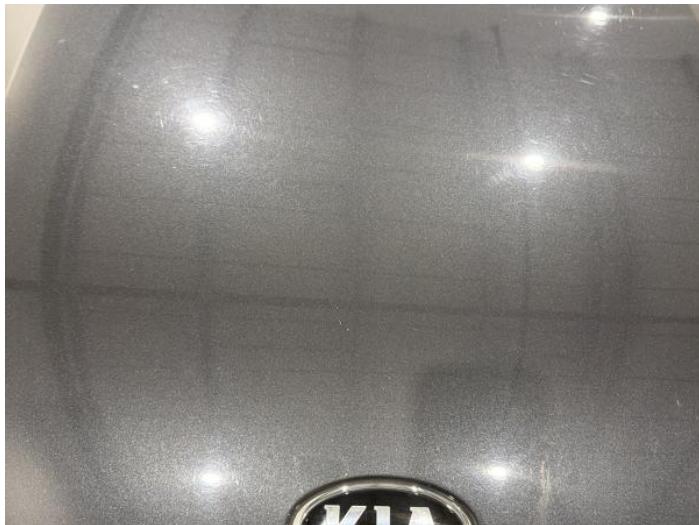
3: Bonnet
Chipped
Multiple Chips

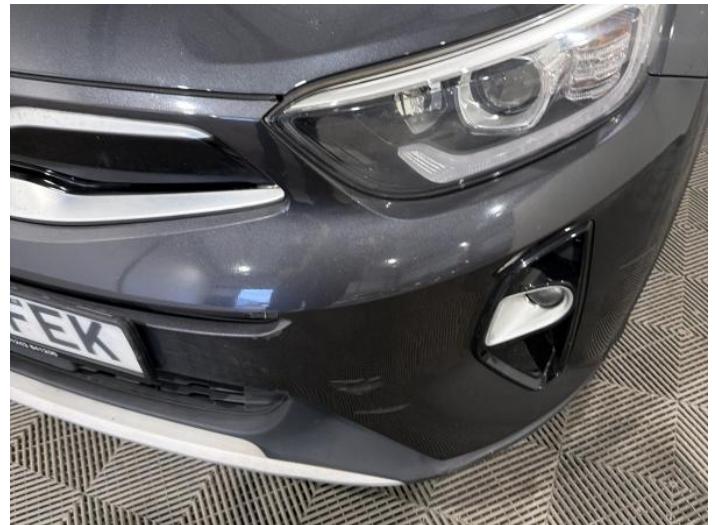
4: Bumper Front
Scratched
Over 100mm Thru Paint

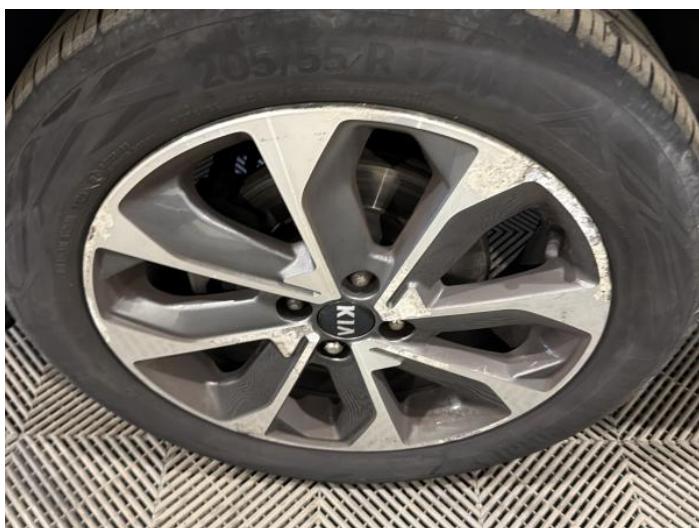
5: Wheel nsf
Scratched
Over 50mm

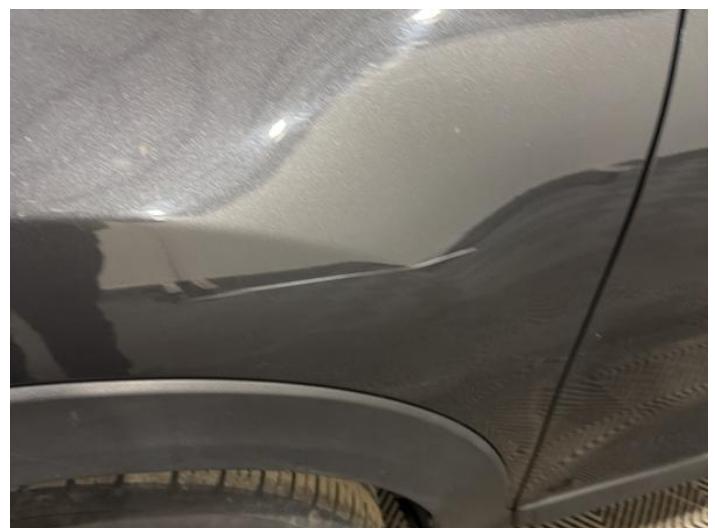
6: Wing nsf
Scratched
Over 25mm Thru Paint

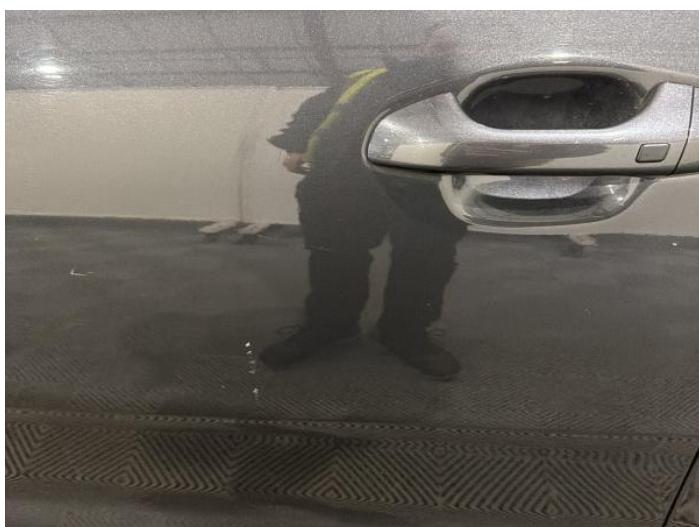
7: Door nsf
Chipped
Multiple Chips

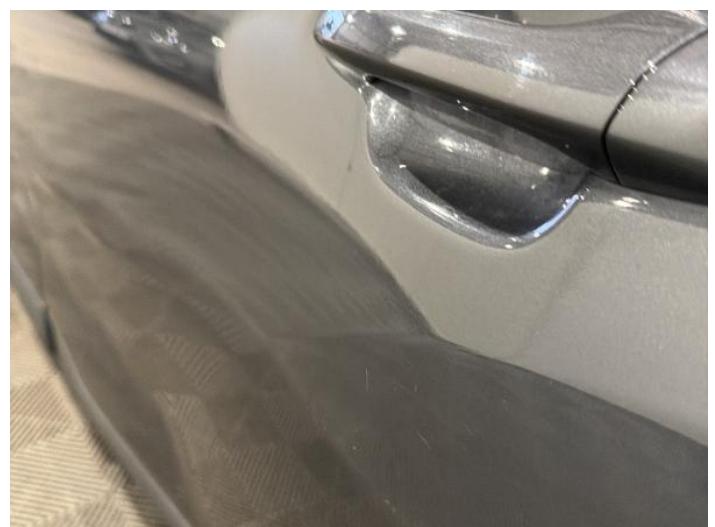
8: Door nsf
Dented
With Paint Damage

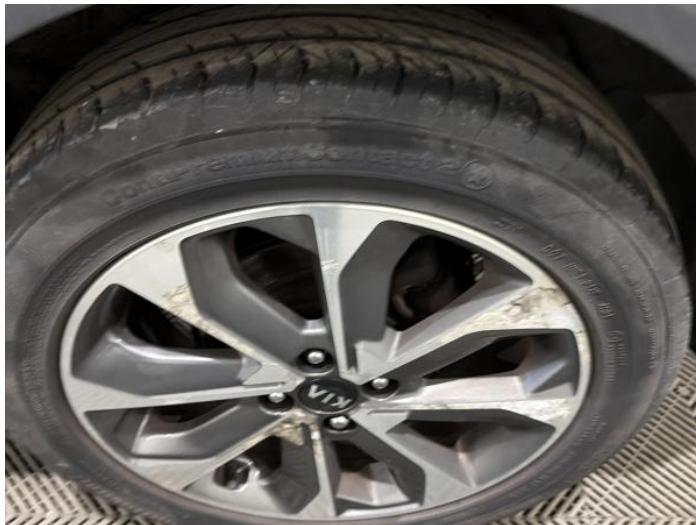
9: Wheel nsr
Scratched
Over 50mm

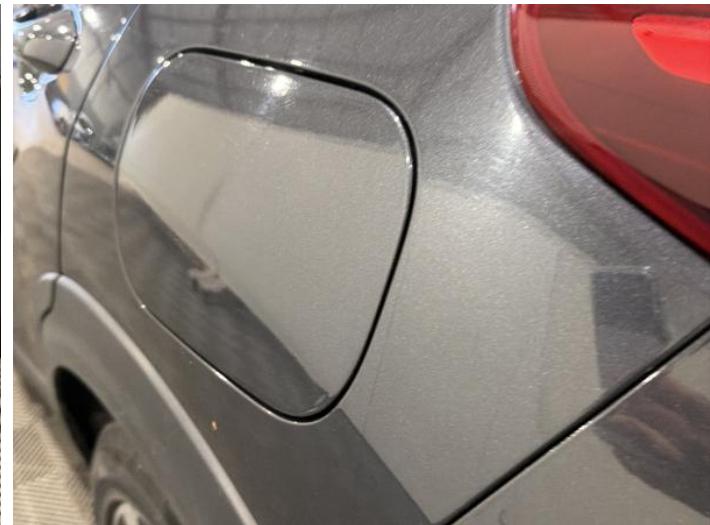
10: Qtr Panel nsr
Chipped
1 To 5

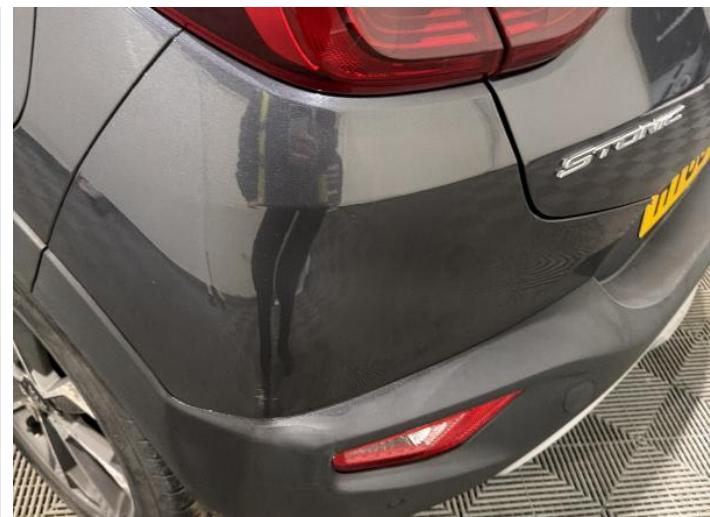
12: Bumper Rear
Scratched
25 to 100mm Thru Paint

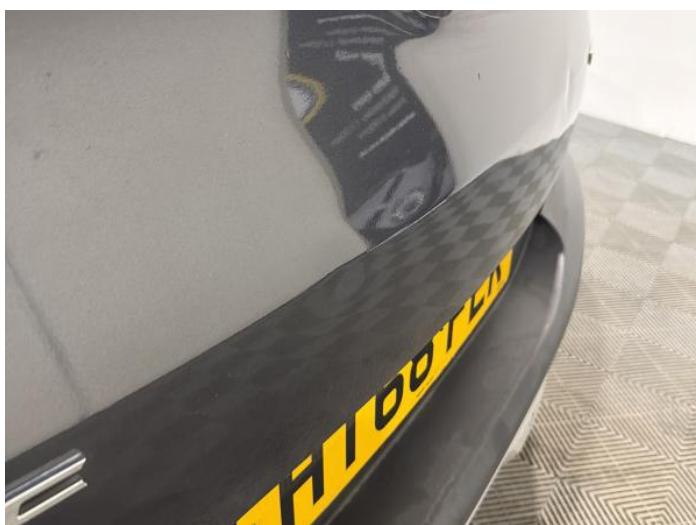
13: Boot Lid
Dented
Over 30mm

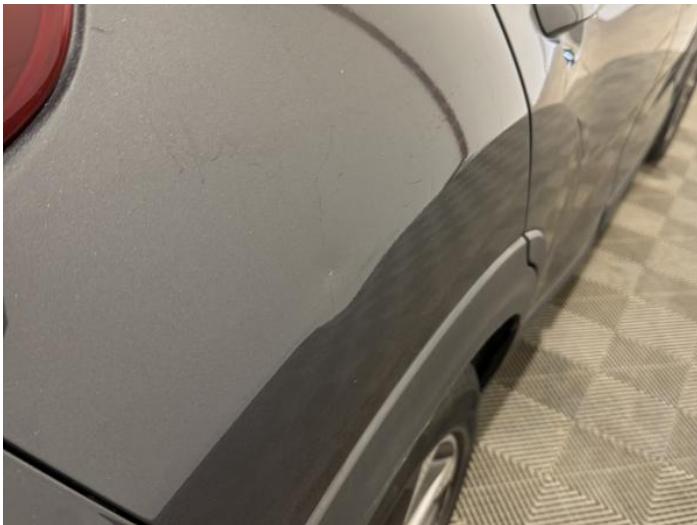
15: Qtr Panel osr
Dented
Between 10mm + 30mm

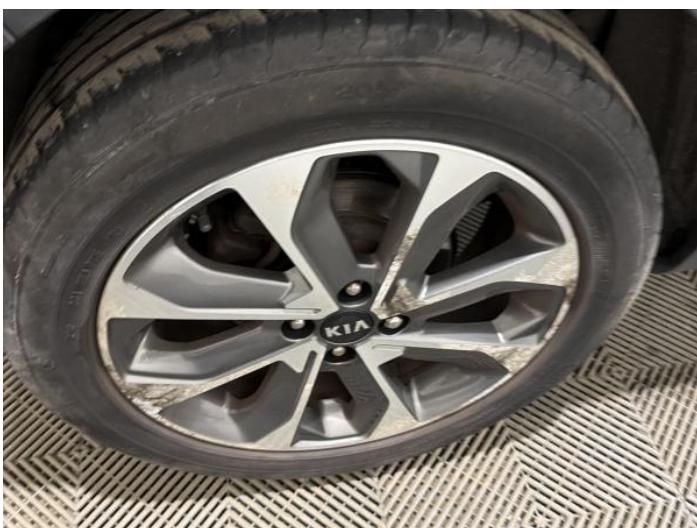
17: Wheel osr
Scratched
Over 50mm

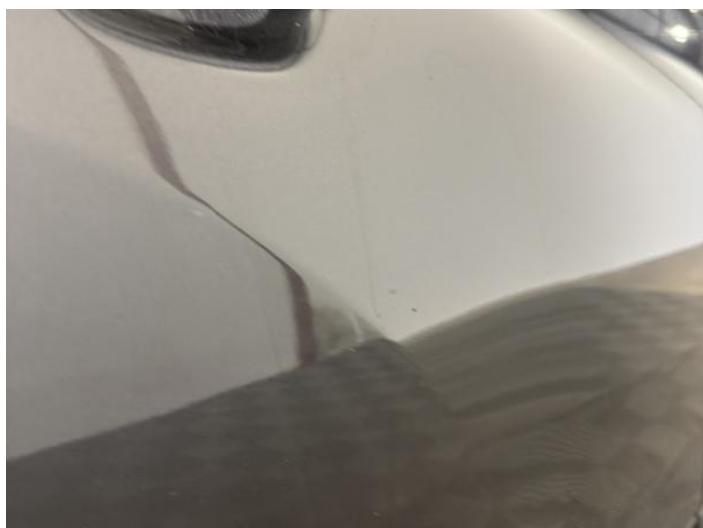
18: Door osr
Dented
Over 2 UpTo 10mm

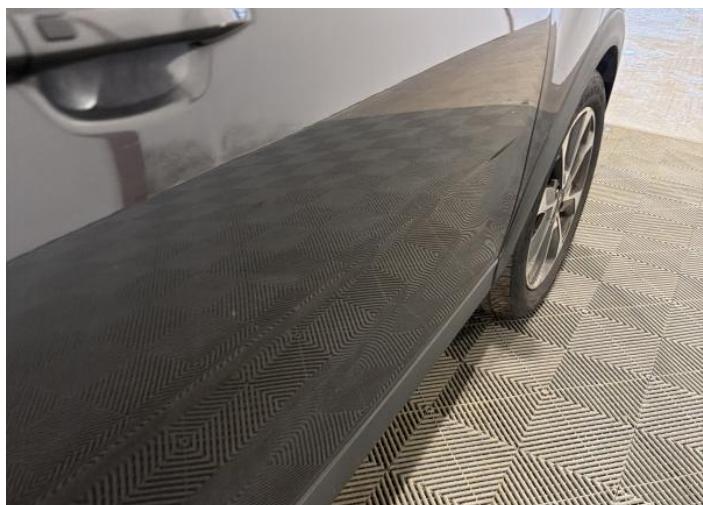
20: Door osf
Chipped
1 To 5

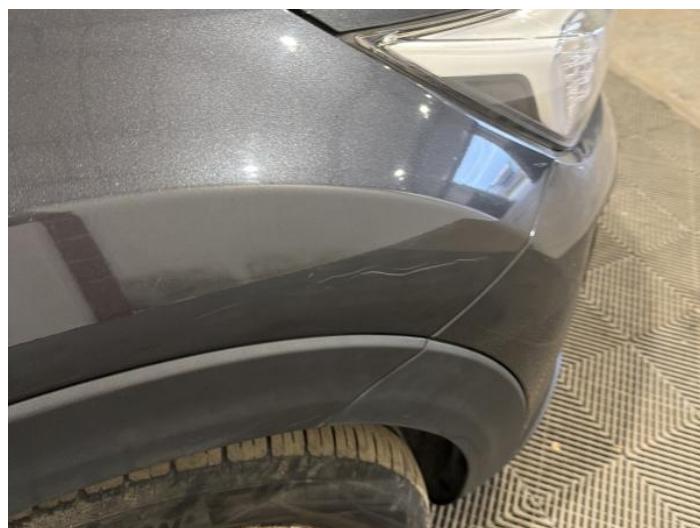
23: Wing osf
Scratched
Over 25mm Thru Paint
