VEHICLE INSPECTION REPORT

GD17JYG

Suzuki Swift 1.0 Boosterjet SZ-T 5dr

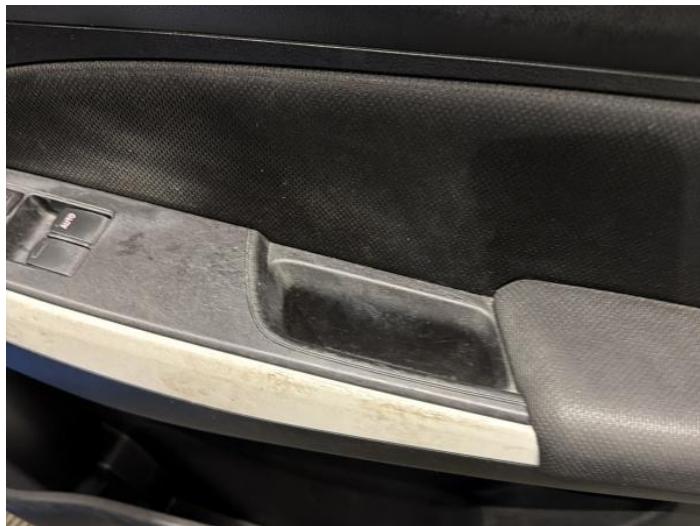
1: Door Pad osf
Scuffed
UpTo 25mm

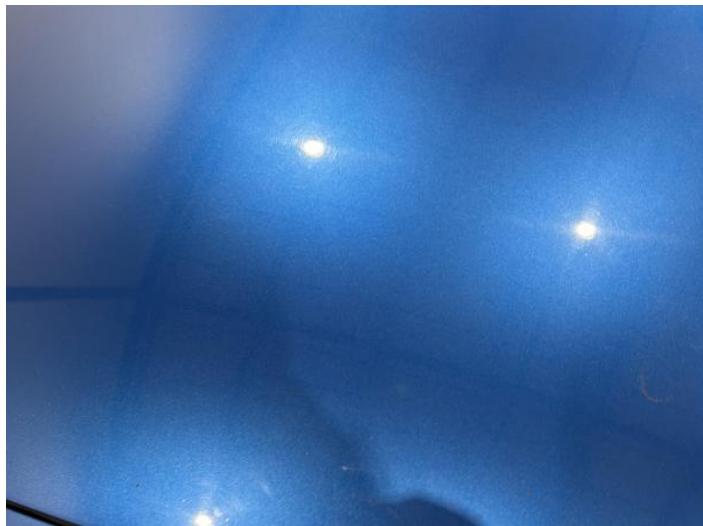
2: Bonnet
Dented
With Paint Damage

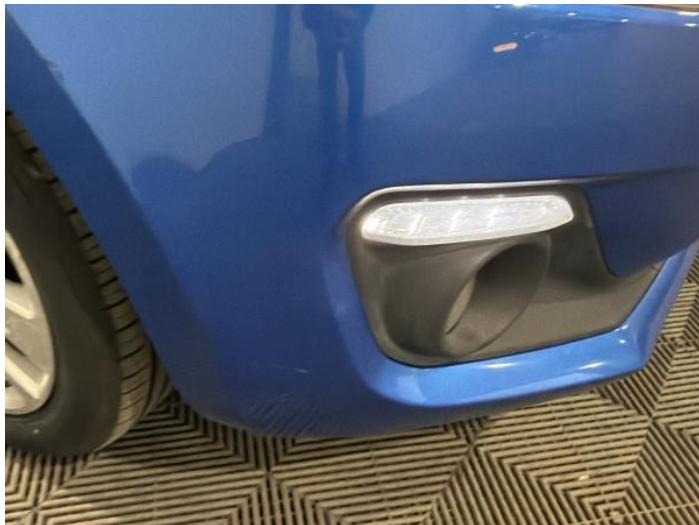
3: Bumper Front
Scratched
Over 100mm Thru Paint

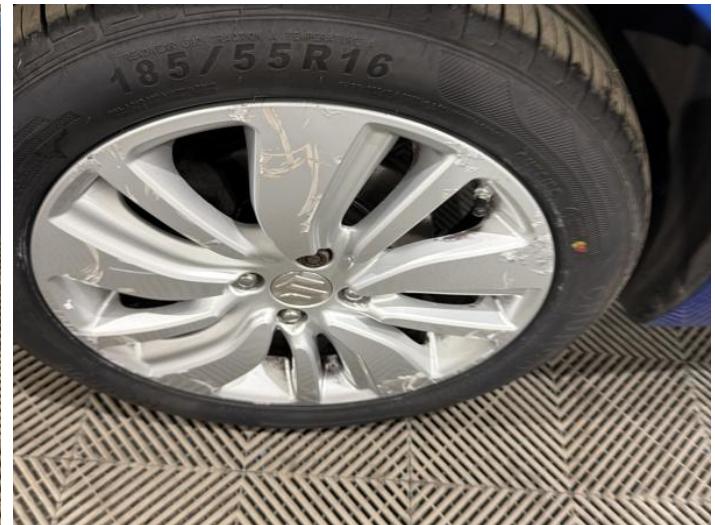
4: Wheel nsf
Scratched
Over 50mm

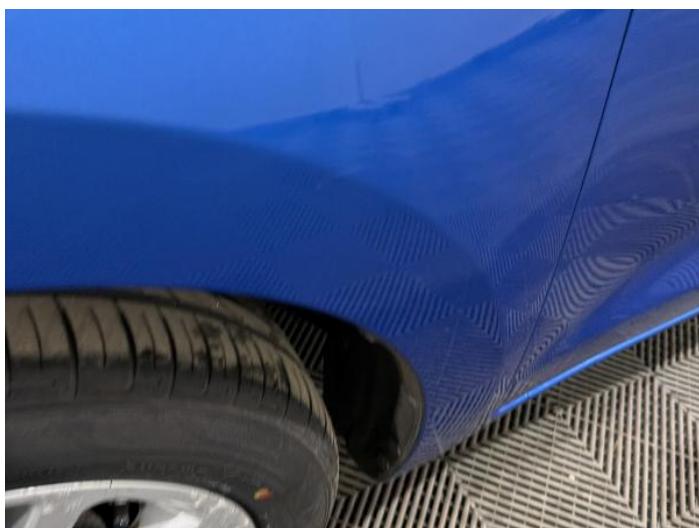
5: Wing nsf
Scratched
UpTo 25mm Thru Paint

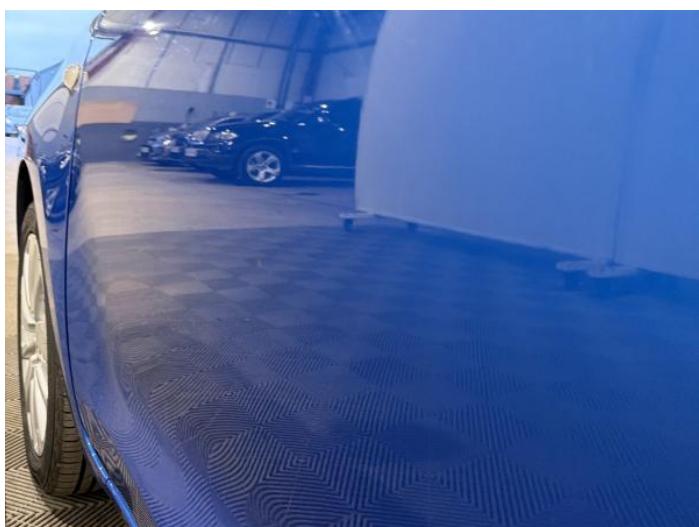
7: Door nsf
Dented
Over 2 UpTo 10mm

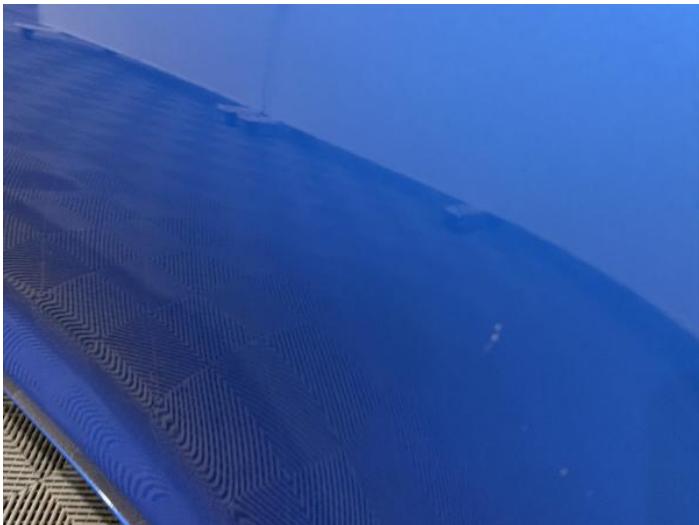
9: Door nsr
Chipped
1 To 5

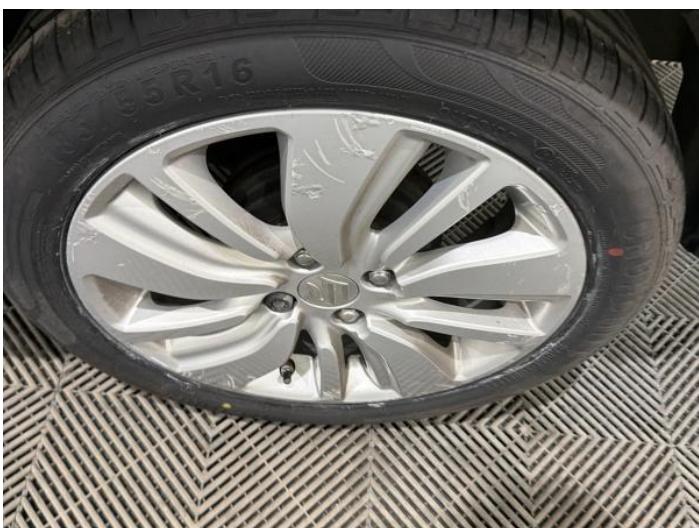
11: Wheel nsr
Scratched
Over 50mm

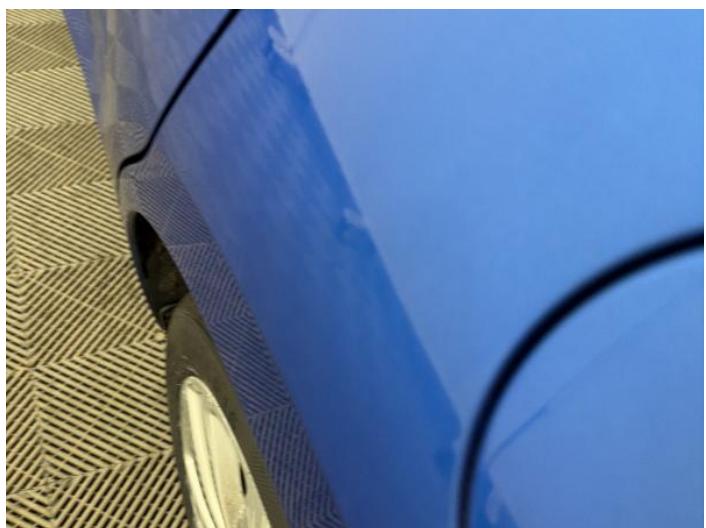
12: Qtr Panel nsr
Dented
Over 2 UpTo 10mm

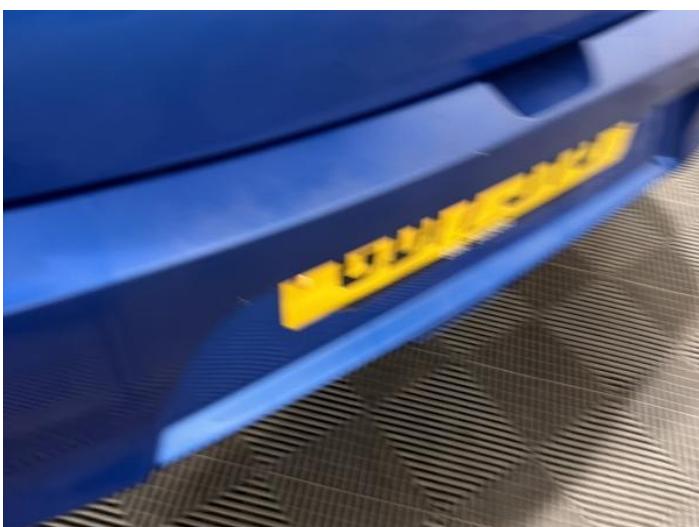
13: Bumper Rear
Poor Previous Repair
Poor Paint

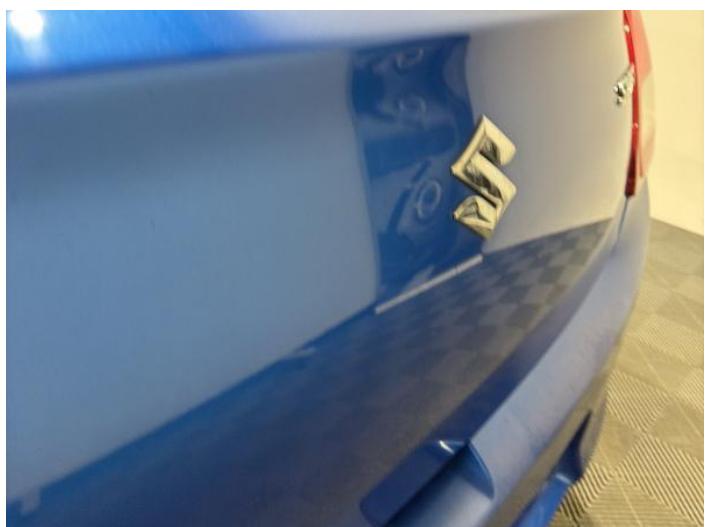
14: Boot Lid
Dented
Over 2 UpTo 10mm

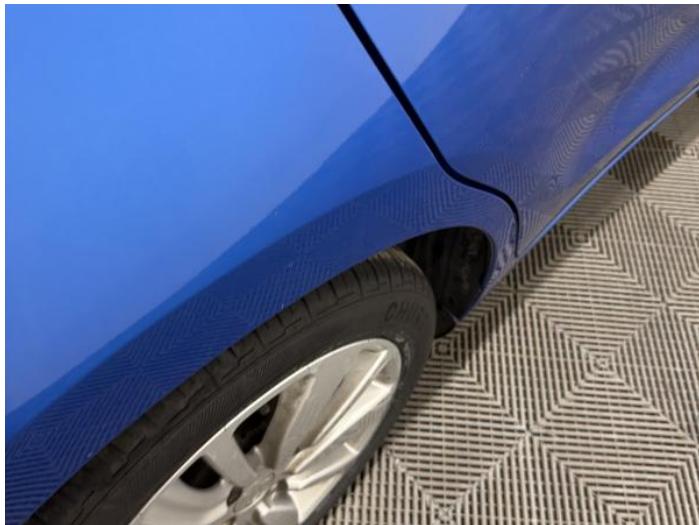
15: Qtr Panel osr
Chipped
1 To 5

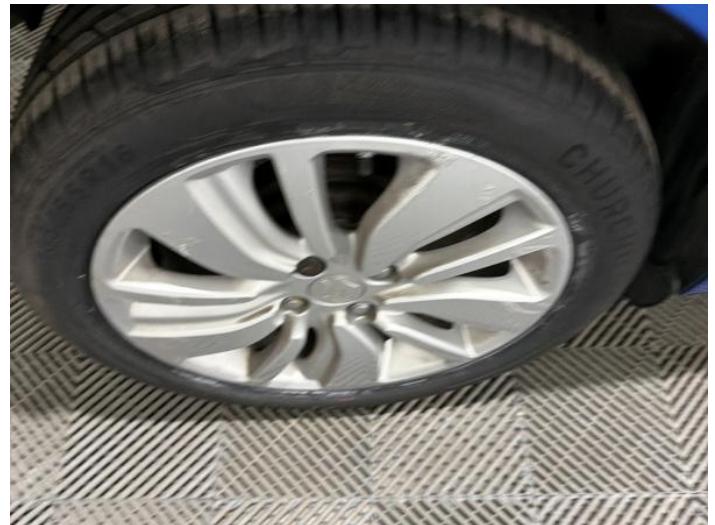
16: Wheel osr
Scratched
Over 50mm

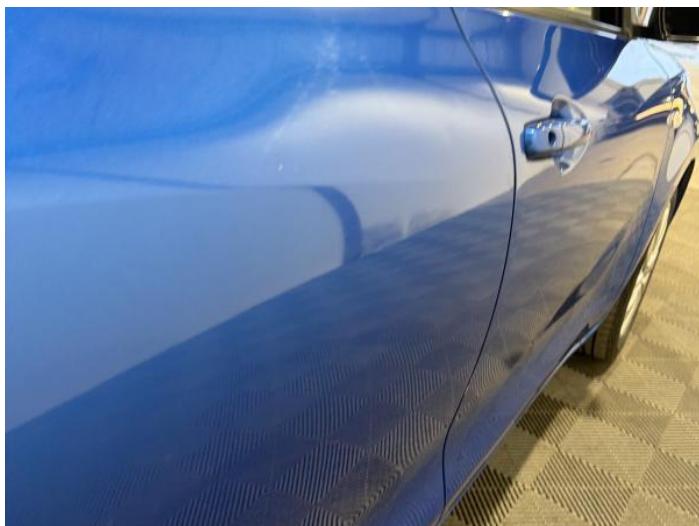
17: Door osr
Dented
Over 2 UpTo 10mm

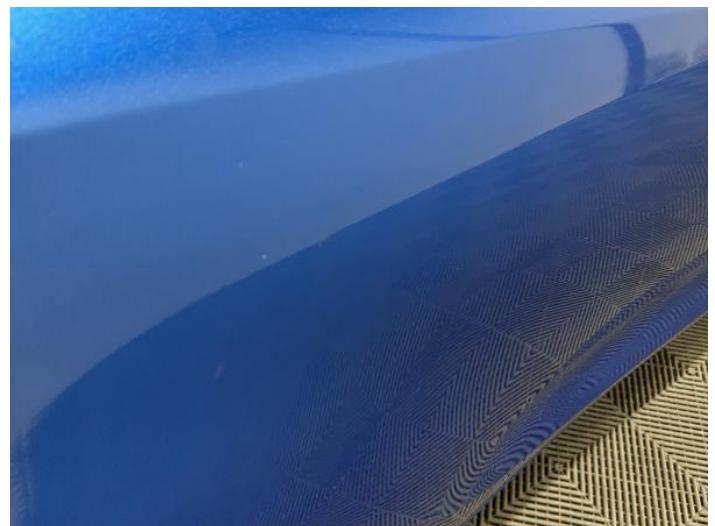
18: Door osr
Chipped
1 To 5

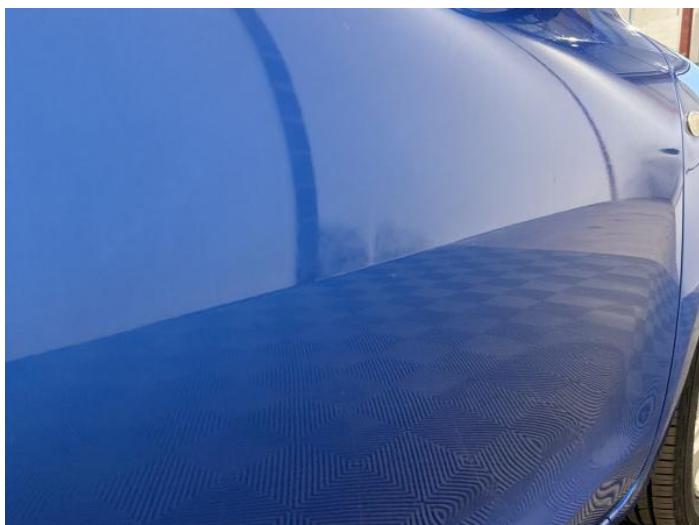
19: Door osf
Chipped
1 To 5

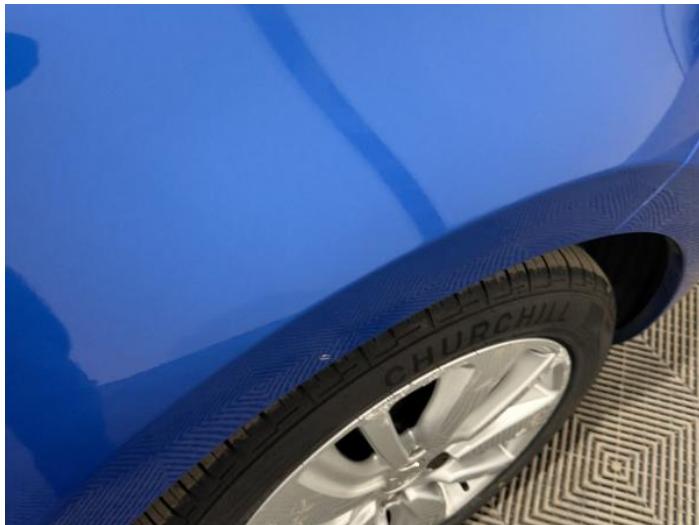
21: Wing osf
Chipped
1 To 5

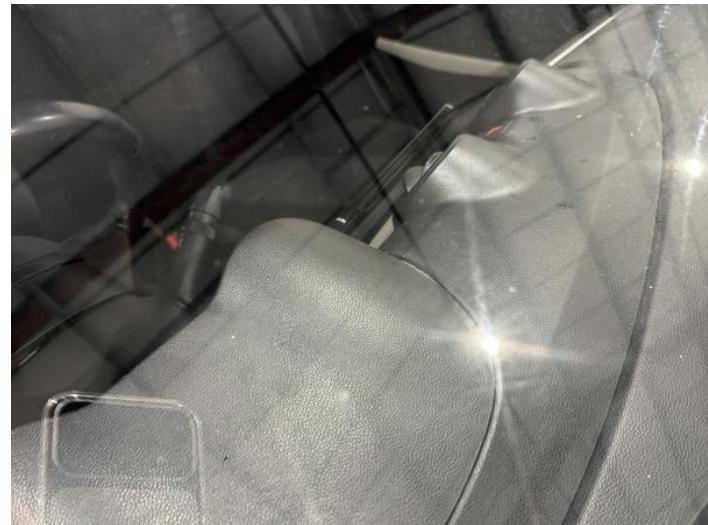
22: Screen Front
Chipped
UpTo 10mm

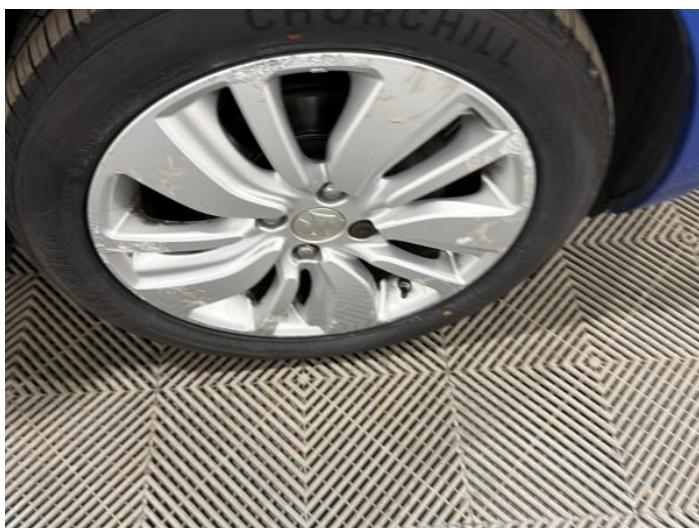
23: Wheel osf
Scratched
Over 50mm
